ATSB TRANSPORT SAFETY INVESTIGATION REPORT

Aviation Occurrence Investigation – 200601640

**Loss of control
4 km ENE Archerfield Airport, Qld
31 March 2006
VH-BST
Amateur built Lancair 320**

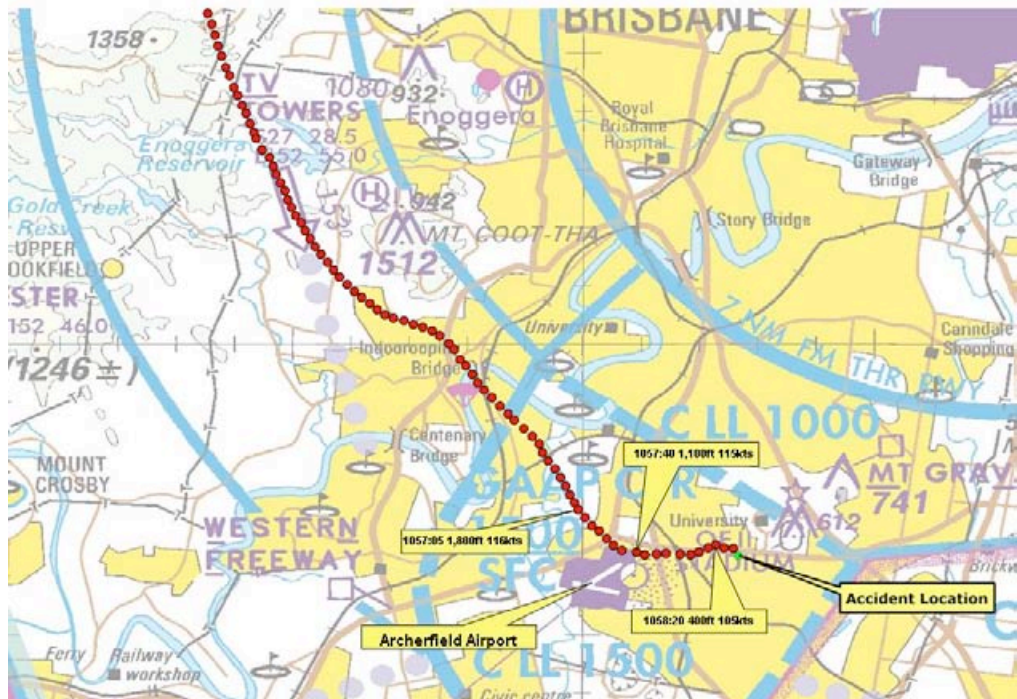
Figure 2: Radar track

Radar position and altitude information from the aircraft's transponder was received and recorded by the Airservices Australia air traffic control system. This information is overlaid on the Brisbane Visual Terminal Chart in Figure 2.

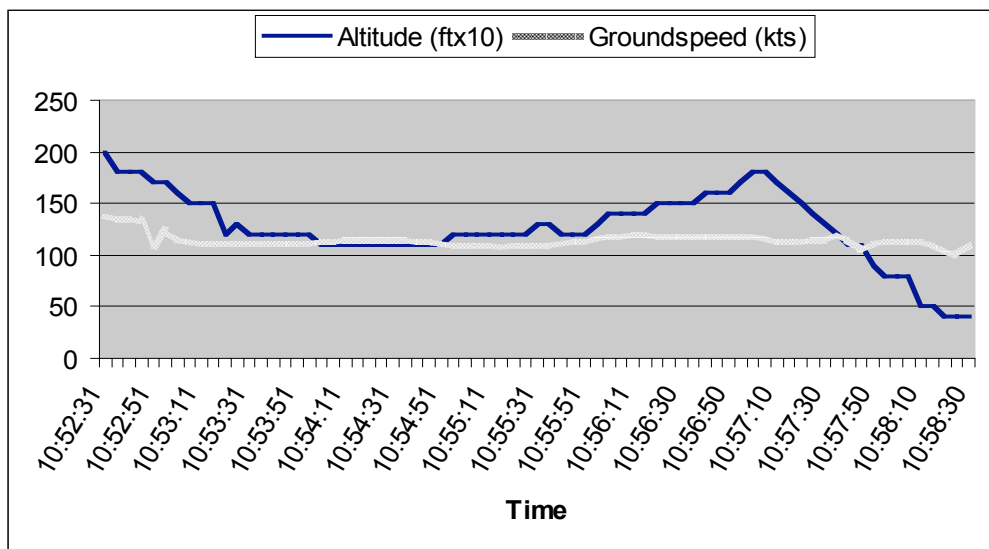
Figure 3: Aircraft altitude and groundspeed

Examination of the radar information indicated that as the aircraft approached Archerfield, it descended at high rates (Figure 3), up to approximately 1,200 ft per minute for short periods of time.

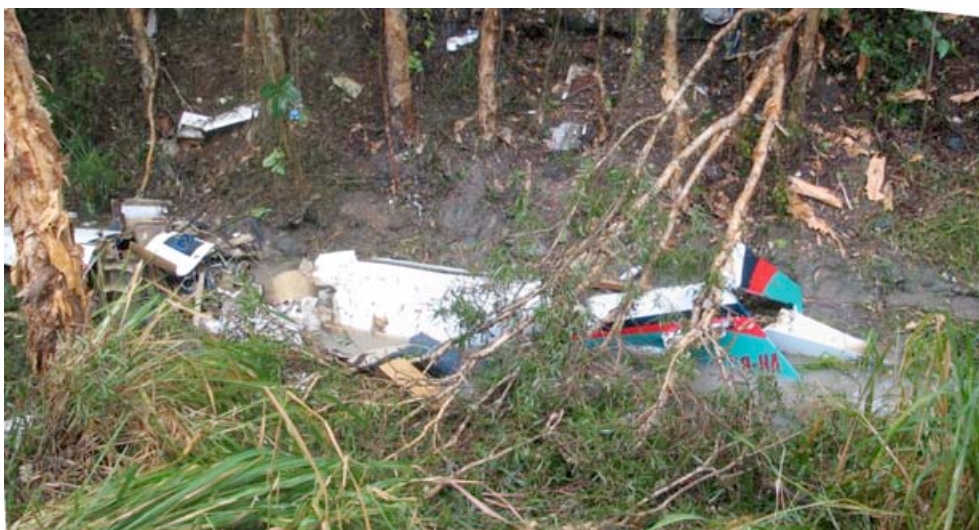
Figure 4: Accident site

The accident site was 4 km east-north-east of Archerfield Airport, near the northern boundary of the grounds of the Queensland Health Scientific Services facility. The aircraft initially collided with trees before coming to rest in a creek. Most of the

aircraft components were located in or on the banks of the creek (Figure 4), with a few components recovered from Kessels Road.

- the aircraft was in a steep nose-low, near vertical pitch attitude at the initial impact point
- the aircraft was rotating rapidly to the left around the vertical axis at the time of impact
- damage to the propeller was consistent with the engine delivering power at the time of impact
- the frangible plastic drive shaft of the engine-driven vacuum pump was intact
- there was no evidence of any pre-impact structural or flight control defects
- the wing flaps were positioned at the cruise flight setting of -7 degrees⁶
- the aircraft altimeter subscale was set to 1015.
