**ATSB TRANSPORT SAFETY INVESTIGATION REPORT**

Aviation Occurrence Report – 200603130

**Taxi Incident – JFK Airport, NY, USA – 29 May 2006**

**Boeing Co. 747-400**

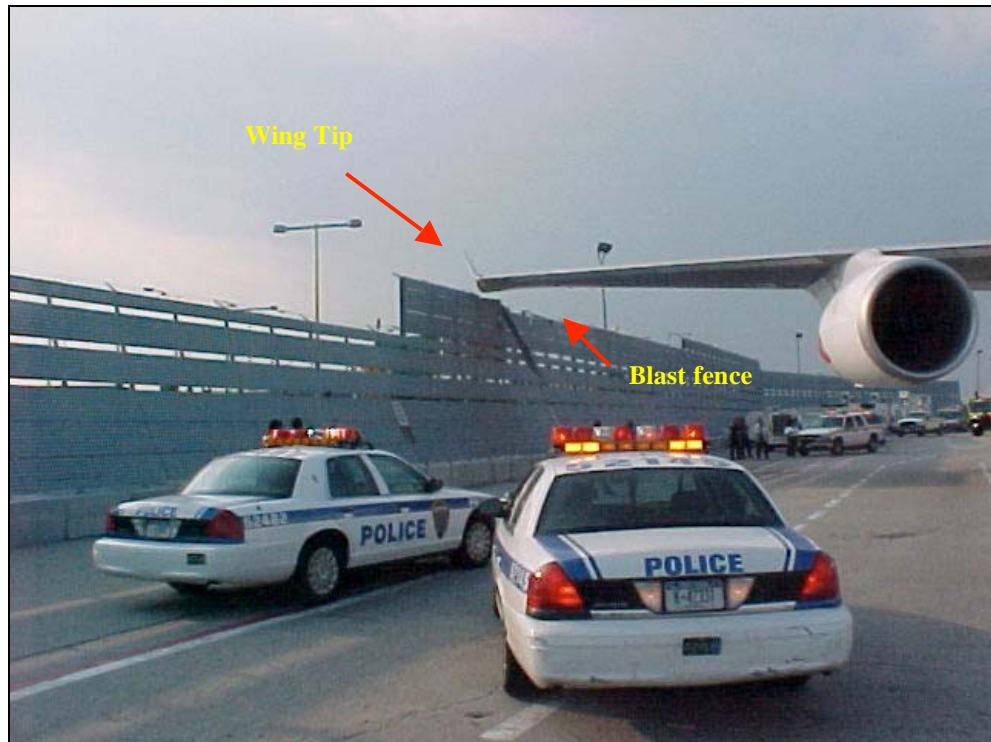
**Figure 1: 747-400 wing tip and blast fence**

On 29 May 2006, a Boeing Co. 747-400 was taxiing at New York, John F Kennedy (JFK) Airport. During the aircraft's final turn into its allocated parking bay (terminal 7, bay 3), the right wingtip contacted a blast fence<sup>1</sup> (Figure 1), resulting in damage to the outboard end of the right wing.

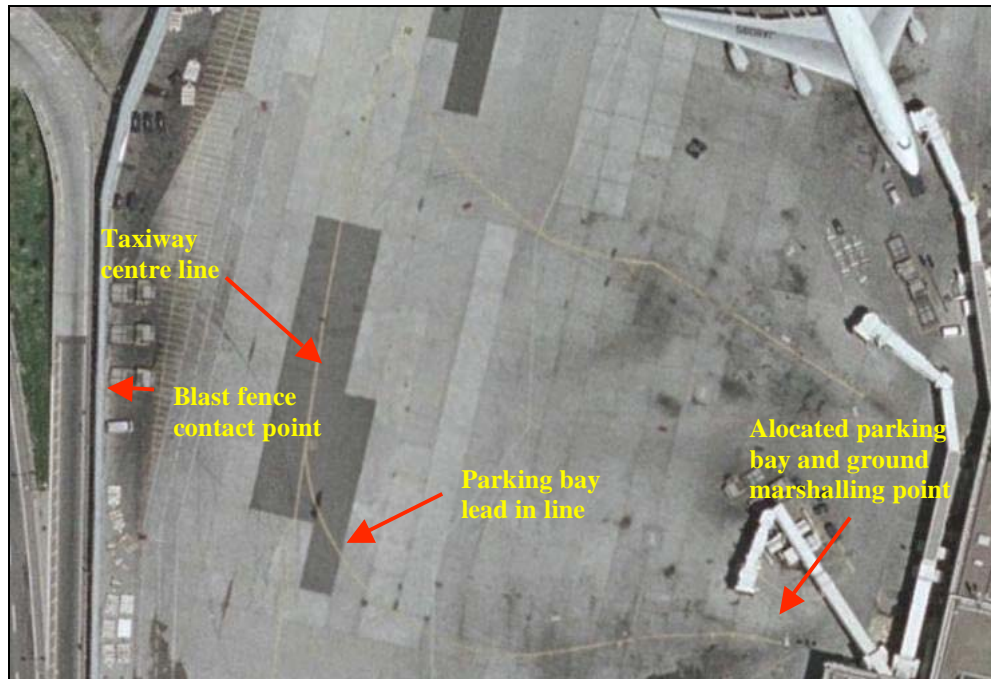
**Figure 2: JFK Airport incident taxiway**

The aircraft had deviated to the right of the taxiway painted centreline and had also taxied past the assigned parking bay lead-in line.

The convergent nature of the taxiway with the blast fence was not noted in any pilot documentation. An almost identical incident had occurred in 2003 at the same section of taxiway with the same aircraft type belonging to a different operator.

Figure 2 is a picture of the taxiway and parking bays at JFK airport where the incident occurred. A 747 aircraft does not have to taxi too far past the parking bay lead-in line before the wing tip clearance to the blast fence becomes insufficient to safely make a turn.

The ramp area at terminal 7 between gates 1 through 6 was re-surveyed and mapped. Clearance between all aircraft types shown on charts and scale available to verify distance between B747 wing tip and blast fence.

The European Aeronautical group terminal information map was updated to add a caution about the importance of maintaining the taxiway centre line to avoid contacting the blast fence.
