**ATSB TRANSPORT SAFETY INVESTIGATION REPORT**

Aviation Occurrence Report – 200603726

**Pressurisation system event – Brisbane, Qld  
29 June 2006  
VH-QOD  
Bombardier DHC-8-402**

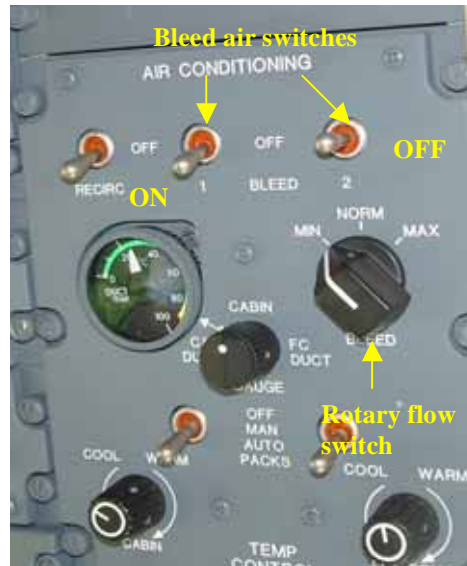
**Figure 1: Overhead air conditioning panel**

The captain reported that, on the flight immediately prior to the Mackay flight, the copilot had selected the aircraft's bleed flow rotary switch<sup>2</sup> to the Minimum<sup>3</sup> (MIN) position, and the bleed air<sup>4</sup> switches (figure 1) to OFF for takeoff. Those selections reflected the procedure in the earlier models of the Dash-8. During the pre take-off checks for that flight, the captain had identified the mis-selection, confirmed that the bleed flow rotary switch was selected to MIN, and re-set the bleed air switches to ON for the takeoff as required in the Dash 8-400.

The bleed air and rotary flow switches were located on the right overhead panel (figure 1). There was about 3 mm switch movement between the OFF and ON selections. The bleed air switches did not have dedicated background or associated lighting for use during night operations, instead relying on general residual ambient lighting from the electronic flight instrumentation system screens to illuminate the switches and their ON/OFF selection. The captain reported that, in retrospect, at night it was difficult to visually confirm the position of the bleed air switches from the respective pilot's control station. That was particularly the case from the captain's control station (figure 2 – a daytime view).

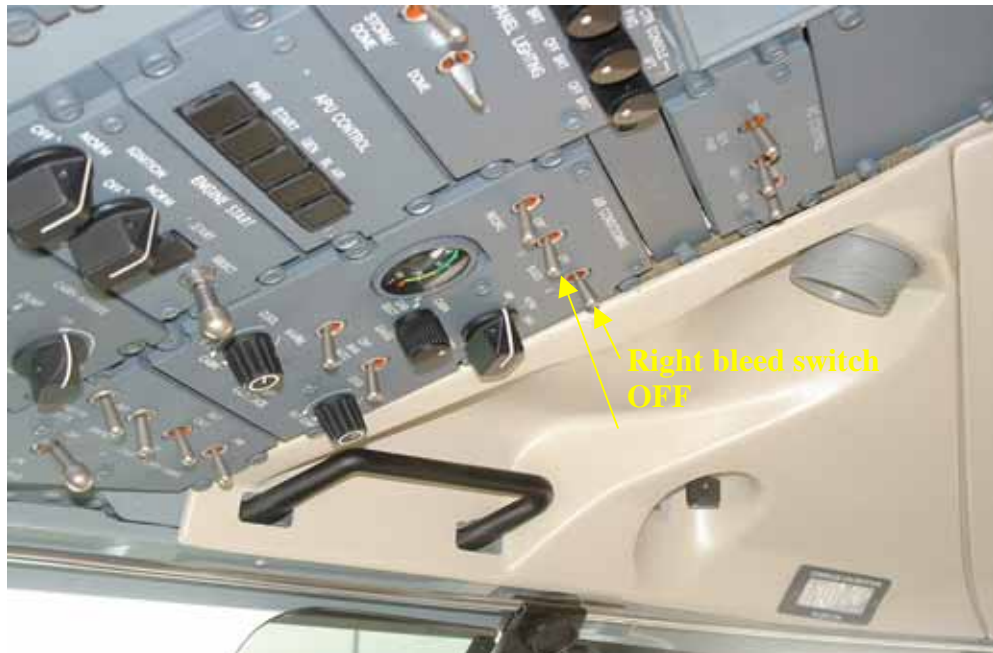
**Figure 2: Daytime view of the right overhead panel from the captain's control station**

The inconsistent detection by the captain of the mis-selections of the bleed air switches by the copilot confirmed the unreliability of the visual taxi and after take-off checks of the pressurisation system controls. The difficulty experienced by the captain during those visual checks was exacerbated by the lack of dedicated background or associated lighting to illuminate the right overhead panel.

- During the taxi for takeoff to Mackay, the copilot mis-selected the bleed air switches to OFF.
- The nature of the right overhead panel lighting and the minimal bleed air switch movement made it difficult to visually determine the position of the bleed air switches from the captain's control station. The reliance in the after take-off checklist on a visual check of the position of those switches increased the risk that any mis-selection of the switches would remain unnoticed until the activation of the cabin altitude warning light and associated warnings.

- revised responses to the pressurisation-related checklist items
- an additional Pressurisation checklist requirement to be conducted at Transition<sup>6</sup>
- the addition of the requirement for the tactile confirmation of some checklist responses, including when one pilot has responsibility for both the 'challenge' and 'response' actions.
