ATSB TRANSPORT SAFETY INVESTIGATION REPORT

Aviation Occurrence Investigation – 200604439

Stall warning device event – Alice Springs, NT

Boeing Company 717-200

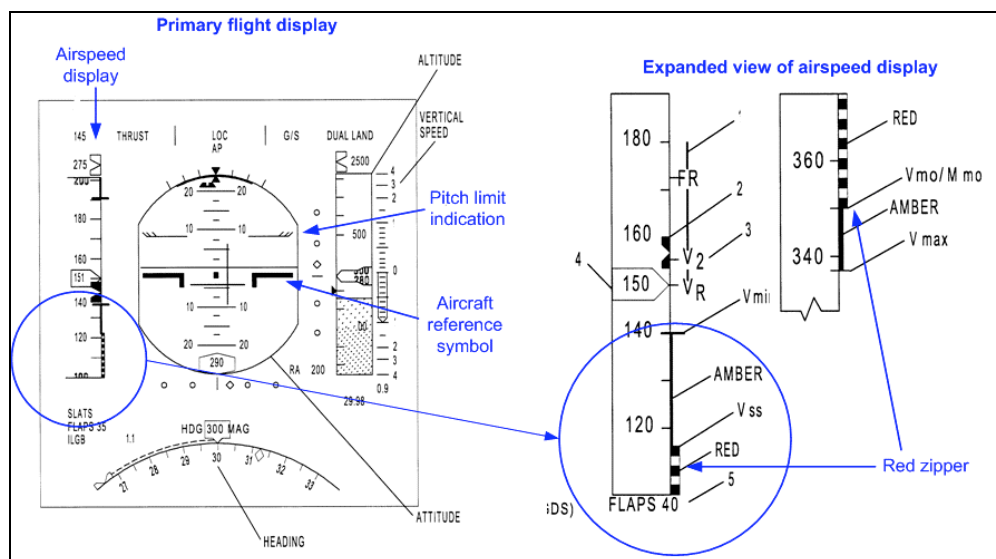
The copilot was the handling pilot for the takeoff. The flight crew reported that, as the non-handling pilot selected the landing gear lever to the retract position after lift off, they both noticed the red checked columns¹ ('red zippers') appear from the top and bottom of the airspeed display on the electronic primary flight display, and that the red zippers were converging. The aircraft pitch limit indicator² was also observed by the crew to be converging with the aircraft reference symbol on the primary flight display (Figure 1).

Figure 1: Primary flight display showing airspeed tape with 'red zipper' warning indication⁵

- the red checked column ('red zipper') appeared on the lower part of the airspeed display on both pilot's primary flight displays (Figure 1);
- the stick shakers rapidly vibrated both pilots' control columns; and
- the cyan pitch limit indicators on both pilots' primary flight displays changed to red in colour at stick shaker activation.
