ATSB TRANSPORT SAFETY INVESTIGATION REPORT

Aviation Occurrence Report – 200604514

**Engine failure
5 km W Archerfield Aerodrome, Qld
8 August 2006
VH-WNR
Cessna Aircraft Company 182P**

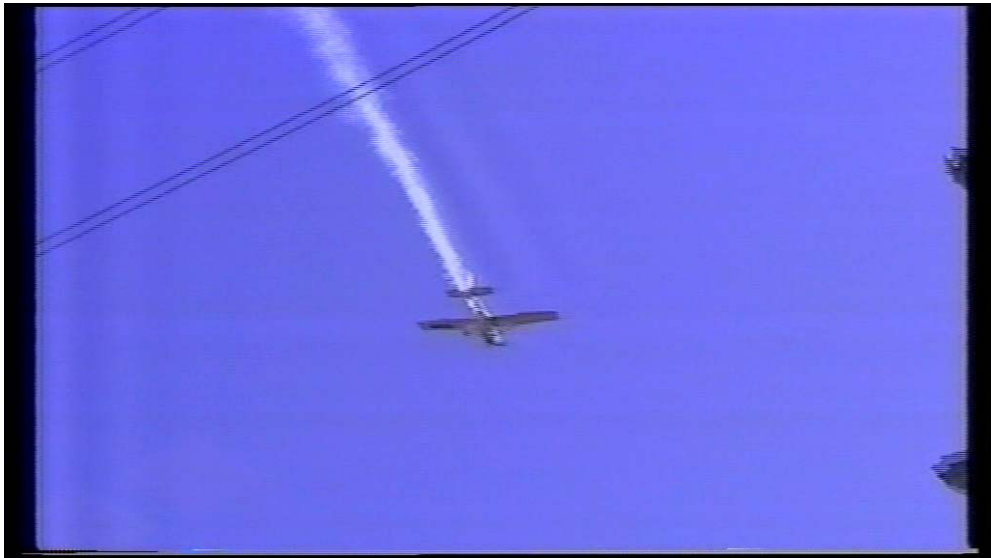
Ground witnesses reported hearing a normal aircraft piston engine noise as the aircraft approached overhead before their attention was drawn skywards by a loud 'thump'. They saw a thick stream of white smoke emanating from the right side of the engine² (Figure 2). They reported that the engine sounded as though it was 'knocking very badly' but continued to operate at reduced RPM. They observed the aircraft turn left and begin to descend. It completed two left orbits before straightening towards a clear area and disappearing from view.

Figure 2: Amateur video snapshot showing aircraft streaming white smoke

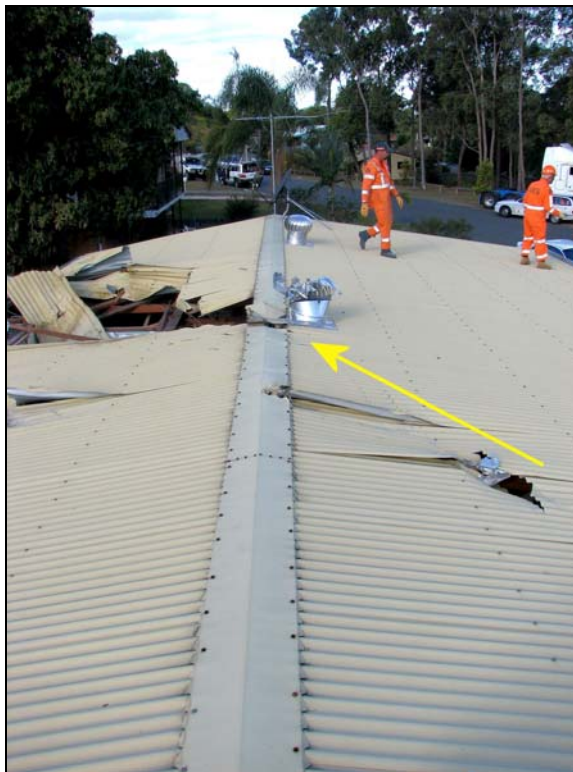
The aircraft struck powerlines before impacting the roof of a house (Figure 3). The point of contact with the power lines was approximately 20 m left of the road at the front of the house. After traversing the roof, the aircraft came to rest inverted a short distance from the rear of the house (Figure 4) and caught fire when fuel from the ruptured right wing tank ignited. The pilot received serious burns to his upper body as he escaped from the wreckage. The aircraft was destroyed by impact forces and fire. The house sustained substantial impact damage and some heat damage. Two of the three occupants of the house received minor injuries.

Figure 3: Damage to roof of house (arrow depicts aircraft path)

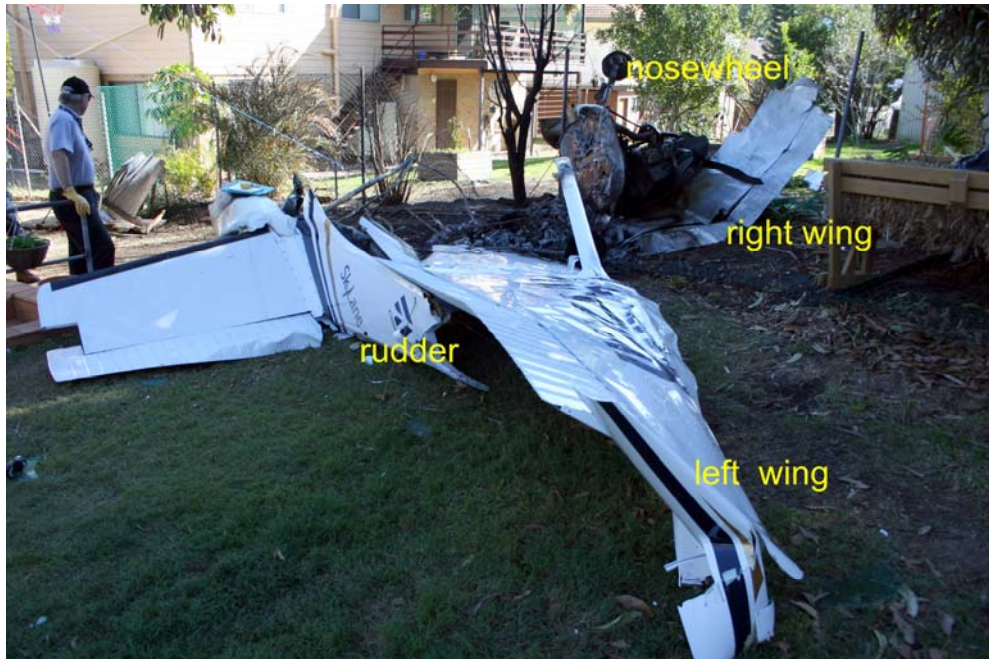
Figure 4: Aircraft wreckage

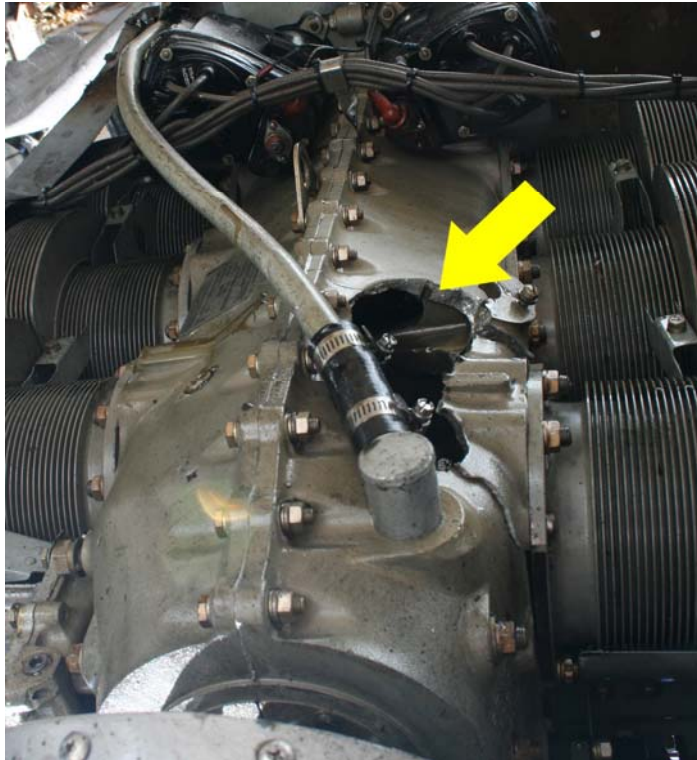
The condition of the propeller blades indicated that they were rotating at low RPM at impact. There was evidence of oil residue on the engine firewall. The engine had sustained minor impact damage. However, there was a large hole in the engine crankcase adjacent to the base of the number five cylinder that did not appear to be the result of the impact (Figure 5). The accessory drive-train remained intact. No other fault was found with the aircraft systems that might have contributed to the occurrence. The wing flaps were found in the 10 degrees position. However, airframe disruption during the impact sequence meant that the flap setting at impact could not be confirmed.

Figure 5: Engine as removed from wreckage showing hole in crankcase

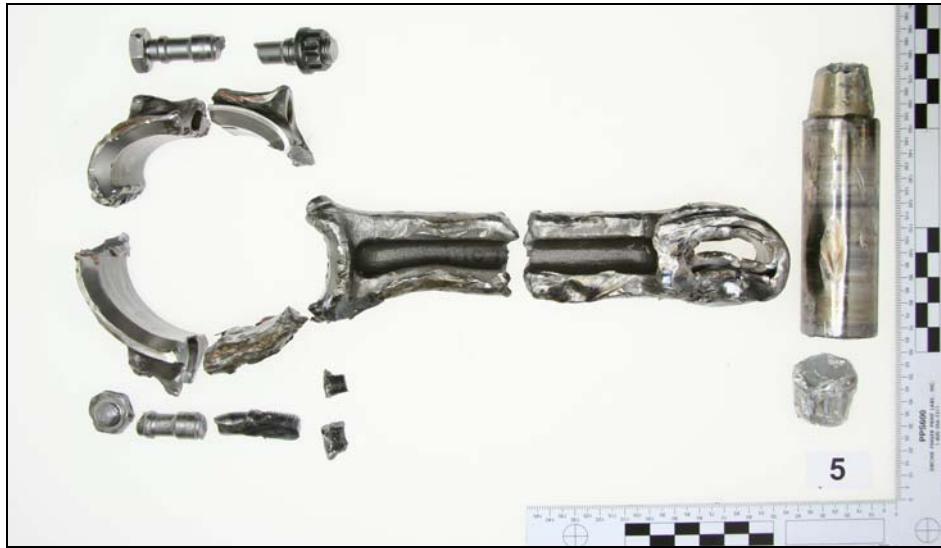
Metallurgical examination of the recovered number-5 connecting rod segments revealed that all fractures were the result of overload. Figure 6 presents the fragments collectively and illustrates the level of mechanical damage sustained.

Figure 6: Number-5 cylinder connecting rod bolt and nut assembly

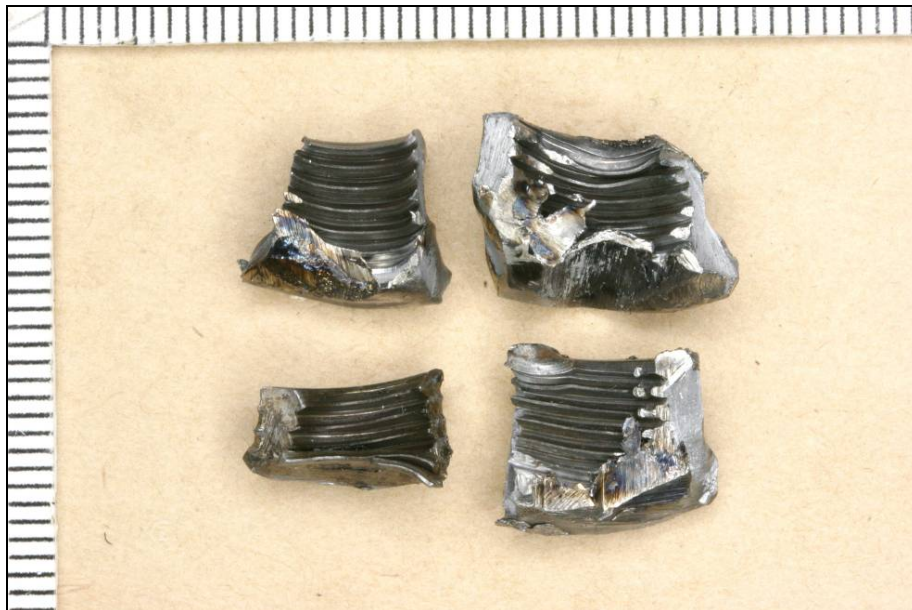
Both bolts from the number-5 connecting rod assembly had fractured and separated from the rod boss. A single point, unidirectional bending overload failure through the central shank was evident on one bolt. The other bolt was recovered in three sections that had sustained significant impact damage. The nut from the bolt was found in four pieces (Figure 7) amongst the engine crankcase debris.

Figure 7: Fragments of nut from number-5 connecting rod bolt 'B'

The nut had fractured radially. Internally, the nut thread form was intact and had not stripped onto the threads of the bolt and there were no indication that the bolt

threads had stripped within the nut. The nut fragments showed some evidence of thread-form deformation consistent with shear forces transferred through the lower nut threads.

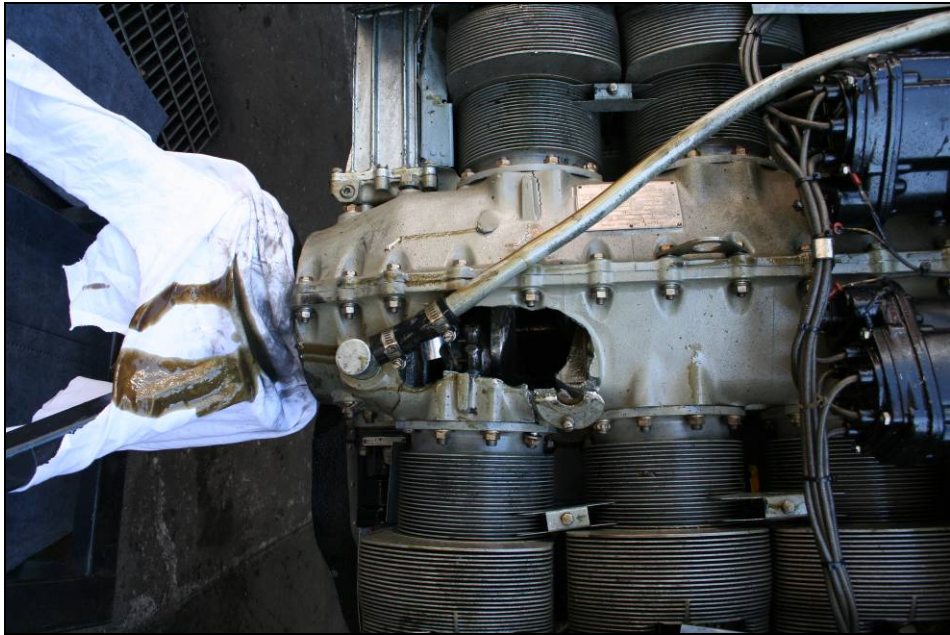
Following removal from the airframe, the engine was progressively disassembled and examined under the supervision of ATSB investigators. It was readily evident that a large section of the upper left-side crankcase had been punctured and broken away during the failure event, exposing the crankshaft and reciprocating assembly for the number-5 and 6 cylinders, as shown in Figure 1. Extensive cracking was also evident through and around the number-5 and 6 cylinder mounts. Removal of

Figure 1: Crankcase perforation sustained during the engine failure

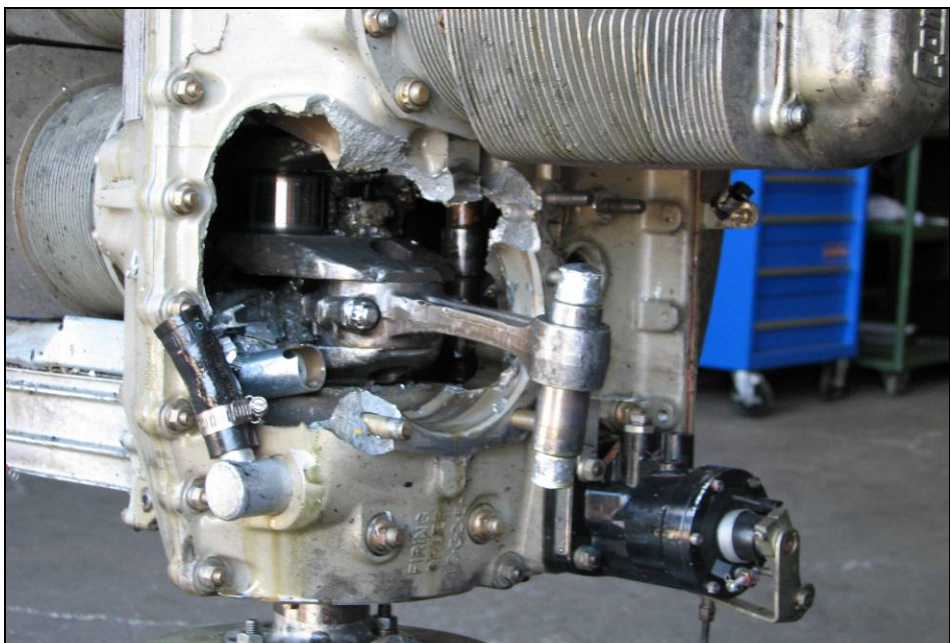
the number-6 cylinder barrel and the associated fractured crankcase section (as shown in Figure 2) exposed the number-6 connecting rod and gudgeon pin; the piston having broken up completely within the cylinder bore. Also evident through the exposed crankcase was the complete separation of the number-5 connecting rod from its respective crankshaft journal. The connecting rod and pin had also broken away from the piston body, leaving the piston upper section within the cylinder. Multiple pieces of the number-5 connecting rod were recovered from within the crankcase and sump pan, along with many piston and crankcase wall fragments.

Figure 2: Damage exposed following removal of the number-6 cylinder

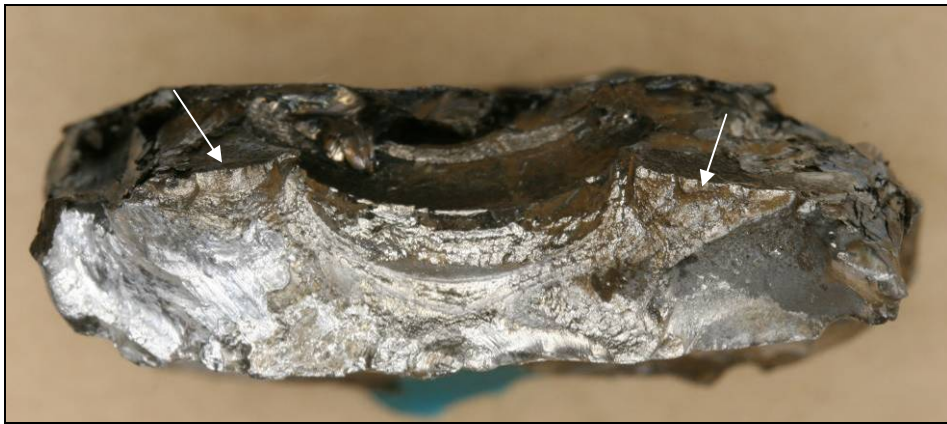
The identification of fatigue cracking within one side of the connecting rod boss signified the presence of abnormally high flexure and bending stresses within the upper boss walls. Due to the level of post-failure damage sustained by the connecting rod fragments, it was not possible to establish with any certainty the sequence of connecting rod failure. It was probable however, that reduced joint rigidity and the associated elevated stresses resulting from a reduced connecting rod bolt preload, led either to the fracture of the upper boss section from the area of fatigue cracking, or the destruction and separation of the connecting rod nut.

All major fragments of the number-5 connecting rod assembly were recovered and examined to ascertain the mechanisms contributing to the failure. Attachment A presents the fragments collectively and illustrates the level of mechanical damage sustained. The crankshaft journal boss (big-end boss) had separated into five segments, with fractures to either side of the rod-arm transition and through the centre of the bearing cap. All fractures showed significant levels of ductility and associated plastic deformation of the surrounding material, with all having sustained significant levels of post-failure mechanical impact damage. The outer surfaces of the fracture between the rod arm and one side of the journal boss (between segments 1 and 2, Attachment A) also showed some evidence of progressive, cyclic crack growth, with areas presenting features consistent with high-stress, low-cycle fatigue crack initiation and development, see Figures 3 and 4. The remaining fractures, where not obscured by damage, were all consistent with ductile tensile or bending overload failures, with no pre-existing cracking or other latent defects. Similarly, the centrally located fracture through the rod arm was also entirely consistent with mechanical overload.

Figure 3: Fragment of the number-5 connecting rod boss, showing evidence of fatigue crack initiation and growth (arrowed areas)

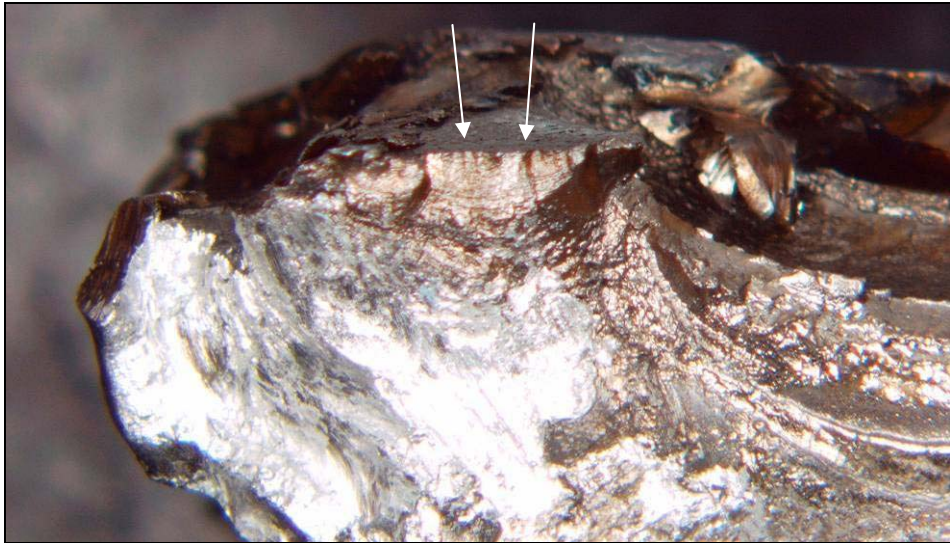
Figure 4: Closer view of a region of fatigue cracking shown in Figure 3. Surface origins as indicated

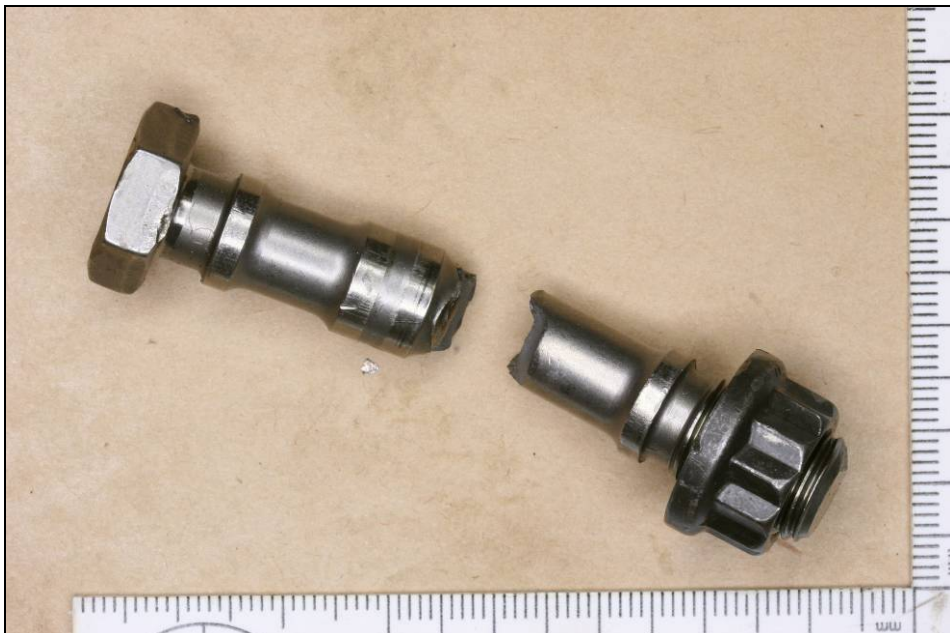
Both bolts from the number-5 connecting rod assembly had fractured and separated from the rod boss. Bolt 'A' (see Attachment A and Figure 5) presented a single point, unidirectional bending overload failure through the central shank. The typically ductile fracture showed a single crack arrest mark (see Figure 6), suggesting failure to have occurred over two loading cycles.

Figure 5: Number-5 connecting rod bolt 'A'

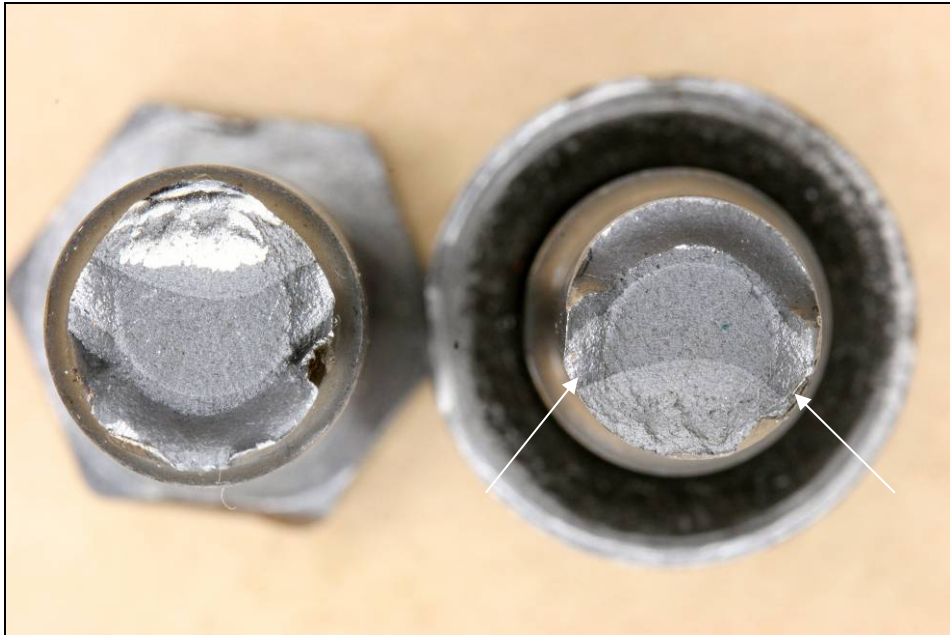
Figure 6: Characteristic bending overload fracture with single crack arrest mark

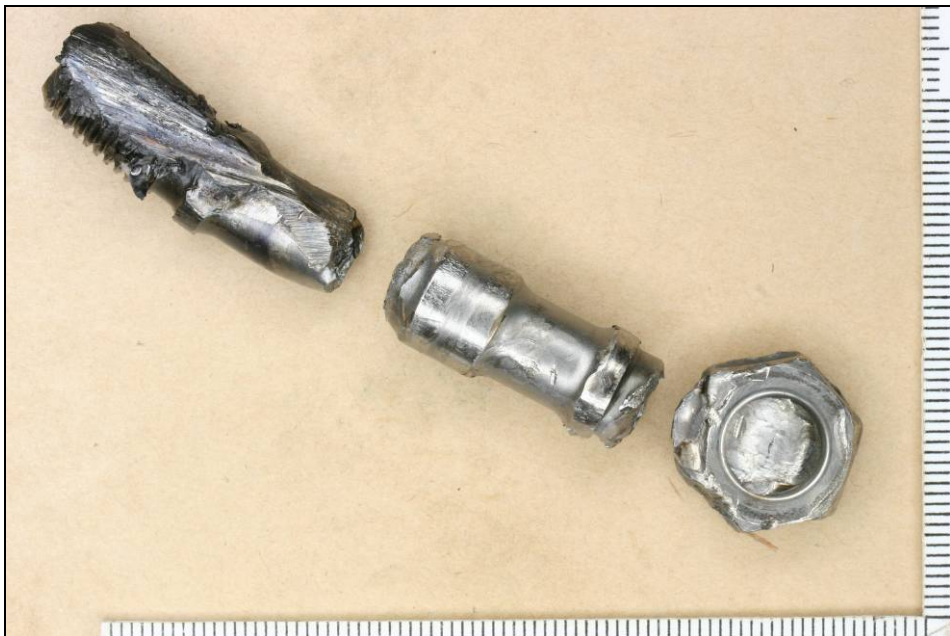
The opposing bolt (bolt 'B', attachment A and Figure 7) was recovered in three sections; all having sustained forceful sliding and impact damage. All shank fractures were typical of ductile overload under bending or shear conditions.

Figure 7: Number-5 connecting rod bolt 'B'

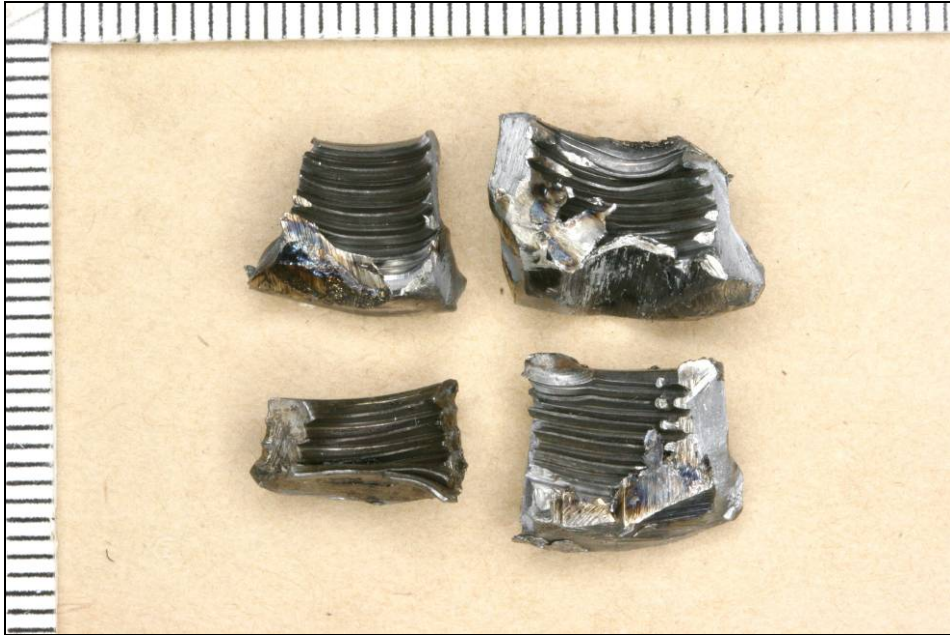
As shown in Figure 8, the nut associated with bolt 'B' was recovered in four fragments from amongst the finer debris removed from the engine crankcase during the disassembly.

Figure 8: Fragments of nut from number-5 connecting rod bolt 'B'

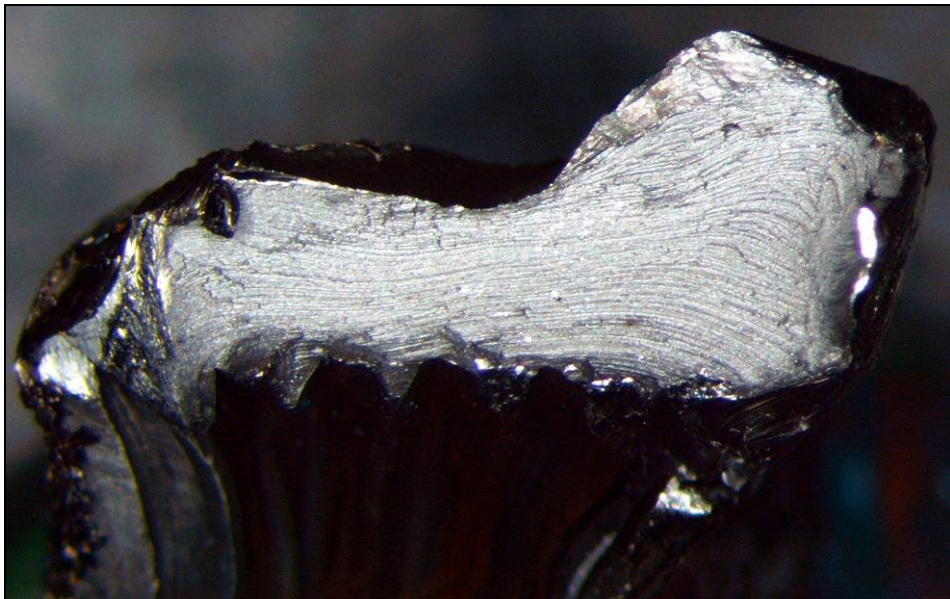
The nut had fractured radially, with all fractures presenting a coarse, woody morphology (see Figure 9), reflecting the underlying wrought material microstructure and being typical of gross overloading conditions. Internally, the nut thread form was intact and had not stripped onto the threads of the bolt, nor was there any indication that the bolt threads had stripped within the nut. Low-power stereomicroscopic study of the nut fragments did show some evidence of thread-form deformation consistent with shear forces transferred through the lower nut threads, while the threads of a similar undamaged nut showed only markings consistent with uniform thread engagement.

Figure 9: Typical 'woody' fracture surface of the failed nut

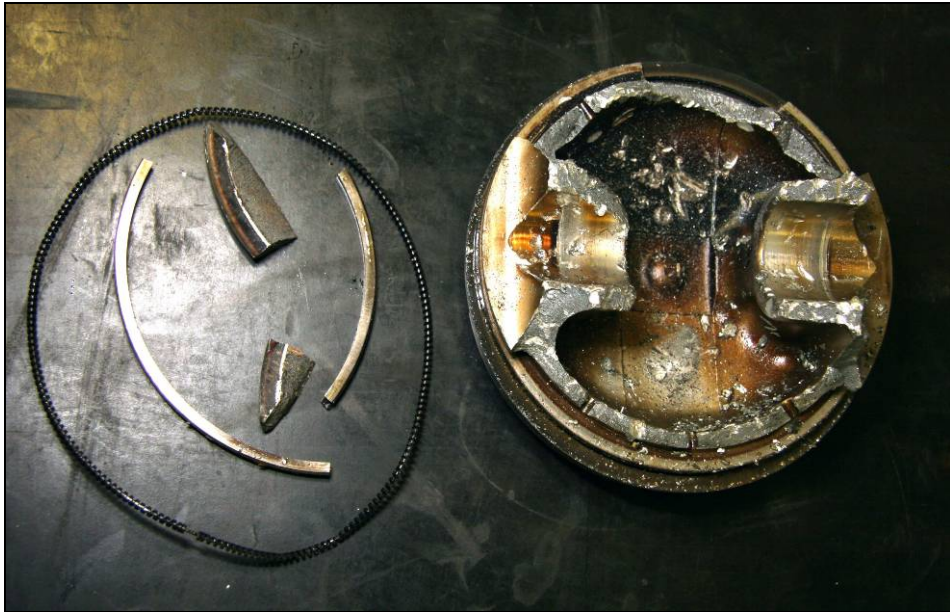
The number-5 piston had broken up around the lower skirt and gudgeon boss region, releasing the crown and upper section (see Figure 10) which remained in the cylinder until engine disassembly. All examinable fractures were similar to the number-6 piston, in that they were brittle-impact type failures, with no evidence of pre-existing defects.

Figure 10: Upper section of the number-5 piston that remained in the cylinder bore after the failure
