Aviation Occurrence Report – 200604807

Final

**In-flight engine fuel leak
482 km NW Darwin
Boeing Co. 747-438, VH-OJP
18 August 2006**

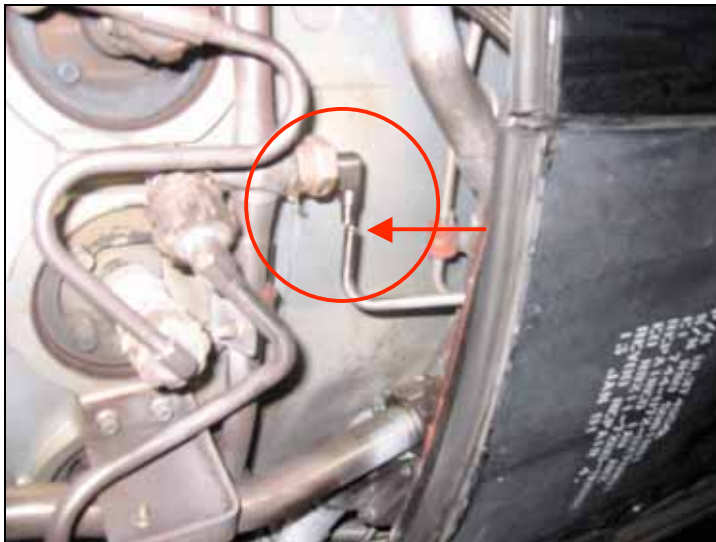
Figure 1: Previous fuel manifold drain line fracture

In 2005, the ATSB investigated two other fuel manifold return line fractures, from the same engine type, under similar circumstances (Figure 1).

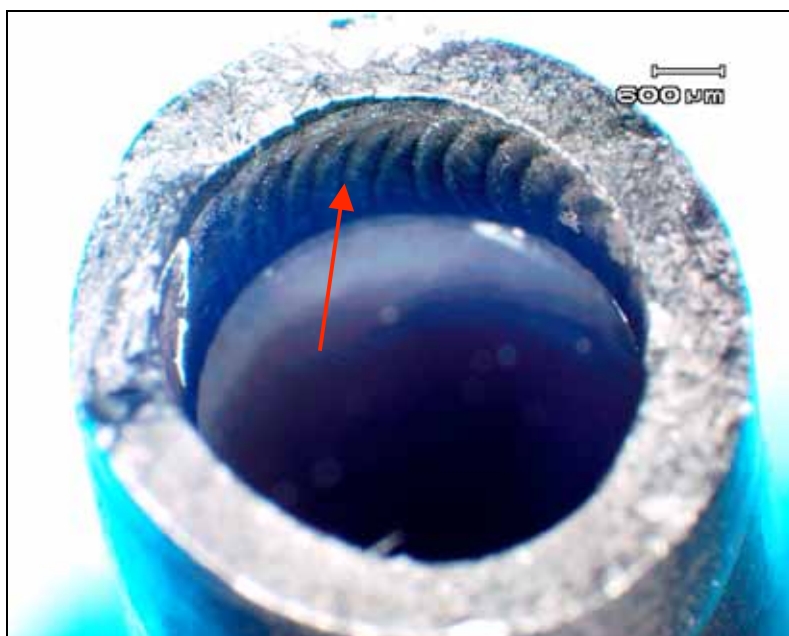
Figure 2: Fuel line fracture surface

The examination revealed that the line had fractured adjacent to a weld Heat Affected Zone³, between the fuel line and the connector (on the connector side). Using light microscopy to examine the fracture surface, a dark, crescent shaped region from the inner diameter of the line was observed. This initiation region was consistent with fatigue crack progression. The final fracture was characteristic of rapid failure.

Visual examination of the weld showed no obvious geometrical abnormalities. The weld was a relatively smooth and uniform butt weld, with no visually evident cracking along its internal or external surfaces. Figure 2 shows the welded area as indicated by the red arrow.

The line fracture surface displayed the same characteristics as the previous two lines that were inspected by the ATSB in 2005. (ATSB Safety Investigation Report BO/200505952⁴).

Due to a number of fuel manifold return line fractures on RB-211 engines (there had been seven world wide events as of 4 August 2006), the engine manufacturer introduced service bulletin SB RB.211-71-F152 on 4 August 2006. The service bulletin required the replacement of the fuel manifold return line with a new type and a change to the line retention clipping arrangement. The engine manufacturer recommended that the service bulletin be carried out at the next scheduled maintenance opportunity.

The aircraft operator, on receipt of the Service Bulletin, issued engineering instruction EI GEN-071-0180R01 on 18 August 2006. The engineering instruction detailed what engines were affected in the aircraft operator's fleet and an implementation schedule to replace the affected fuel lines.
