**ATSB TRANSPORT SAFETY INVESTIGATION REPORT**

Aviation Occurrence Investigation – 200605039

**Smoke event  
80 km west-north-west of Ravensthorpe, WA  
29 August 2006  
VH-NJE  
BAE SYSTEMS BAe 146-100**

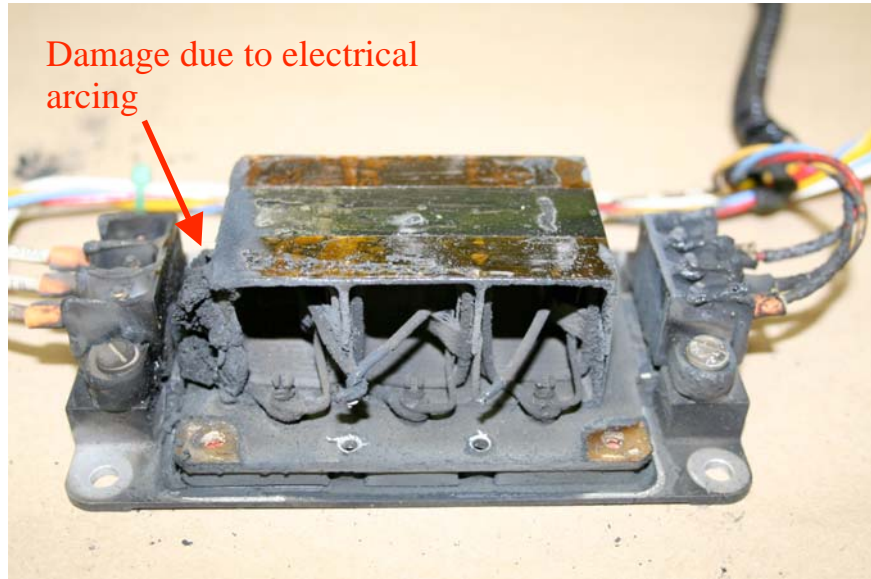
The investigation determined that the aircraft's 'A' windscreen electrostatic filter had failed. That failure was consistent with an electrical arcing event.

**Figure 2. Disassembled electrostatic filter exhibiting damage consistent with severe electrical arcing**

The failure of the 'A' windscreen electrostatic filter was consistent with an electrical arcing event. The correct operation of high voltage equipment, such as the electrostatic filter, requires effective electrical insulation. Any ingress of water, as was apparent in this case, can compromise the required insulation, with the result that electrical arcing can occur. The presence of corrosion on the filter's screw heads confirmed the presence and effect of condensation on that filter. The location of the filter in the aircraft increased the risk for that to occur.

Following the Operators' Conference, the aircraft manufacturer issued Service Information Letter (eSIL) No. 25-146-RJ-512-1. That eSIL advised operators to check the correct positioning of the insulation blankets in the vicinity of their aircraft's overhead electrostatic windscreen filters. The intent was that removing the surrounding insulation bag from direct contact with the filters would reduce the potential consequence of the event – that is, smoke on the flight deck.

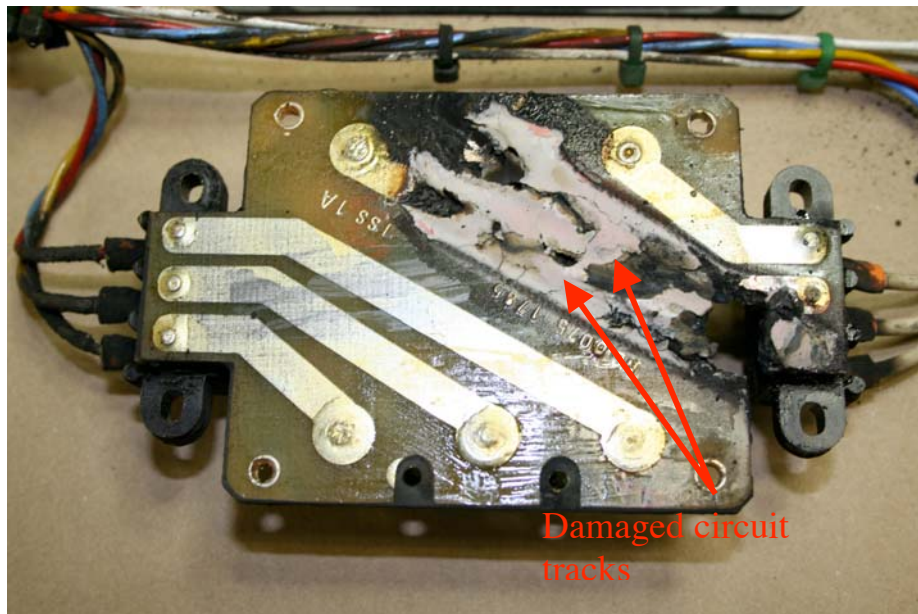
**Figure 3. Filter base, showing damaged circuit tracks**

The screw heads were subjected to microscopic examination in order to characterise the white substance. That examination identified the substance as a corrosion product of the surface cadmium plating. The corrosion was evident over all of the screw heads' external surfaces, and its structure and distribution was consistent with its formation in the presence of condensed moisture.
