Aviation Occurrence Report –200605133

Loss of control - Mt Vernon Station, WA

VH-RIL

Cessna 172L

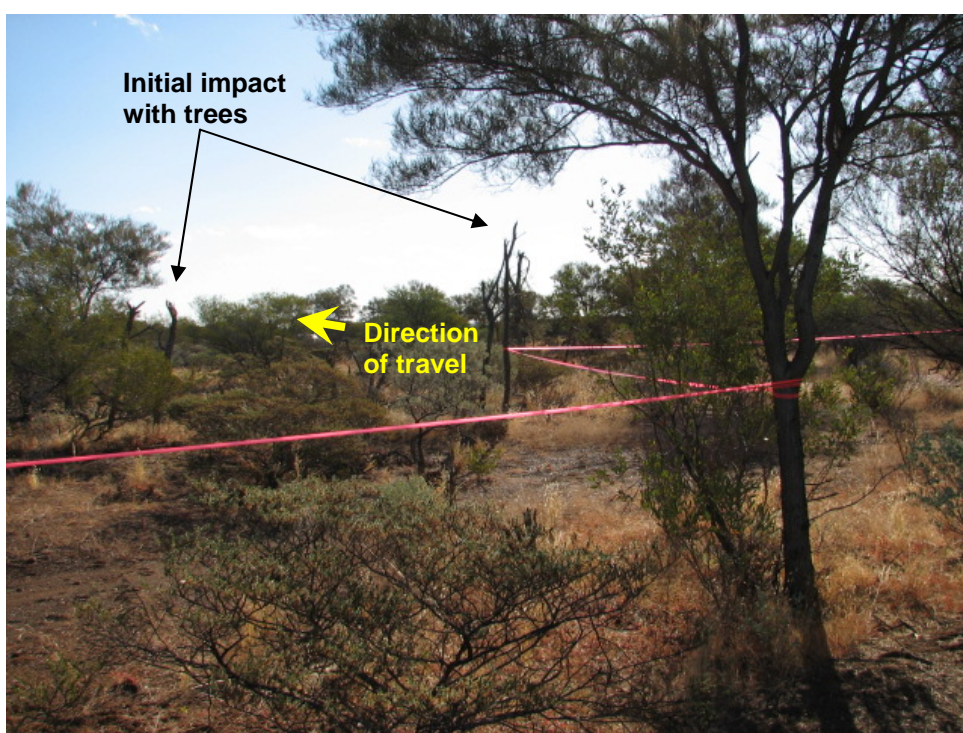
The wreckage trail extended for 70 metres, with the initial impact being contact with Mulga trees. From the dissimilar heights of the damaged tree trunks (Figure 1) and given the length of the wreckage trail, it was determined that the aircraft had entered the foliage in a left wing-low, near-horizontal attitude with a descent angle of approximately 4 degrees.

Figure 1. View looking at initial impact with trees

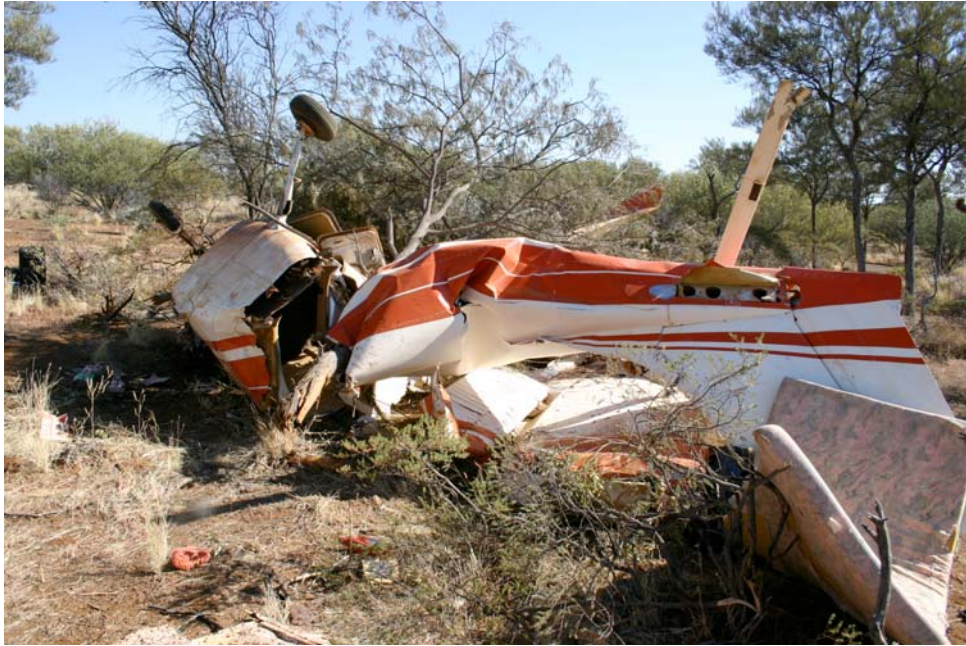
An examination of the accident site indicated that, during the impact sequence, the aircraft contacted several trees, tearing the right wing and right horizontal stabiliser from the fuselage, which resulted in the aircraft rolling to the right. The right main landing gear also separated from the fuselage, coming to rest on the left side of the wreckage trail approximately 50 metres from the initial impact. Because of its rotated attitude, the right side of the aircraft sustained the most damage, with the right door and door pillar being torn from the aircraft structure. The aircraft came to rest in a near inverted position with the fuselage breached behind the cabin (Figure 2).

Figure 2. Fuselage breached at the rear of cabin with right wing, horizontal stabiliser and main landing gear torn away

The severity of the injuries sustained by the passengers seated on the right of the aircraft were consistent with the high impact loads observed in the structural damage found on the aircraft's right side. Both front seat occupants sustained injuries to their heads and upper bodies consistent with impacting the instrument panel and control columns. These injuries would likely have been reduced had the shoulder straps been worn, restricting upper body movement.
