ATSB TRANSPORT SAFETY INVESTIGATION REPORT

Aviation Report – 200605559

**Loss of control – Canyonleigh, NSW
19 September 2006**

Boeing Stearman

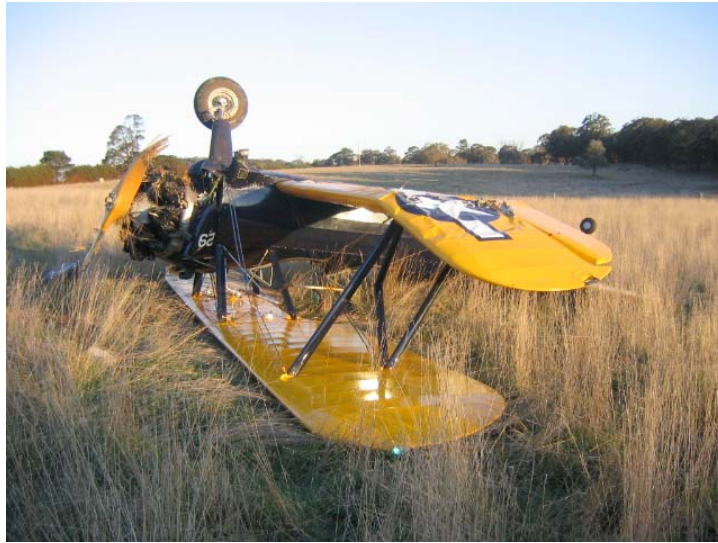
On 19 September 2006 at approximately 1630 Eastern Standard Time¹, the pilot of a Boeing Stearman aircraft, registered N-73410, experienced a control problem while taxiing. The pilot reported that the aircraft inadvertently became airborne and subsequently rolled to the left, impacted the ground, flipped over and came to rest in an inverted position (figure 1). The passenger received minor injuries and the pilot was uninjured. The aircraft was substantially damaged.

Figure 1: Boeing Stearman in paddock next to runway

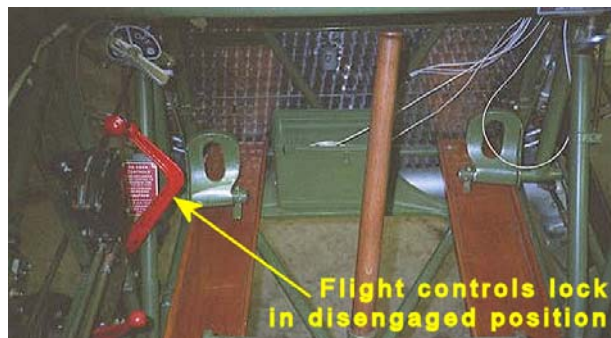
On the day of the accident, the pilot had removed the Stearman from a hanger and parked it outside to make room for a furniture delivery. It had been pre-arranged that five other people would assist the pilot in moving the furniture into the hanger. The pilot reported that the wind became blustery, so he engaged the flight controls lock on the aircraft (figure 2), which he did not normally do while it was parked outside.

Figure 2: Flight controls lock on N73410 before the accident

While conducting the taxi, at an estimated groundspeed of 30 kts, the pilot reported that he felt no control. He checked and found that the flight controls lock was engaged. He reported that he released the lock and commenced a second taxi along the strip. The pilot reported that during that taxi run 'the wind then got up, [the aircraft] hit a bump and bang I'm airborne'. At that time, he decided to continue with the takeoff to complete a circuit, as the runway slope would have made it difficult to flare the aircraft and to land. He applied full power and when he banked to the left, at approximately 40°, had no aileron control and the aircraft impacted the ground. He believes that the flight controls lock had remained engaged and had prevented him from controlling the aircraft.

The investigation could not reconcile the discrepancies between the pilot and witness accounts of the event. However, whatever the actual circumstances, it was likely that the accident would have been prevented if the pilot had prepared the aircraft for flight before taxiing. Had the pilot completed a pre-flight inspection, the

flight controls lock would probably have been disengaged and the aircraft would have been capable of being controlled when taxiing or during flight.
