ATSB TRANSPORT SAFETY INVESTIGATION REPORT

Aviation Occurrence Investigation – 200605620

In-flight engine malfunction and air turn-back

VH-TJI, Boeing Co. 737-476

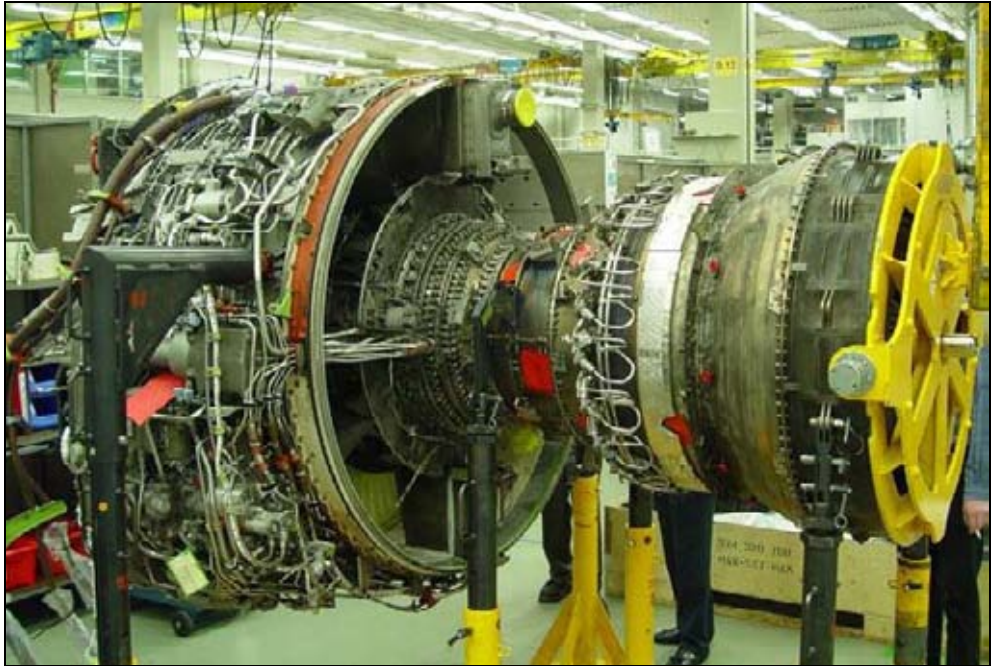
Figure 1: Left engine from VH-TJI, serial number 722113

The damaged engine (model CFM56-3C1, serial number 722113, Figure 1) was transported to the workshops of Lufthansa Technik, Hamburg, Germany, where it was disassembled and examined in the presence of a representative of the German Federal Bureau of Aircraft Accident Investigation (BFU), acting on behalf of the Australian Transport Safety Bureau (ATSB). Representatives of the engine manufacturer (CFM International) and the aircraft operator were also present during the disassembly.

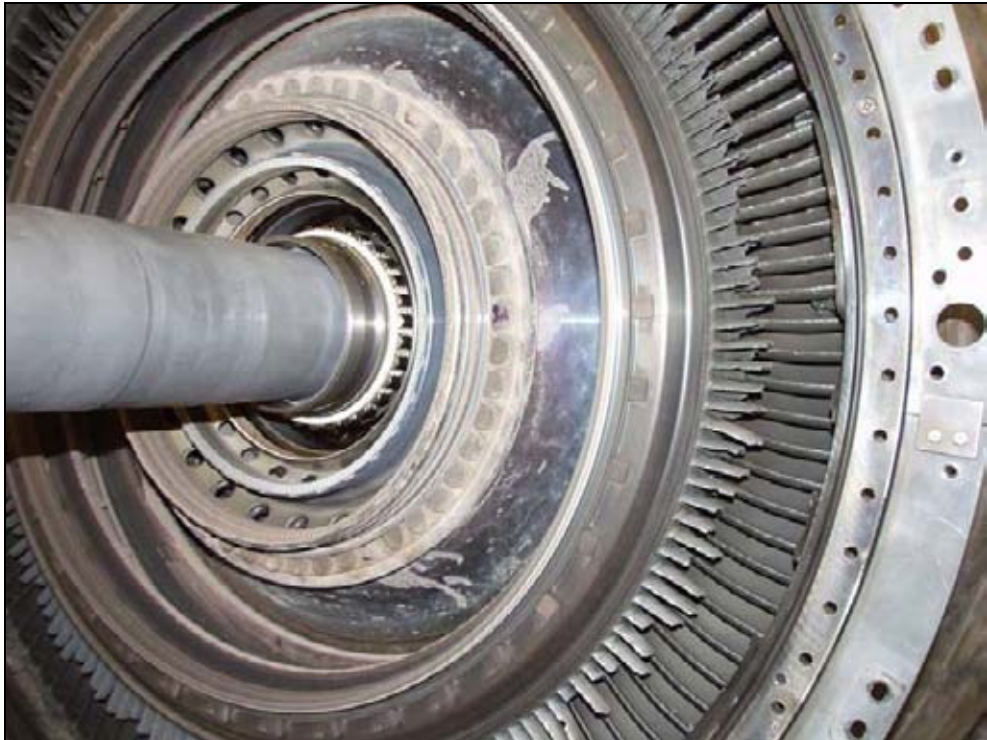
The region of failure was confirmed as the low-pressure turbine (LPT) section of the engine (Figure 2A), with all first-stage LPT blades having fractured through the aerofoil section between the blade platform and mid-span (Figures 3 and 4). Several of the remnant blade sections showed a degree of axial twisting and in-plane curvature opposite the direction of rotation (Figure 5), with the majority also showing random mechanical nicks, cracks and indentations associated with multiple and repeated impacts against the liberated debris. Evidence of prior repair and re-work blending was noted along the leading edges of some blades (Figure 6). However, there was no evidence of a correlation between the planes of fracture and the areas of re-work. The LPT stage-1 air seals and adjacent guide vanes had sustained extensive damage associated with the LPT blade rupture.

Figure 3: Damaged stage-1 LPT blades. View looking towards the rear of the engine

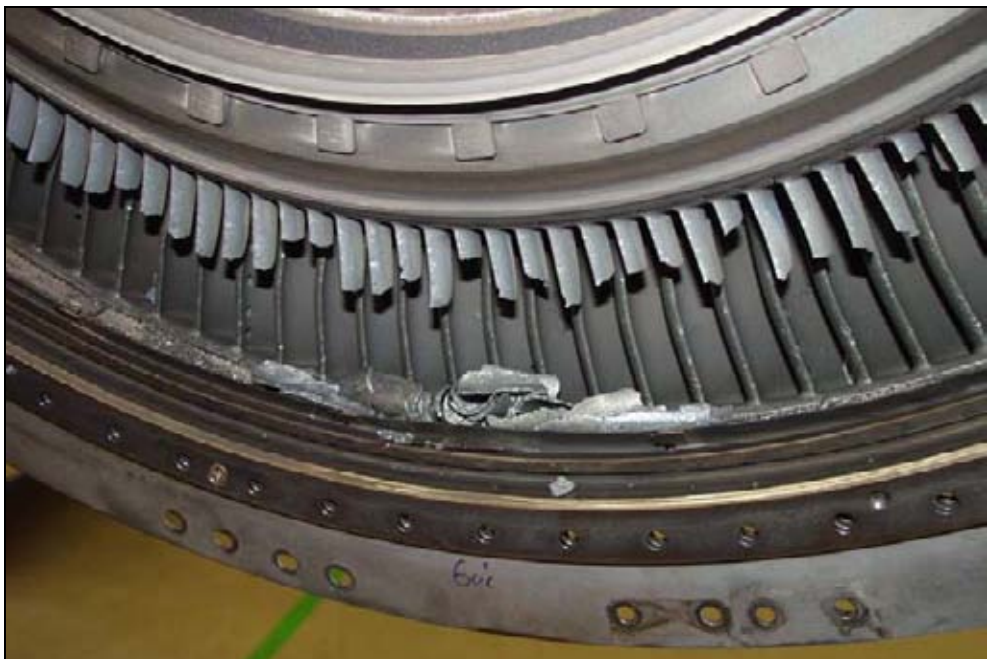
Figure 4: Stage-1 LPT disk and blades, with accumulated blade debris

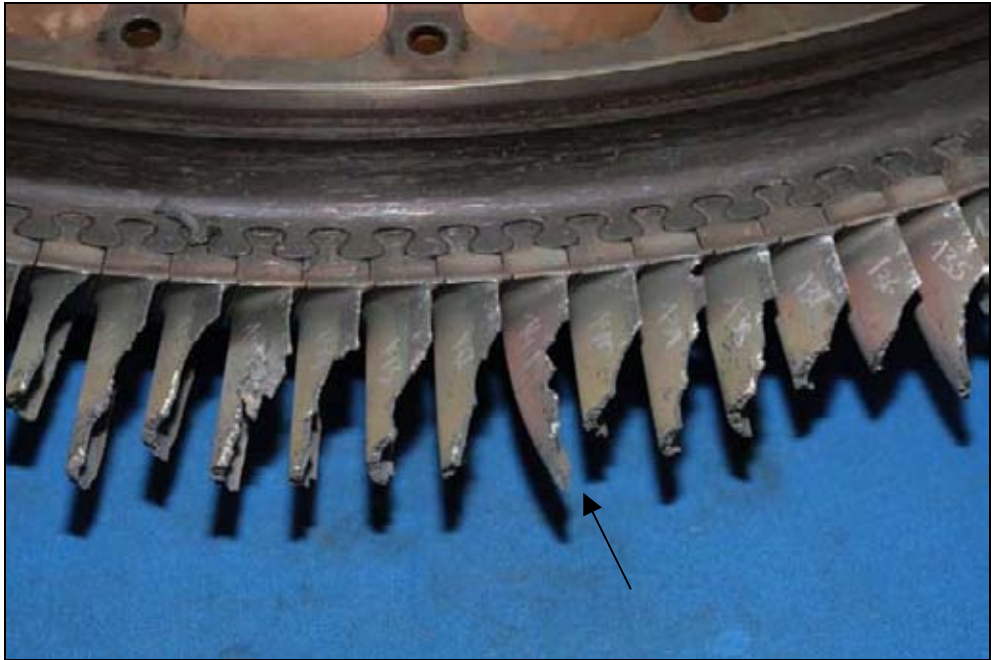
Figure 5: Damaged LPT stage-1 blades. Note the variation in colouration and curvature shown (example arrowed)

A variation noted in the surface colouration between blades from the stage-1 LPT was attributed to the re-coating of some blades using a specific aluminide product (*Sermaloy JTM*) following repair operations. A physical variation was also noted, with many of the *Sermaloy JTM* re-coated blades presenting considerably less aerofoil section twisting and distortion when compared with the unrepaired blades (Figure 5).

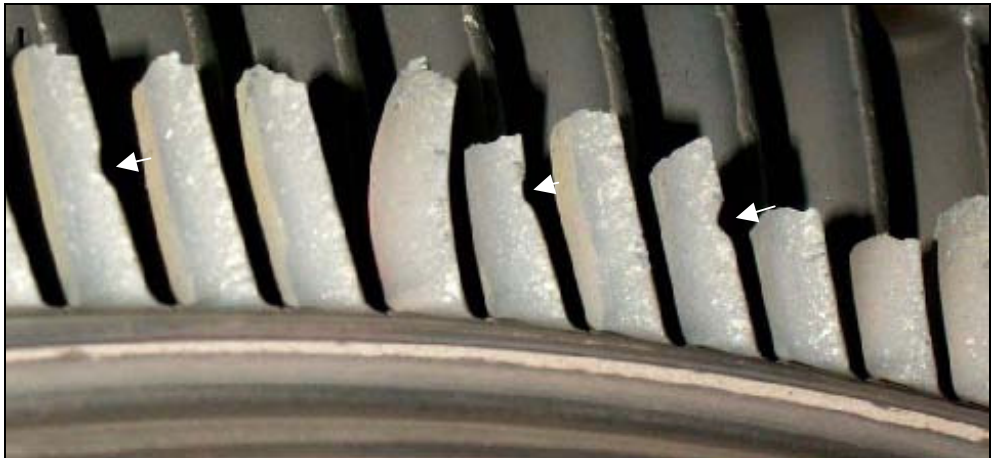
Figure 6: Leading edges of damaged LPT blades, showing areas of prior repair blending (arrowed)

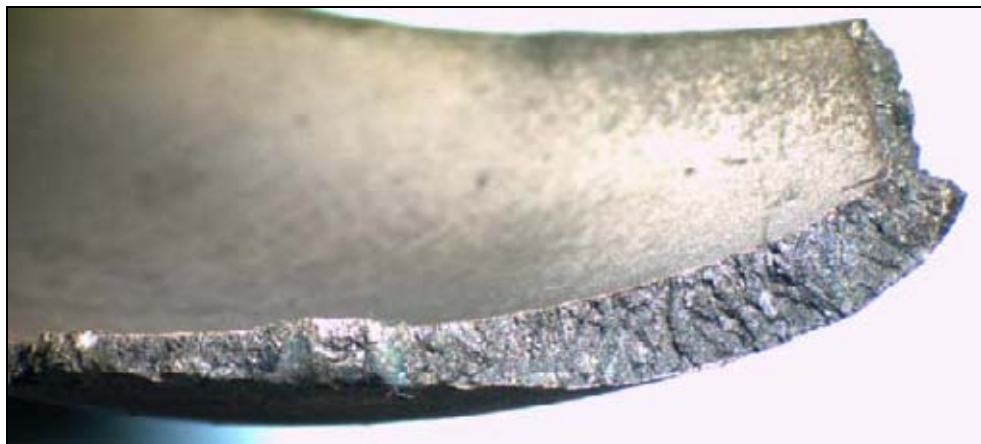
All LPT stage-1 blades were removed from the disk for characterisation of the fractures. All fracture surfaces presented an irregular, semi-crystalline appearance with a vague dendritic patterning that was typical of impact overload fractures in cast superalloy components (Figure 7). None of the fractures or associated cracking showed any evidence of pre-existing or progressive (fatigue) cracking. All LPT stage-1 blades displayed damage typical of the cascading collapse of the blade set

and associated debris impacts. None of the blades or adjacent guide vanes showed evidence of localised gross oxidation or incipient melting from over-temperature effects.

Figure 7: Typical LPT stage-1 blade fracture surface

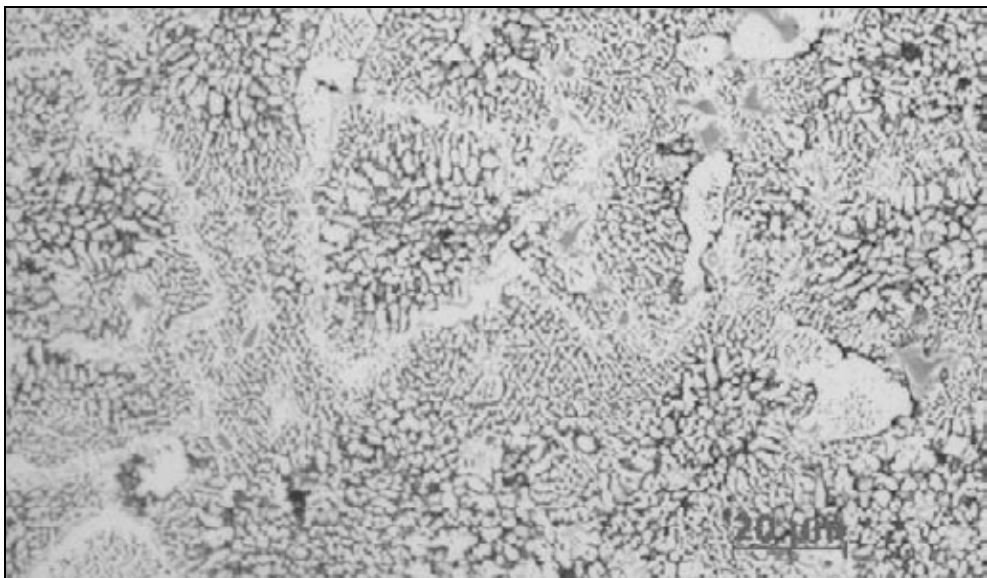
Reports received from both Lufthansa Technik and CFM International⁷ both indicated the absence of any evidence of tertiary microstructural creep⁸ damage within the examined blade sections. The persistence of sigma phase beneath the blade surface coating was cited as evidence that the blades had not experienced temperatures above 1050°C.

Figure 9: Thermally-degraded LPT blade material

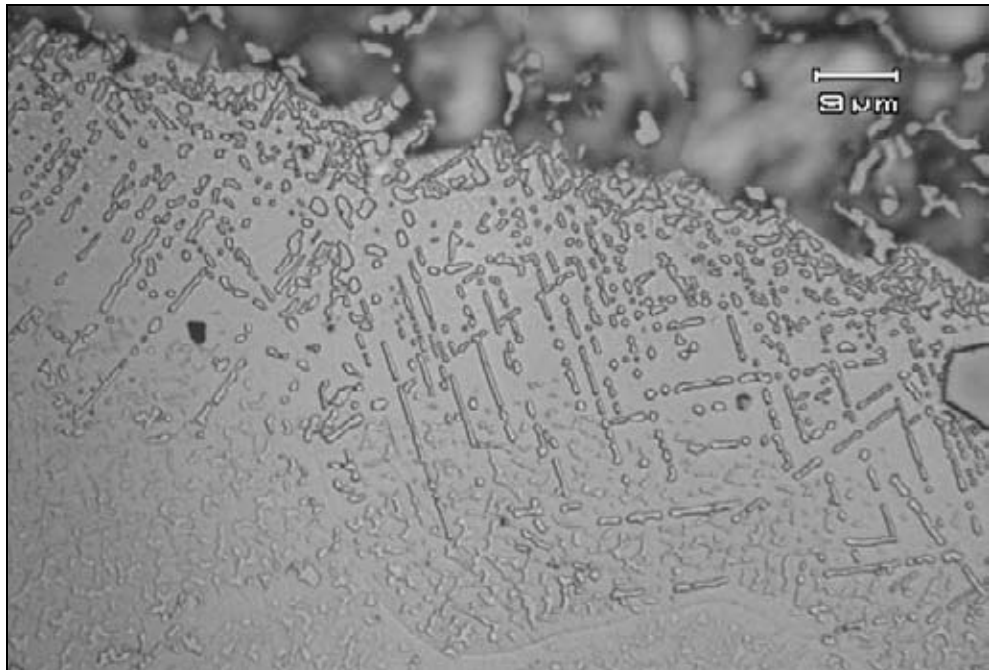
Figure 13: Surface sigma-phase (needles) remaining in the LPT blade microstructure (Kalling's etch)

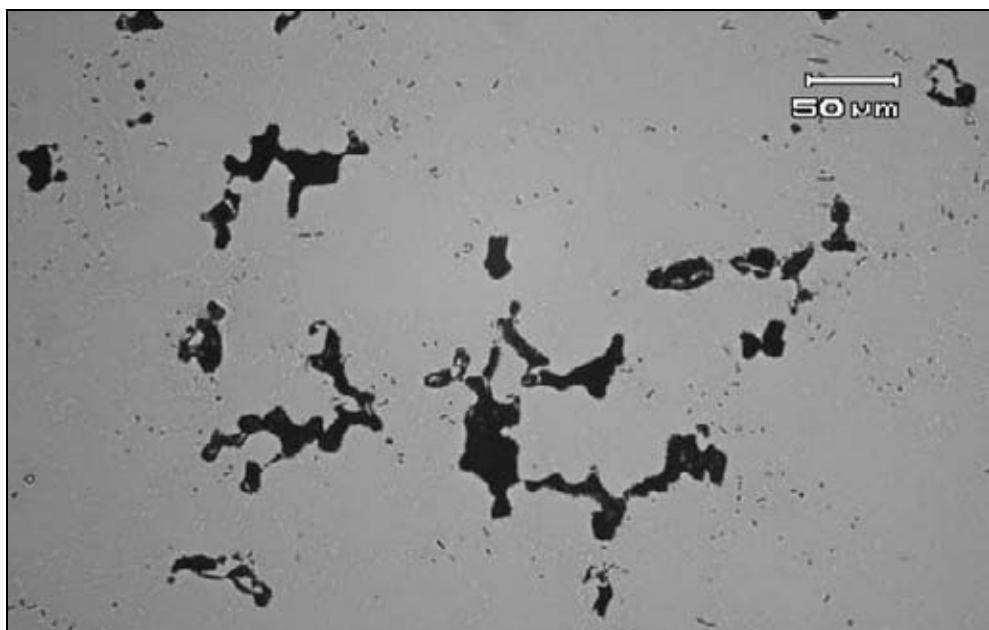
General microscopic examination of the blade sections revealed several additional noteworthy features, including internal solidification voids/micro-shrinkage within the aerofoil sections (Figure 14), full-thickness coating cracks and grain-boundary oxidation (Figure 15), internal intergranular cracking (Figure 16) and limited surface sulphidation in the uncoated blade areas (Figure 17). While potentially injurious to the blade integrity, none of the blades showed any evidence of incipient failure or breakdown as a result of the anomalous features.

Figure 14: Micro-shrinkage and voids within an exemplar LPT blade section (unetched)

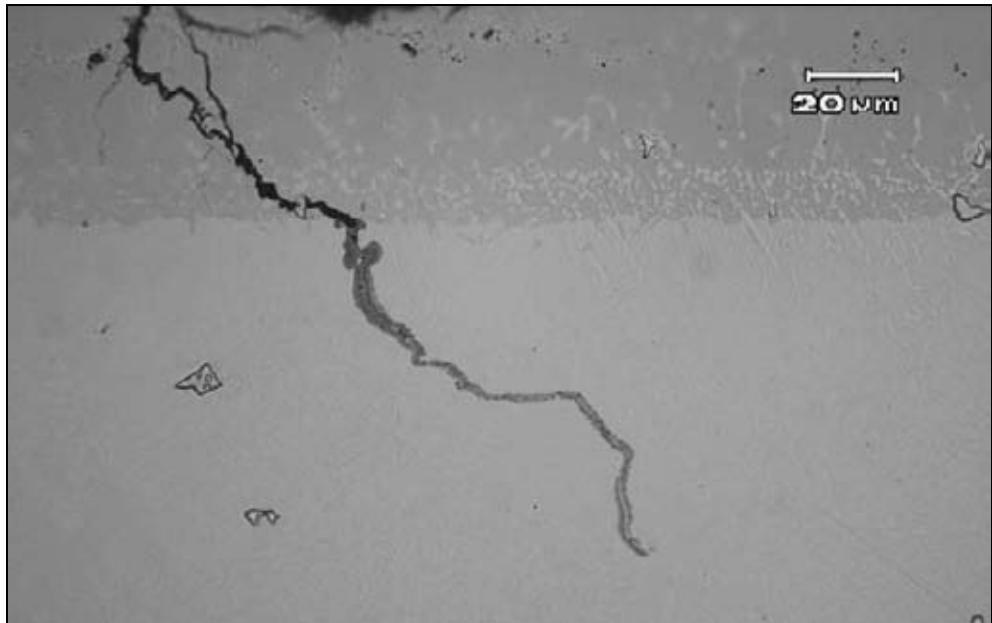
Figure 15: Shallow sub-surface cracking and oxidation within an exemplar LPT blade (unetched)

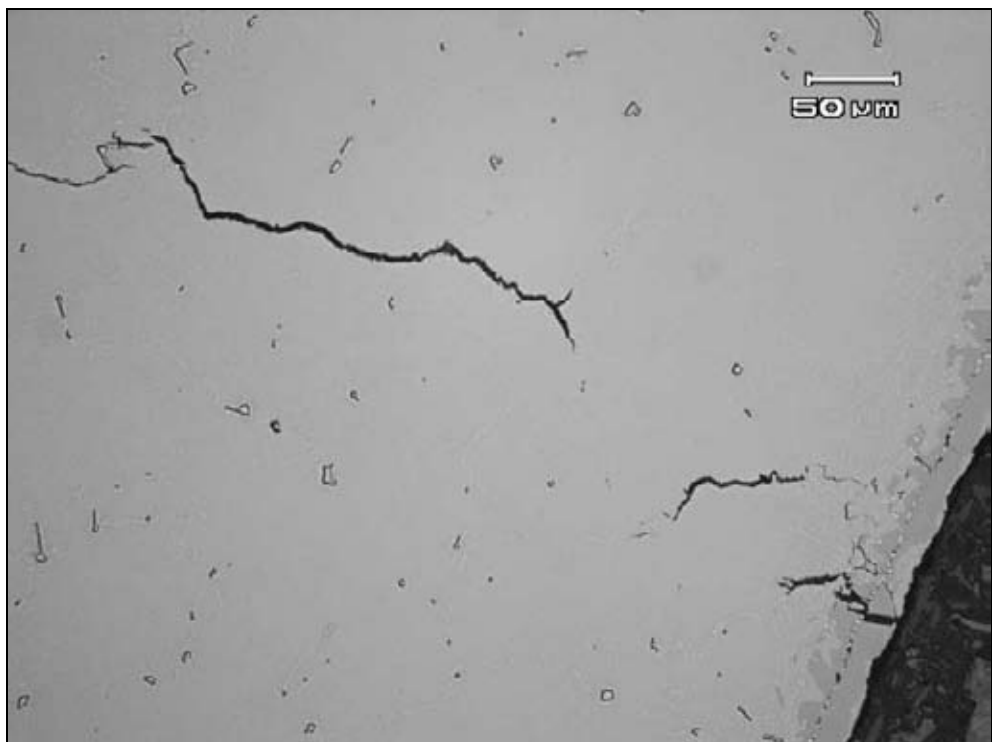
Figure 16: Internal and surface intergranular cracking within an exemplar LPT blade (unetched)

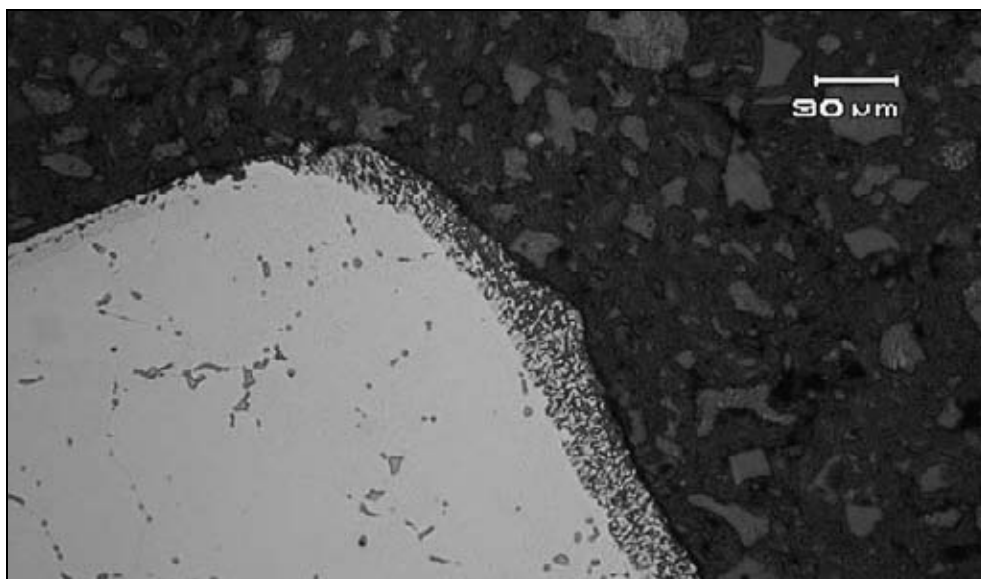
Figure 17: Root surface sulphidation exhibited by an exemplar LPT blade (unetched)

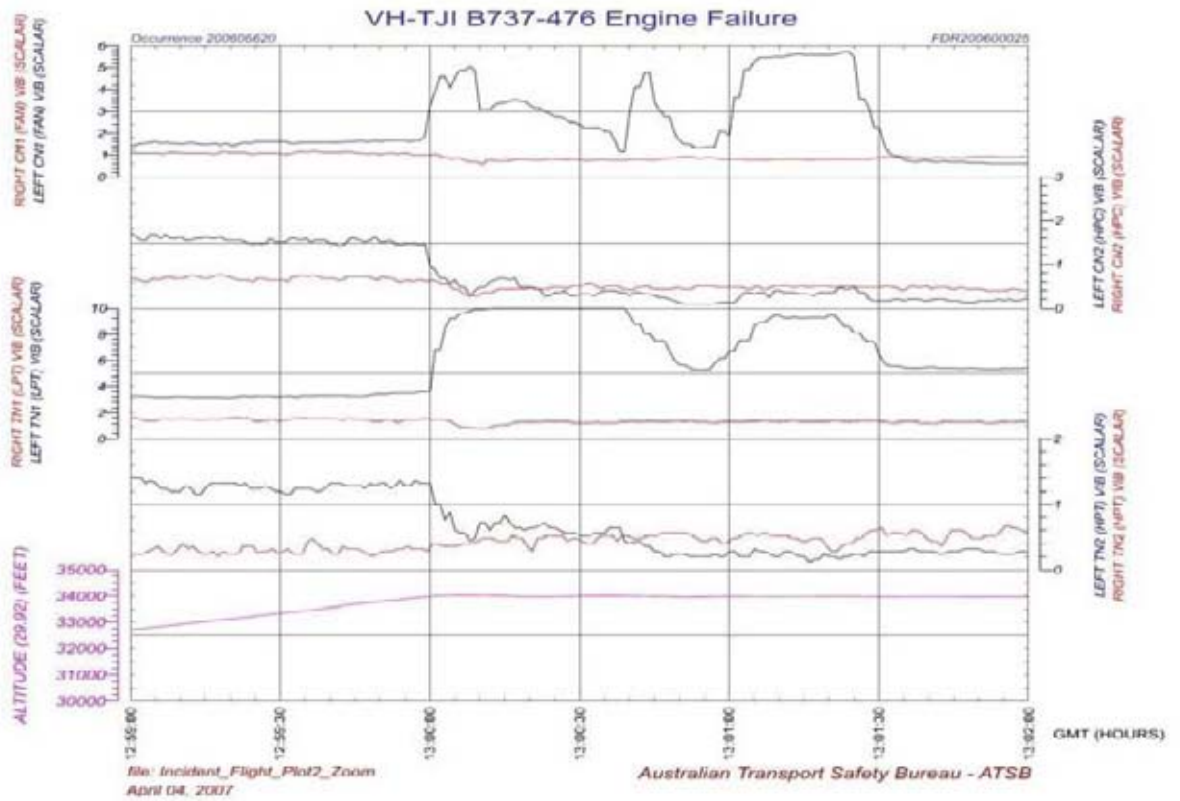
Figure 18: Graphical presentation and comparison of the left and right engine vibration parameters during the engine malfunction event

At 2225:13, while climbing through 26,000 feet, the first irregular engine vibration values were evident. There was a step increase (from 1.16 units to 2.80 units) in the LPT vibration for the left engine. After the initial step increase, the LPT vibration values increased over the next 8 seconds, reaching 4.20 units. There was no change in the LPT vibration for the right engine over this period.

LPT vibration values for the left engine stayed at 3.6 units until 2230:02. After this time, LPT vibration values jumped to 6.8 units and then began to further increase, reaching 10.0 units indicated (maximum recorded value) at 2230:14. Figure 18 presents the vibration data from both the left and right engines of VH-TJI from 2229 to 2232.
