**ATSB TRANSPORT SAFETY INVESTIGATION REPORT**

Aviation Occurrence Investigation – 200605843

**In-flight break-up  
20 km NE Bathurst, NSW  
5 October 2006  
BAC 167 Strikemaster, VH-AKY**

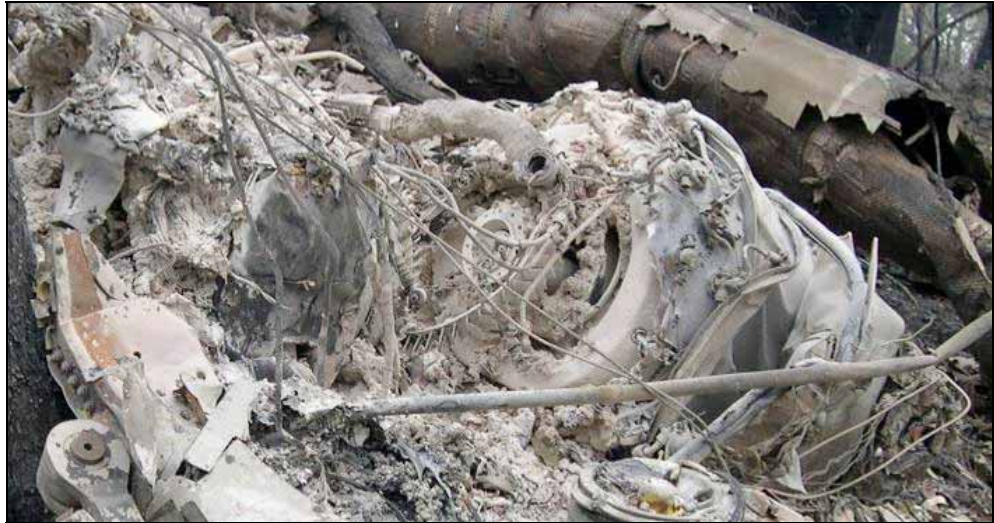
**Figure 7: Engine**

The engine was destroyed by impact forces and the post-impact fire (Figure 7).

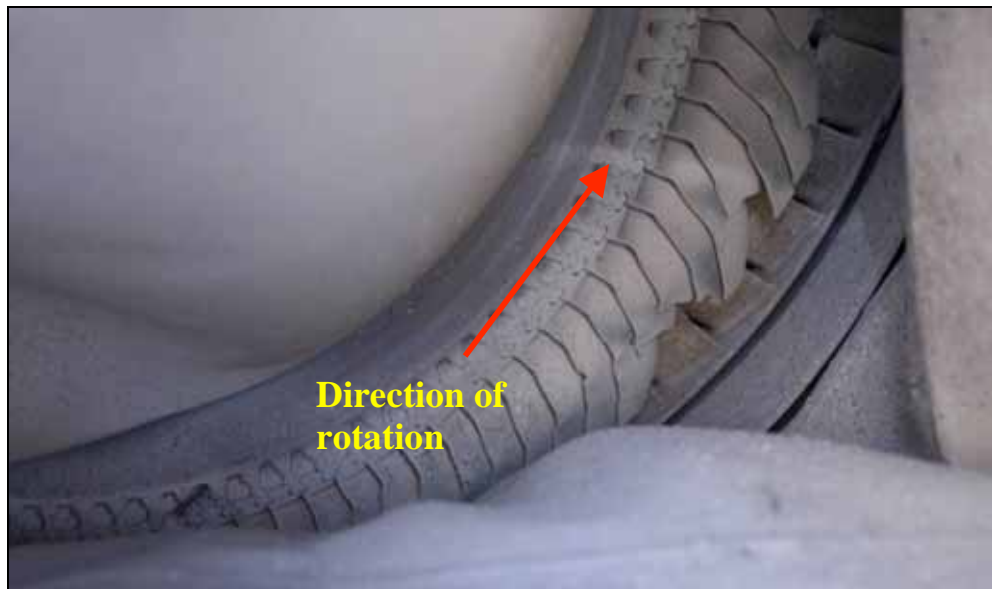
**Figure 8: Turbine section**

The turbine blades had been bent in the opposite direction to rotation and several blades had fractured at their mid section, which indicated that the engine rotor section was rotating and producing power at impact (Figure 8).

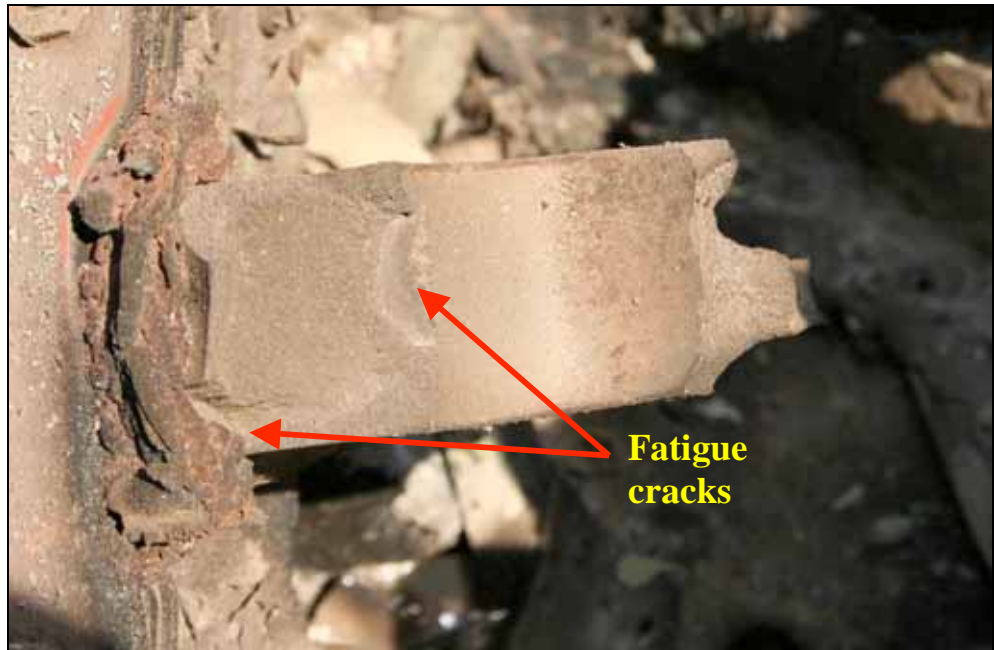
**Figure 11: Upper attachment point as found on the accident site**

The right wing had separated from the aircraft under a single downward bending over-load that fractured the upper main spar attachment lug (Figure 11), then progressed down through the main spar web and finally fractured the lower and rear spar attachments. The investigation identified two areas of pre-existing fatigue cracks in the upper wing attachment lug, identified as positions A and B (Figure 12). Area A was the larger of the two cracks, with an origin at the lug bore surface. Area B had initiated from an area of prior surface/corner blending, which had been carried out for previous defect removal purposes. The attachment point and a section of its surrounding structure were retained for technical analysis at the ATSB's laboratory (Appendix B).

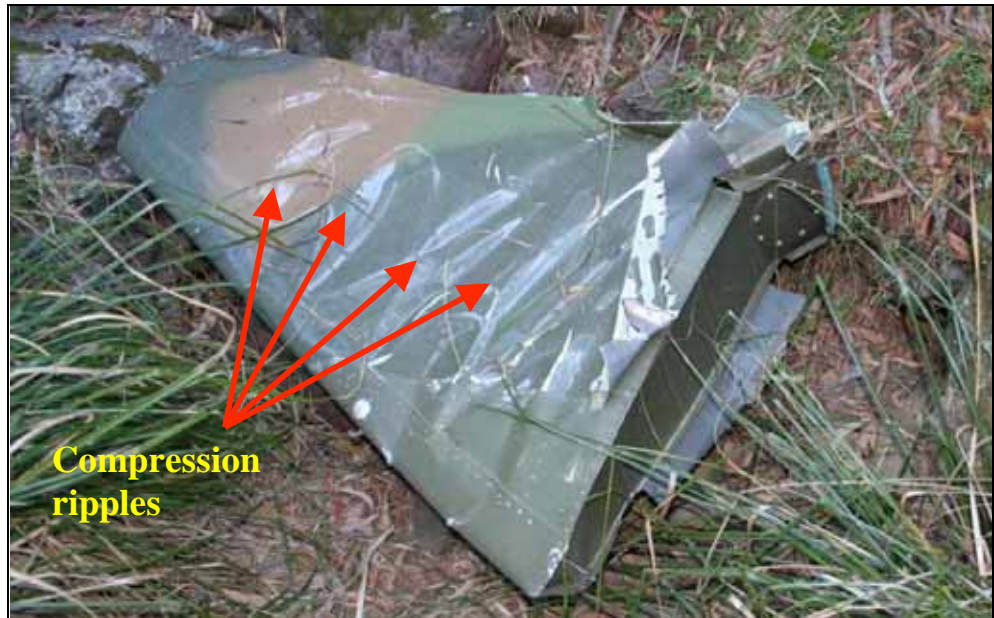
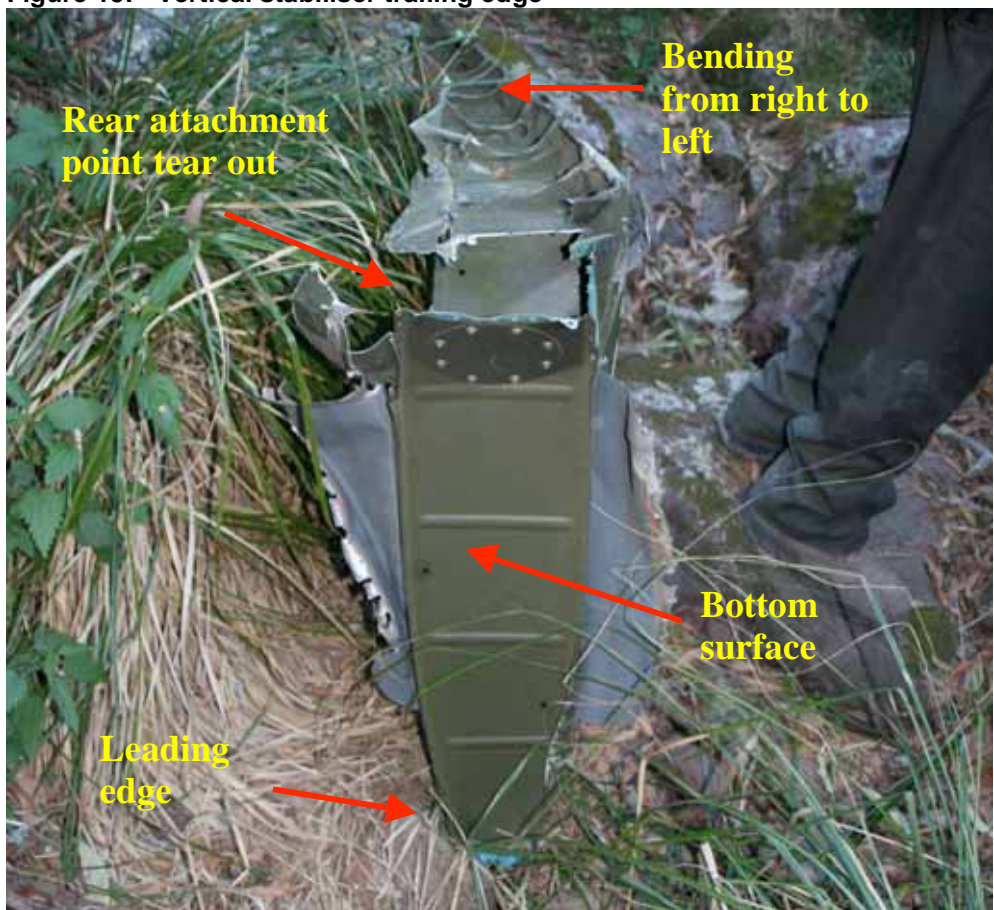
The vertical stabiliser attachment points had been fractured in overload. Fracture surfaces and compression ripples on the left side of the tailplane showed that the fin had experienced severe air loads acting from right to left relative to the longitudinal axis in the direction of flight (Figures 14 and 15).

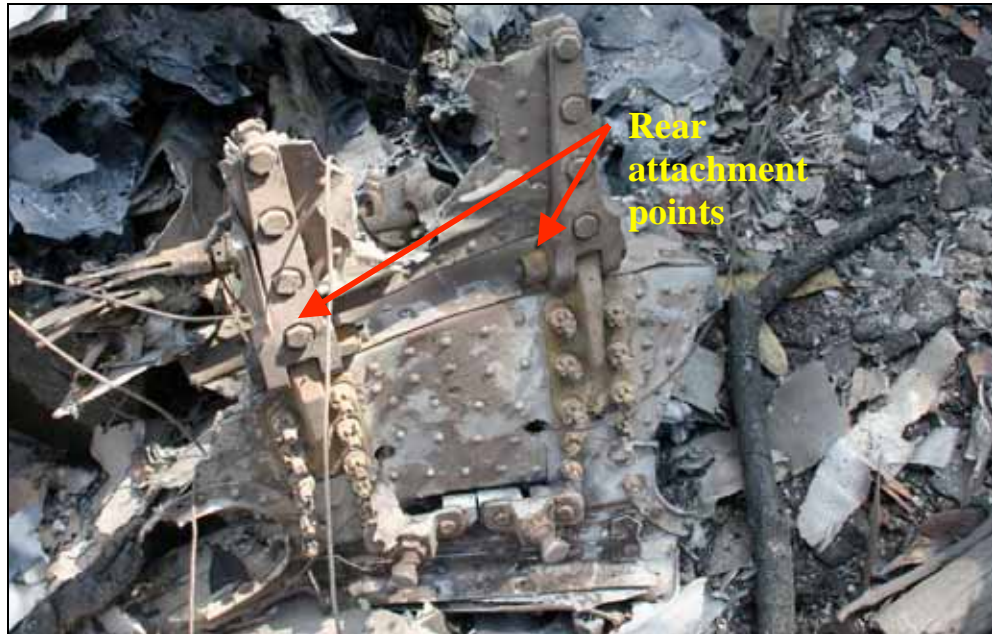
**Figure 16: Vertical stabiliser rear attachment point**

The vertical stabiliser attachment points had been torn from the vertical stabiliser in overload (Figure 16).

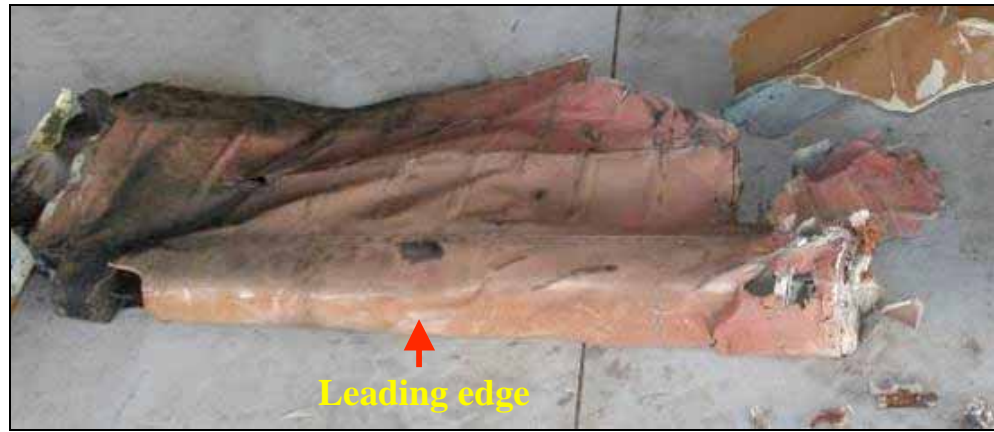
**Figure 21: Rudder upper section**

The upper section of rudder had a large crease from the upper attach point across to the trailing edge. The bottom section had fractured at the rudder torque tube upper end at the leading edge and rearwards to the upper part of the trim tab recess at the trailing edge. All fractures were due to overload (Figure 21).

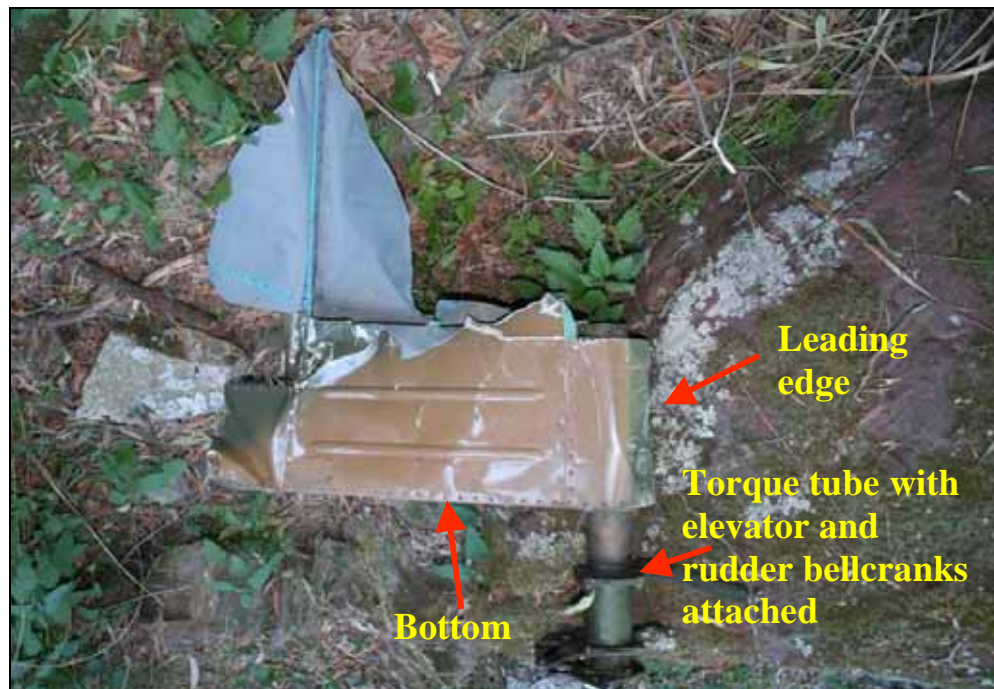
**Figure 22: Lower section of rudder**

The lower part of the rudder had broken just above the torque tube at the leading edge. The damage in that region was consistent with the failure initiating at the leading edge and progressing rearward. There was no evidence of pre-existing damage or defects on any of the fractures examined (Figure 22).

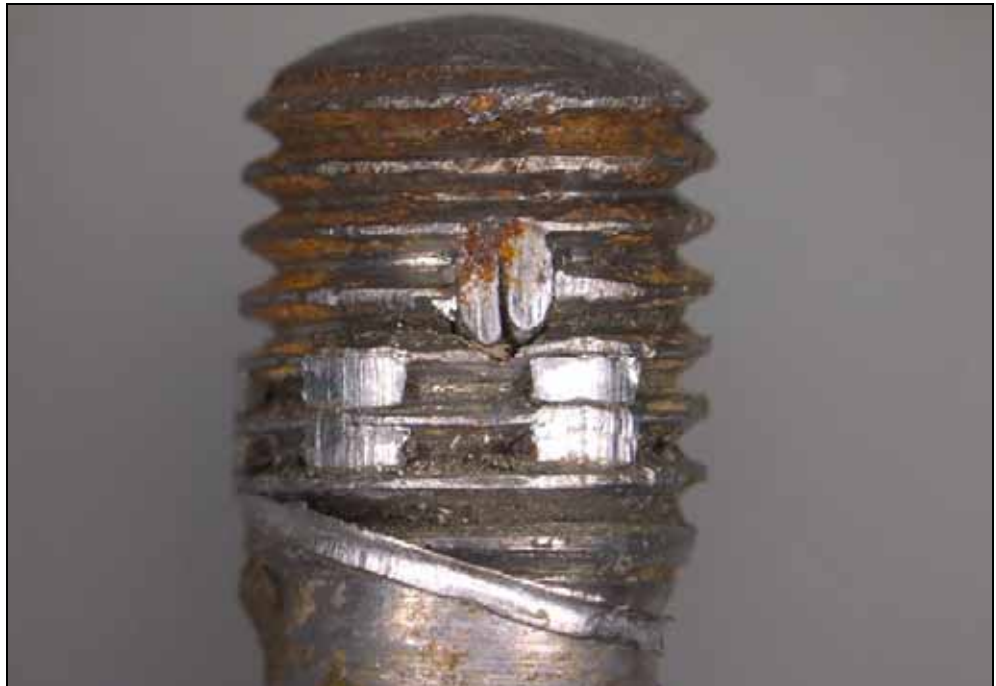
**Figure 25: Thread remnants on rudder lower hinge pin**

nut<sup>4</sup> (Figure 25). Examination of the hinge pin threads indicated that the nut thread had failed in a shear overload mode (stripping).

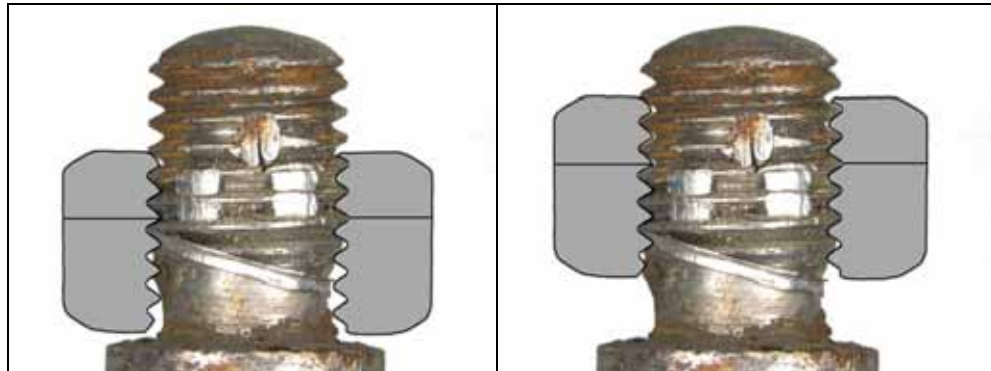
The ATSB found that the lower castellated nut had been screwed down the threaded shank such that only one full thread of the nut body had engaged the pin threads. The majority of the nut threads had entered the unthreaded, reduced-section shank between the threads and the main body of the pin (Figure 26).

**Figure 26: Illustration of over-engaged (left) and normally-engaged (right) pivot pin nuts**

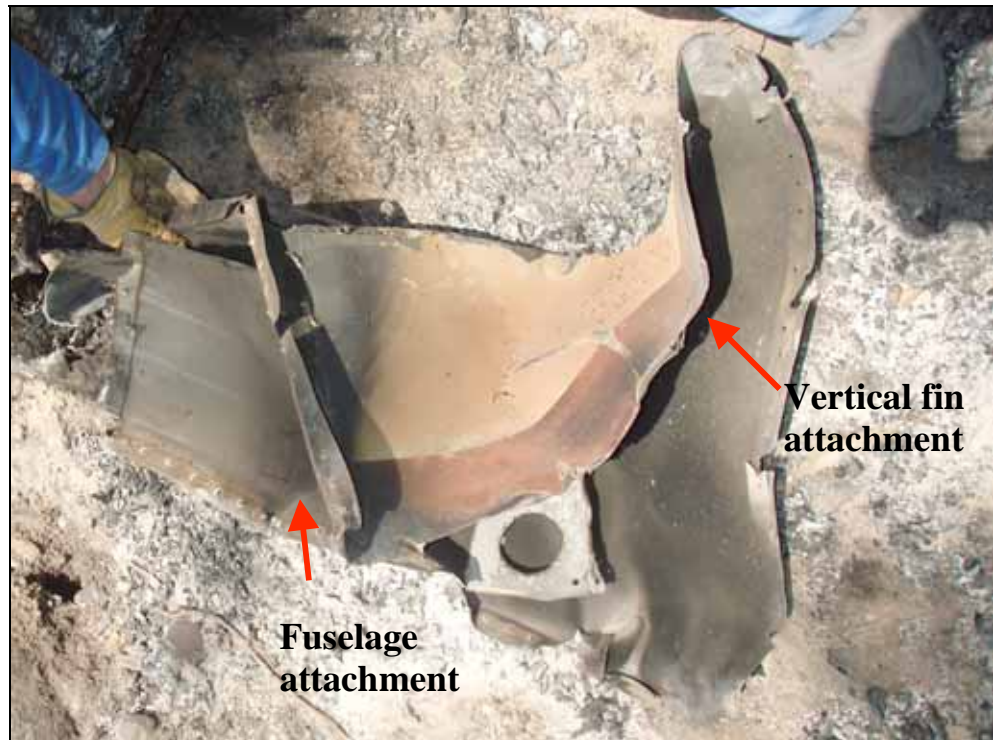
**Figure 27: Fin-to-fuselage fairing**

The fin-to-fuselage fairing had failed in overload and was bent from right to left relative to the longitudinal axis of the aircraft. That was also consistent with the deformation of the vertical stabiliser (Figures 27 and 28).

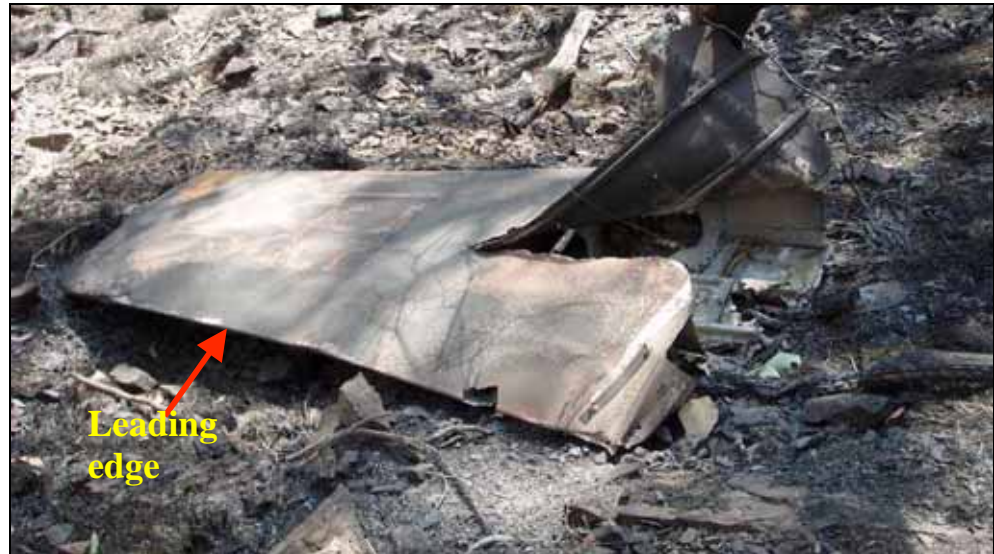
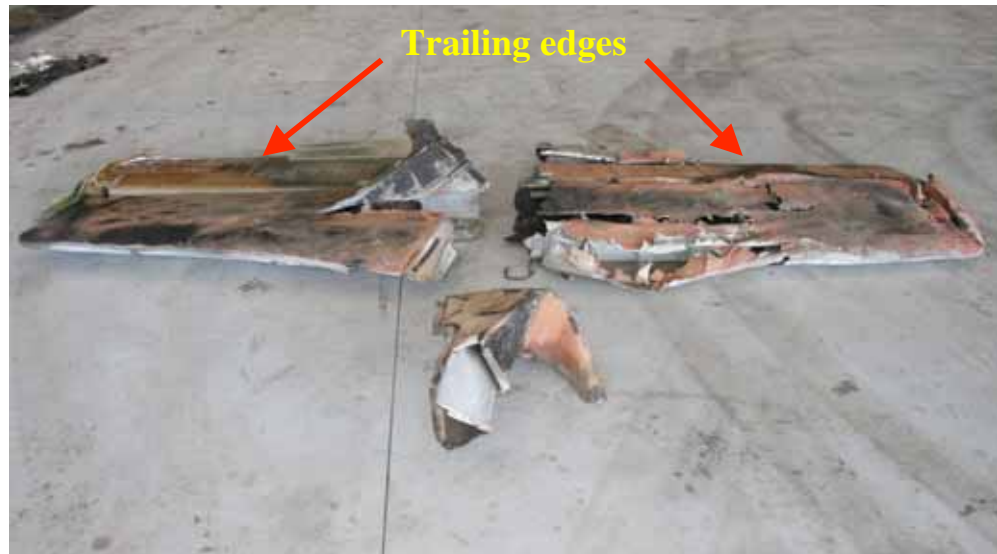
The deformation and fracture of the tailplane primary load-bearing structures (main and rear spars) was consistent with exposure to upward bending forces that exceeded the structural capability of the assembly. However, there was some evidence of compression in some of the lower surface secondary structure (or stringers), which suggested that the tailplane had also experienced a large

downward bending load. All fractures had occurred due to overload (Figures 30 to 32).

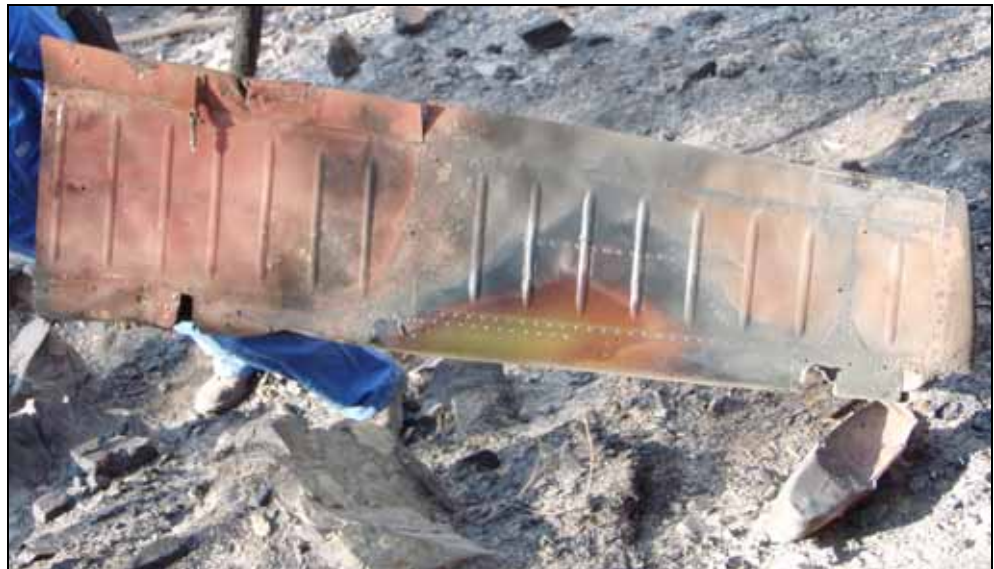
**Figure 33: Left elevator**

The left and right elevators had separated and had been found relatively intact with the tabs still in place. All attachment points were intact. The fracture surface of the left elevator tab control rod was destroyed by the post-impact fire and therefore, the failure mode of that component could not be established (Figure 33).

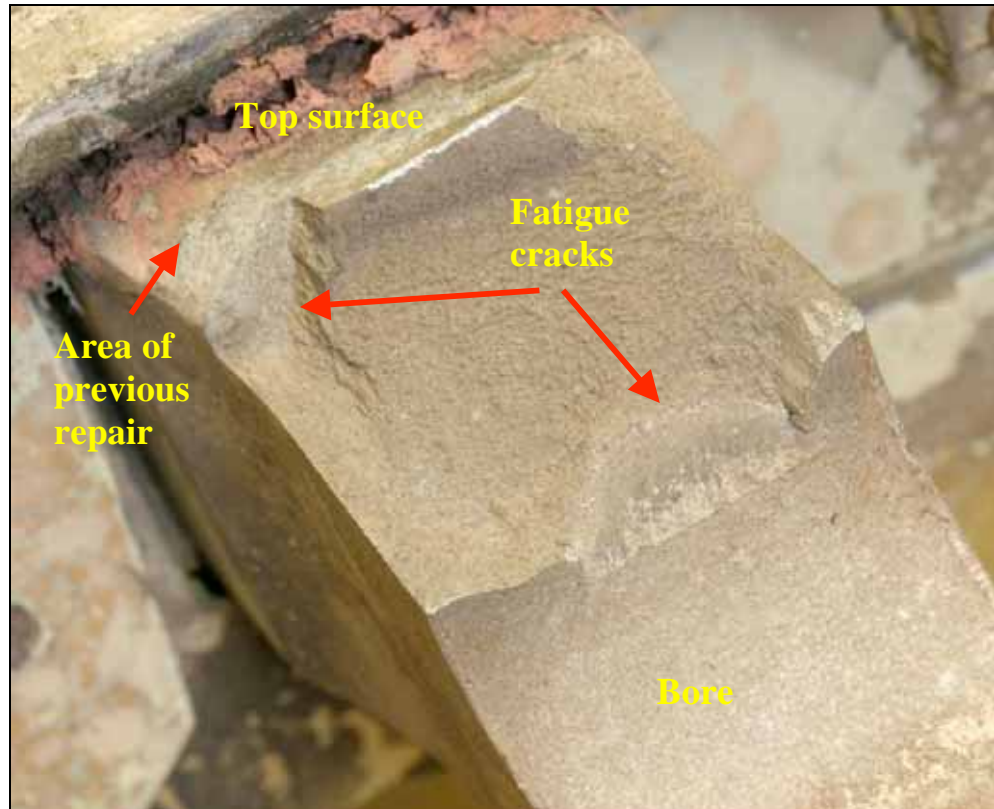
**Figure 39: Right wing upper attachment lug**

Two areas of fatigue cracking were identified in the right wing upper attachment lug. One crack was located on the forward top surface and the other crack was located in the bore of the lug. The crack in the top surface had propagated from the area of a previous repair (Figure 39).

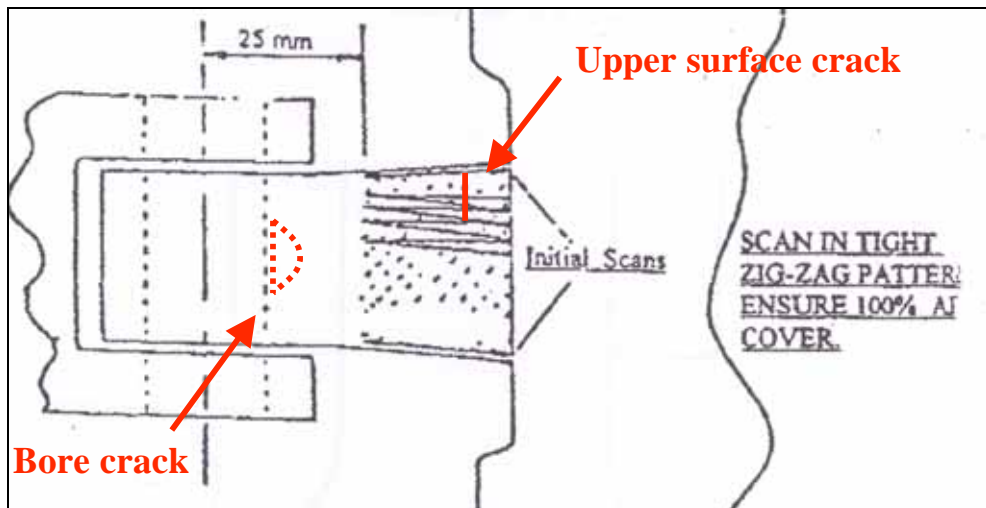
In accordance with the requirements of SP 1137, the area of the required eddy current scan is depicted at Figure 42. The areas highlighted in red are the locations where the two cracks were identified in AKY.

Figure 42: SP 1137 eddy current scan area - upper attachment lug

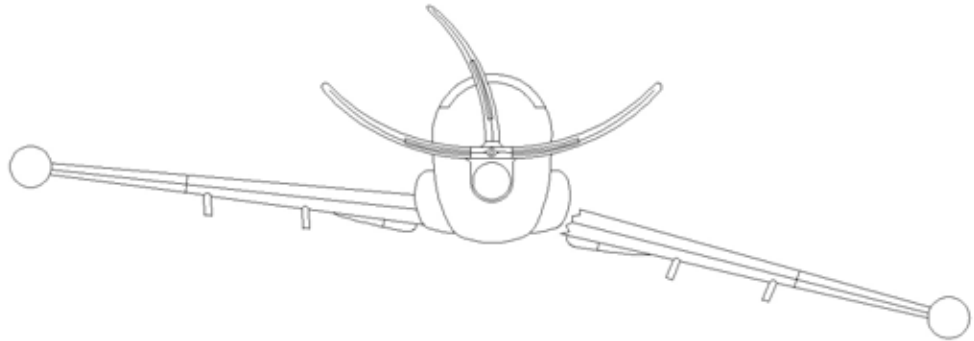
**Figure 47: Observed tail damage**

However, examination of the wreckage indicated that the failure of the tailplane and fin were in the manner shown in Figure 47.

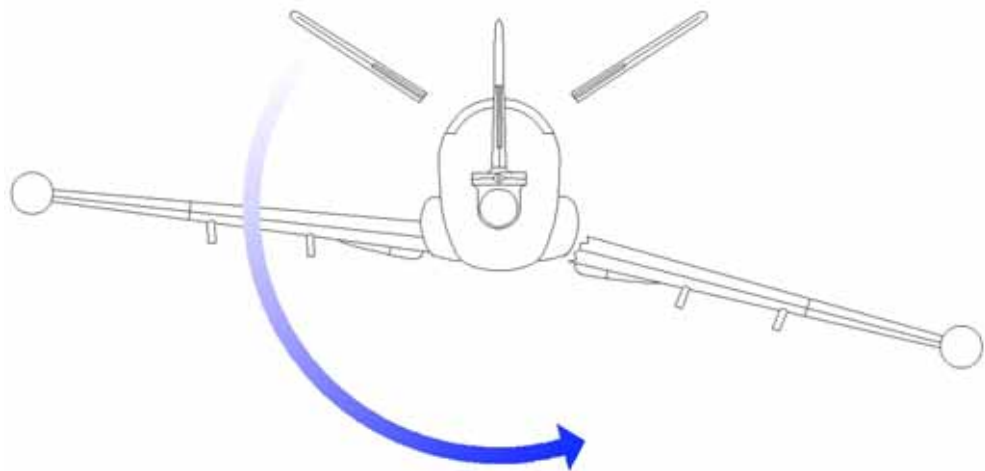
**Figure 52: Tail and wing fracture**

The loads on the tail increased until the tail fractured and separated from the aircraft. The right wing, being weaker than the left due to the fatigue cracks, also fractured and separated from the aircraft. As with the wing-first separation scenario, the loss of the right wing resulted in a rapid left roll (Figure 52).

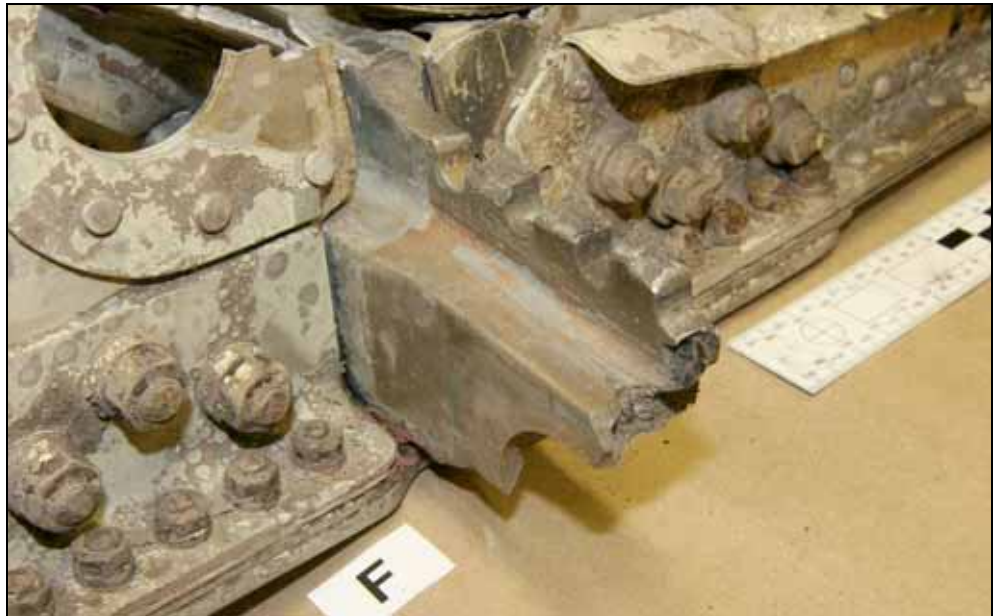
**Figure 8. Underside of right wing attachment lug showing tearing along flange section**

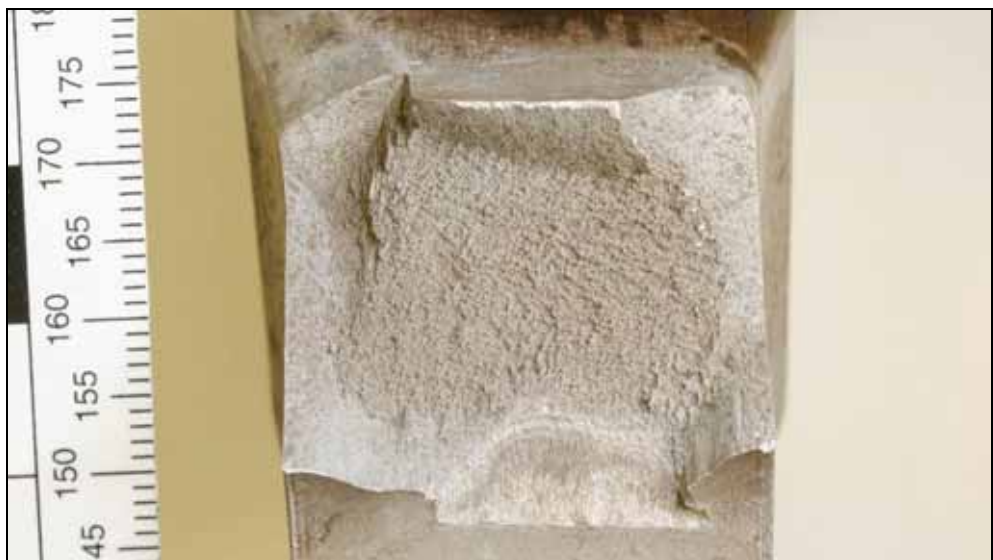
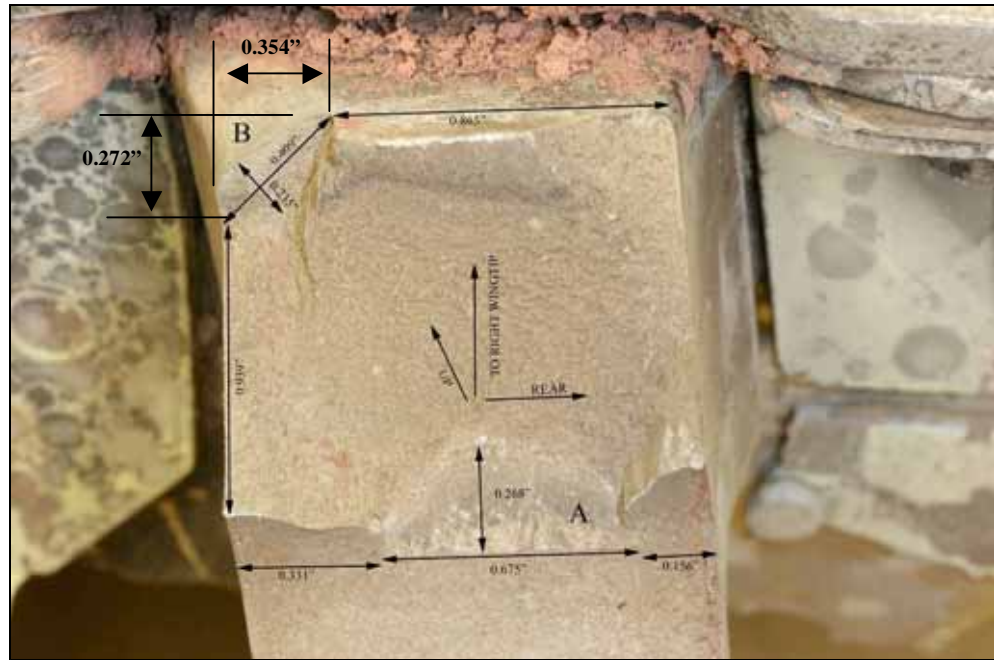
Under low power stereomicroscopic examination, the two atypical areas on the upper diagonal fracture (Figures 9 and 10) presented surface characteristics indicative of the initiation and growth of fatigue cracking. The larger of the two areas (area 'A') had initiated within the bore of the spar lug and propagated along a semi-elliptical crack front, to a maximum depth of 6.8 mm (0.268") and length of 17.1 mm (0.675") along the bore. The smaller cracked area was located at the forward-facing corner of the spar boom where it transitioned into the lug section. The corner exhibited a locally chamfered geometry, typical of having been ground and blended during some prior maintenance activity. Cracking of the corner region (area 'B') had propagated to a depth of 6.9 mm (0.272") and width of 9.0 mm (0.354"). In combination, the approximate area of both cracked regions represented around 30% of the total cross-sectional load-bearing area of the lug upper section.

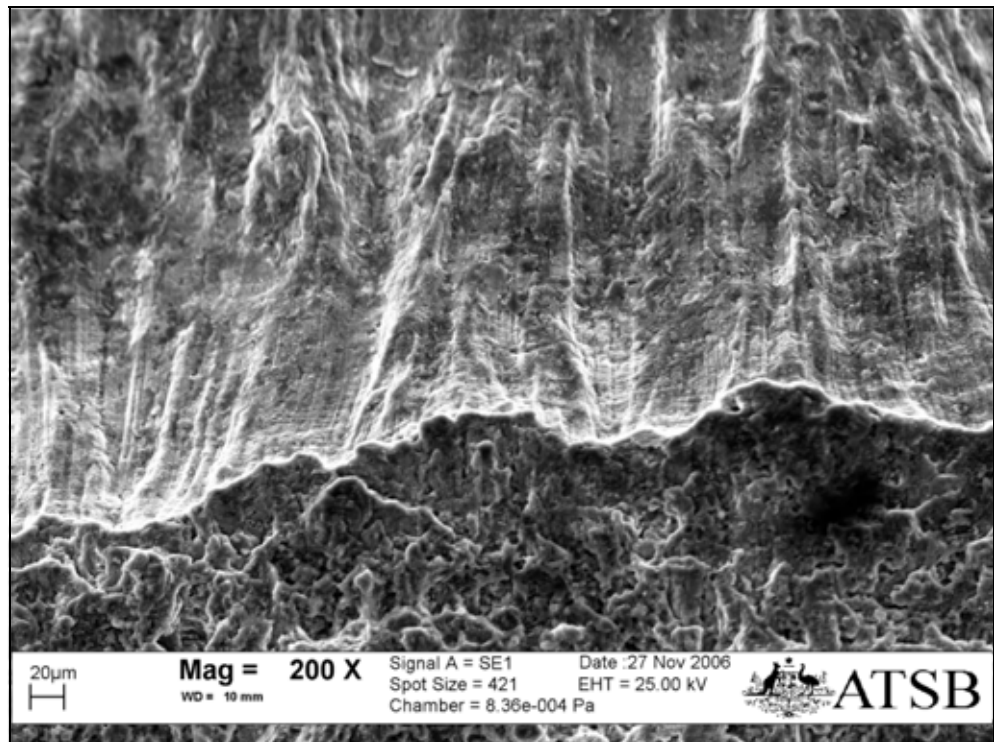
Scanning electron microscopy (SEM) of the two regions of cracking identified surface striations in both regions – confirming high-cycle fatigue cracking as the mechanism of propagation (Figure 11). Both regions showed evidence of multiple origins, however the heavily oxidised, pitted and generally fire-damaged condition of the surfaces prevented any further detailed examination of value.

**Figure 11. SEM fractograph of the fatigue / ductile fracture transition boundary. Fine striations are evident within the fatigue (upper) region**

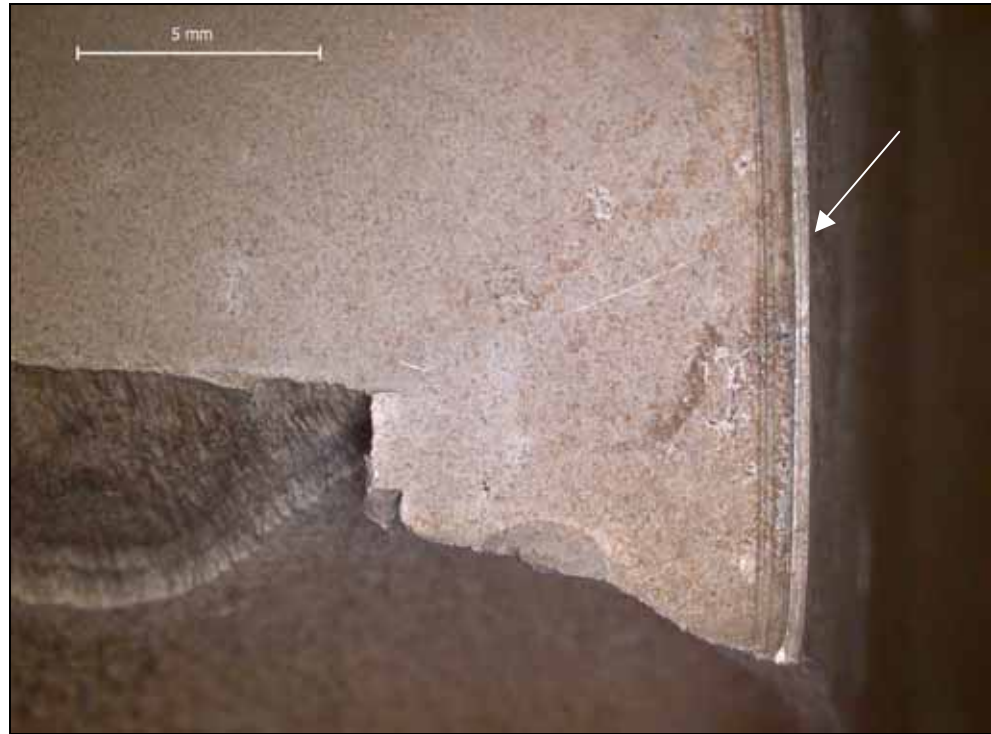
Evidence of localised compressive deformation of the lug material was observed at both ends of the lug bore, with distinct ridges formed where the steel bore sleeve had compressed the central underlying material (Figure 12). Measurements confirmed the lug bore ridges to correspond with the chamfers at the external corners of the bore sleeve. Optical profiling of the lug corners showed the ridging to have been raised approximately 1 mm (0.04”) above the compressed lug bore surface (Figures 13 and 14).

**Figure 12. Compressive deformation of the lug bore produced a ridging of material at the bore ends (arrowed)**

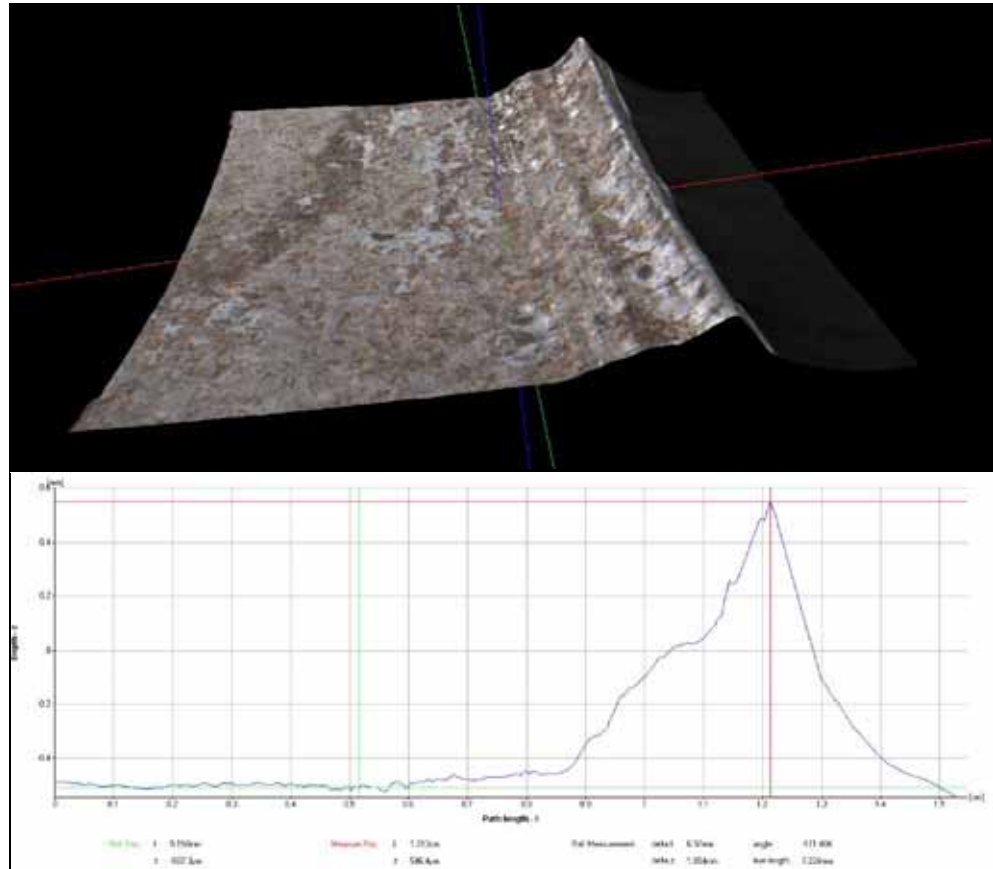
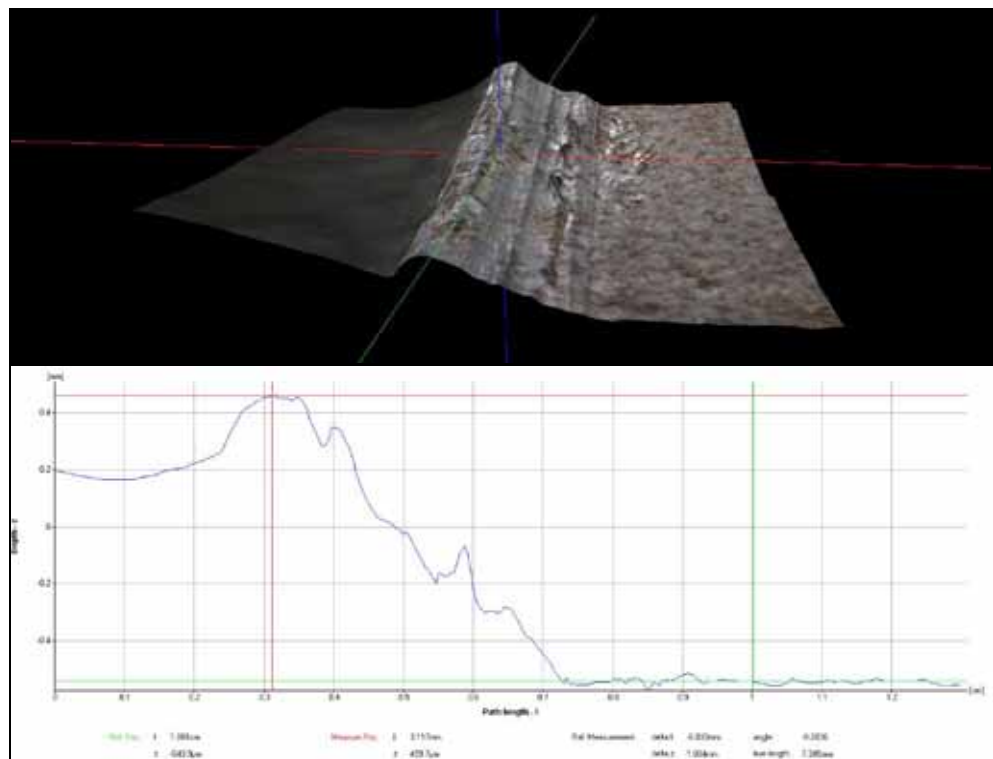
**Figure 13. Three-dimensional image and profile of the ridging effect at the forward end of the lug bore**

**Figure 14. Image and profile of the ridging at the aft end of the lug bore**
