ATSB TRANSPORT SAFETY INVESTIGATION REPORT

Aviation Occurrence Investigation – 200605843

Interim Factual

**In-flight break-up
20 km NE Bathurst, NSW
BAC 167 Strikemaster, VH-AKY
5 October 2006**

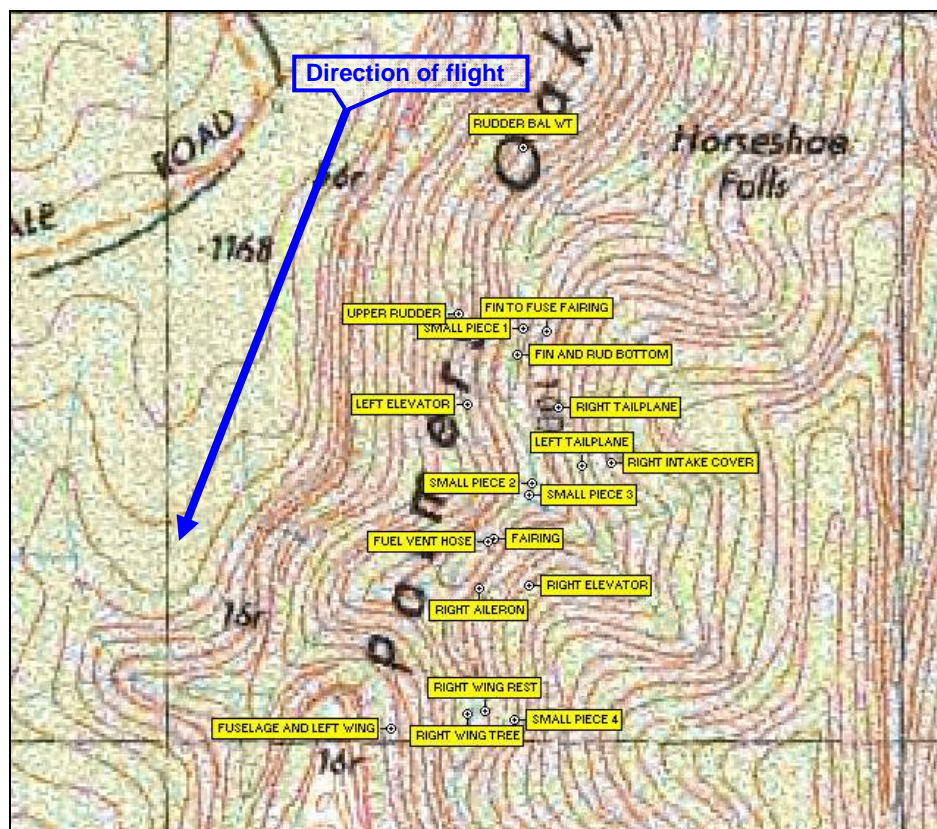
Figure 2: Wreckage distribution²

The wreckage was distributed over about 800 m of sloping, treed, terrain, just to the north of the ground feature that was an intended target, as part of the low-level, simulated, strike mission (Figure 2).

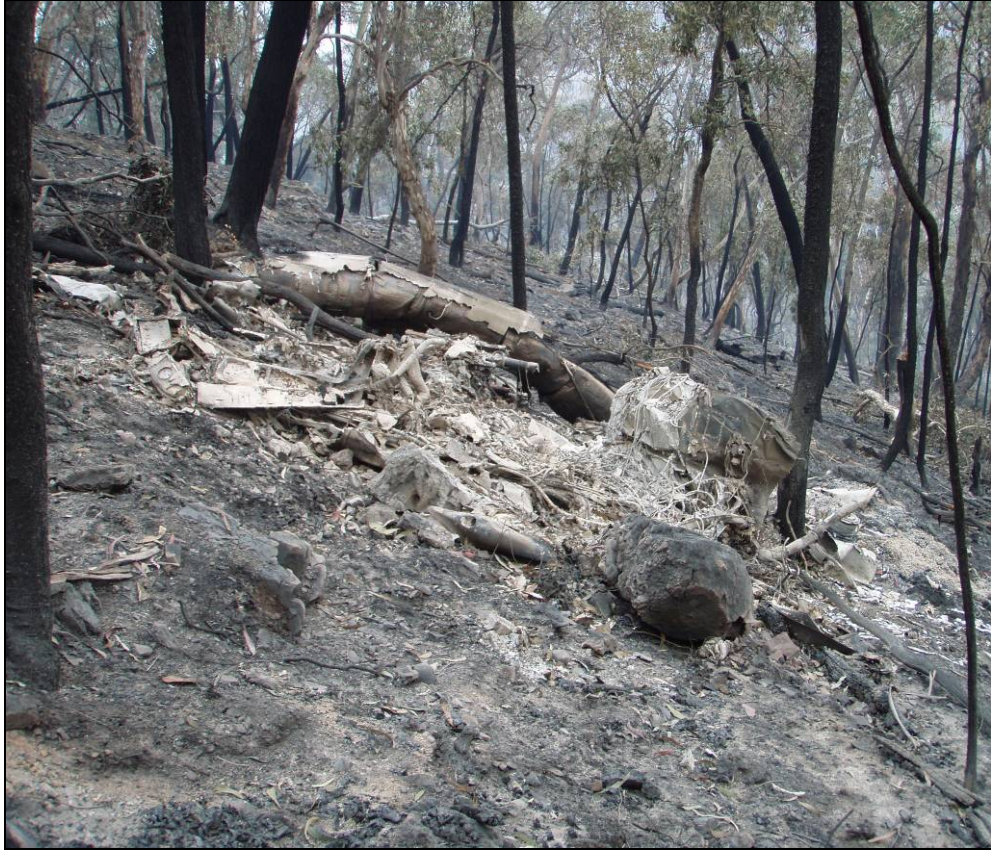
Figure 3: Main aircraft wreckage

The main wreckage, which consisted of the fuselage and left wing, was mostly destroyed by the impact forces and the subsequent fires (Figure 3). Other items of wreckage were damaged to various degrees by impact with the ground and trees and by the bushfire.

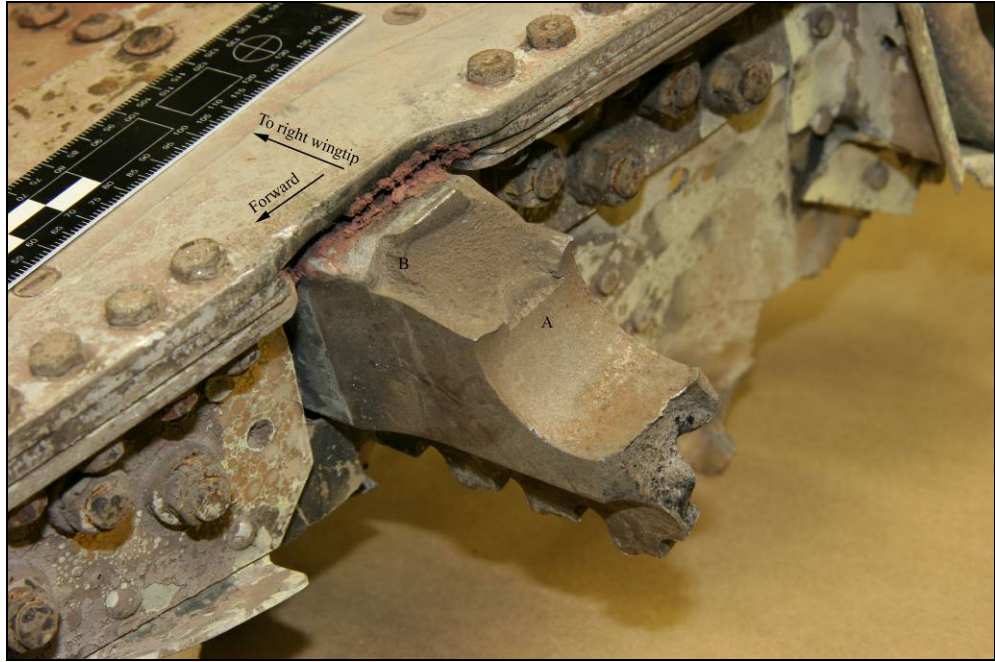
Figure 4: Fracture surface location

The right wing separated from the aircraft under a single downward bending overload that fractured the upper main spar attachment lug (Figure 4) then progressed down through the main spar web and finally fractured the lower and rear spar attachments. The investigation identified two areas of pre-existing fatigue cracks in the upper wing attachment lug, identified as positions A and B (Figure 5). Area A was the larger of the two cracks, with an origin at the lug bore surface. Area B had initiated from an area of prior surface/corner blending, which had been carried out for previous defect removal purposes.

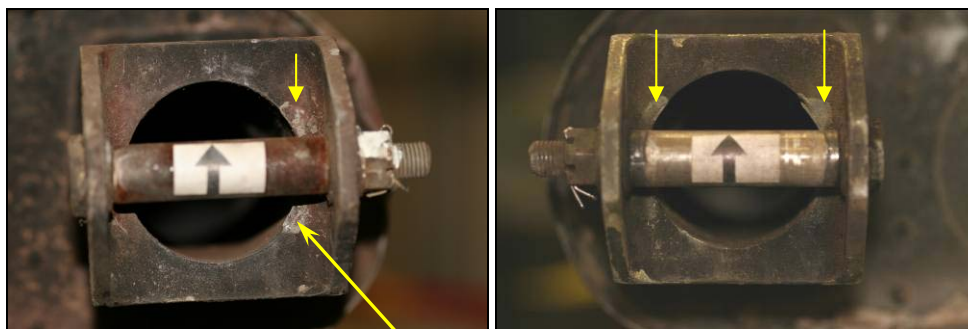
Figure 6: Elevator torque tube connections (left and right, respectively)

Both left and right horizontal stabilisers had separated from the aircraft under upward bending overload forces. Both elevator torque tube connections presented evidence indicating a large upward deflection of the left and right sections of horizontal stabiliser (Figure 6). Some structural elements of the left horizontal stabiliser also exhibited evidence of a large downward deflection. There were no pre-existing defects identified within the stabilisers or elevators.

Contact marks between fittings
due to large stabiliser deflections

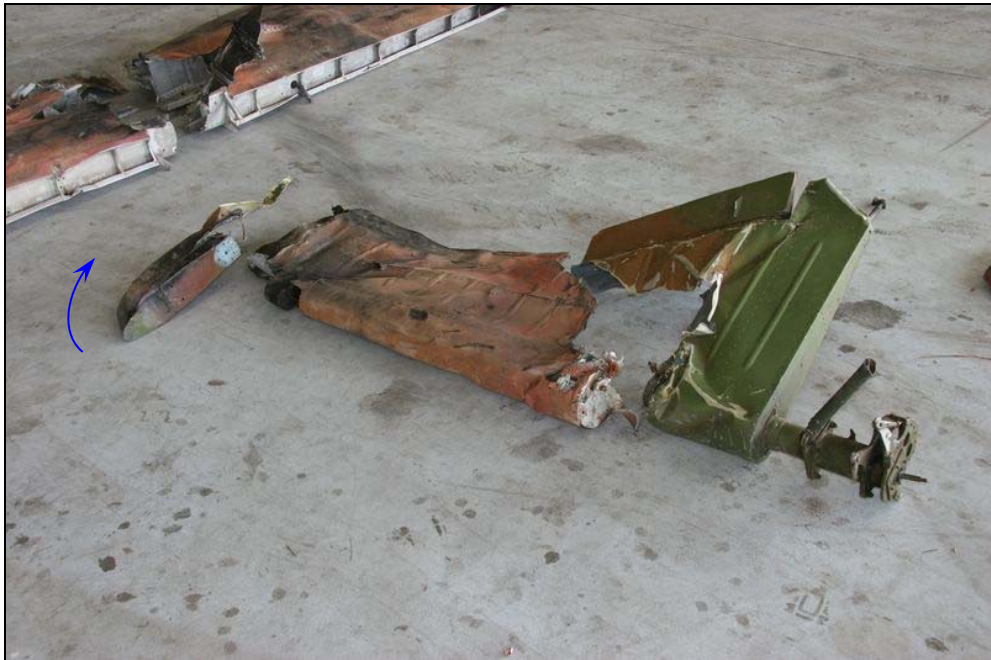
Figure 7: Rudder pieces (note horizontal stabiliser in background)

The aircraft rudder had broken into three pieces comprising the mass balance weight, upper rudder section and lower rudder section (Figure 7). The mass balance weight had separated from the upper rudder in a manner such that the forward tip was pried over the top of the rudder (blue arrow in Figure 7), producing localised trailing edge buckling and tearing at the corners of the upper hinge cut-out. The lower surface of the mass balance weight had several marks of a shape and profile consistent with multiple impacts against the upper surface of the vertical stabiliser (Figure 8). An indentation in the lower surface of the mass balance weight, collocated with the other marks, suggested an impact with a blunt object. However, there was no corresponding mark on the vertical stabiliser to indicate that it was the origin of the impact.

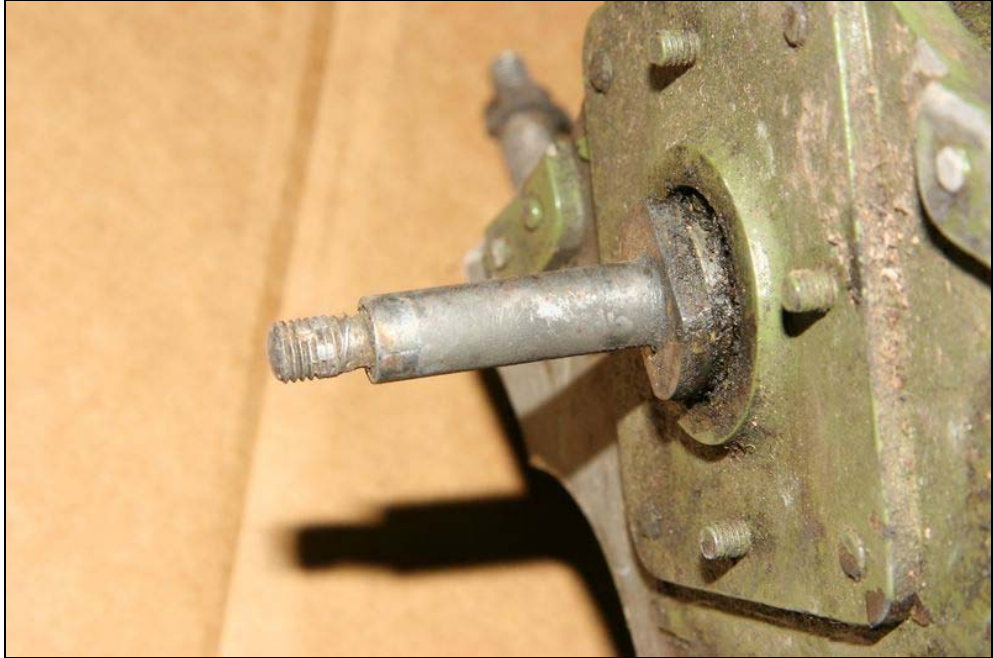
Figure 9: Rudder lower hinge pin

The lower section of rudder included the rudder torque tube, rudder control bellcrank and elevator control bellcrank. The rudder control bellcrank contained the lower hinge pin, which normally attached it to the fuselage structure (Figure 9). The thread on the lower hinge pin contained thread remnants from the retaining nut (Figure 10). Examination of those threads indicated that the thread had failed in a

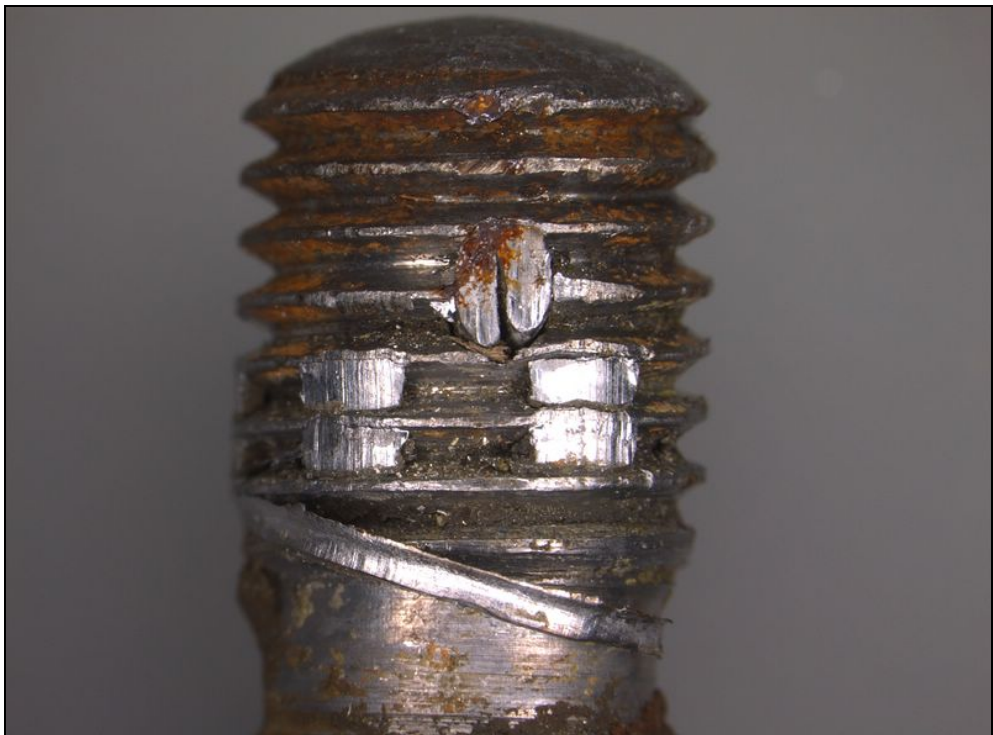
Figure 10: Thread remnants on rudder lower hinge pin

shear overload mode (stripping) and that there was only one full thread engagement below the castellated section of the nut.
