ATSB TRANSPORT SAFETY INVESTIGATION REPORT

Aviation Occurrence Investigation – 200606223

Hydraulic System Event

Bombardier de Havilland DHC-8-315

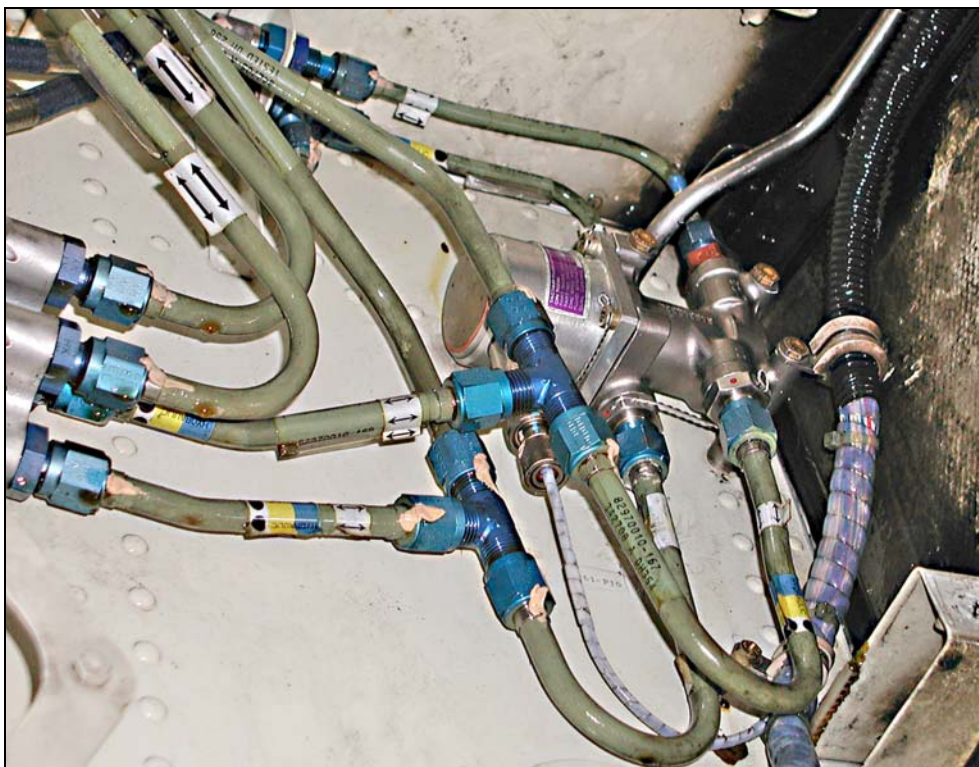
Subsequent examination of the aircraft by maintenance engineers identified that a landing gear solenoid sequence valve had failed, resulting in a leak that led to the loss of the number-two hydraulic system quantity and pressure (Figure 1). The defective unit was replaced and the aircraft was returned to service.

Figure 1: Image of the failed solenoid-sequence valve and associated high pressure plumbing from the number two hydraulic system; shown in-situ within the right nacelle area.

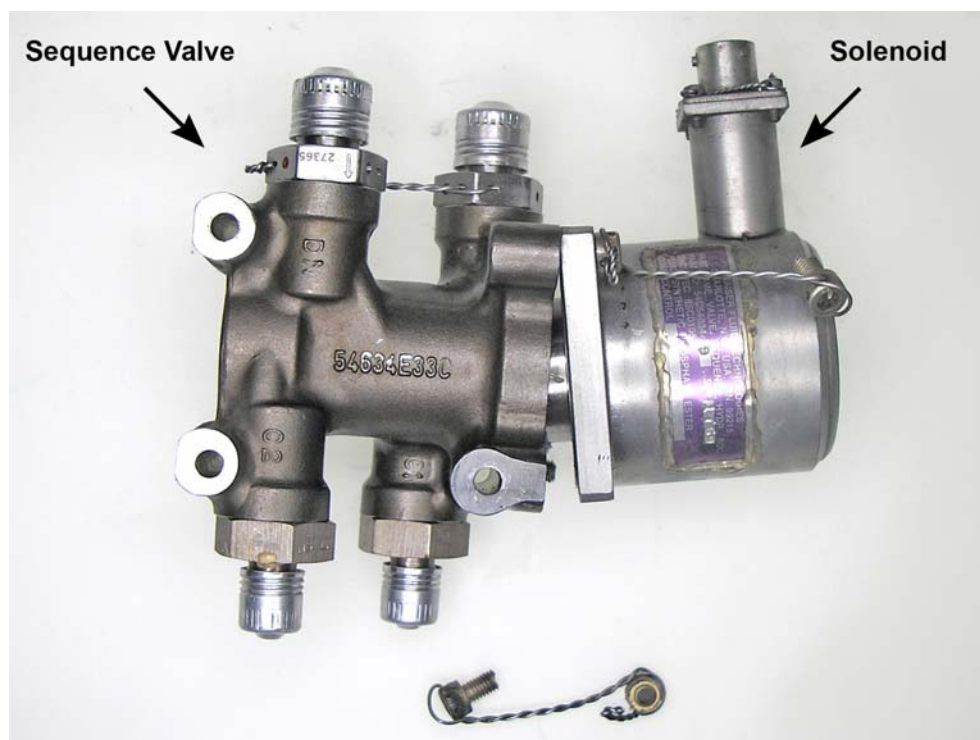
Figure 2: The failed component assembly showing the solenoid (right) and the sequence valve (left) as-received by the ATSB.

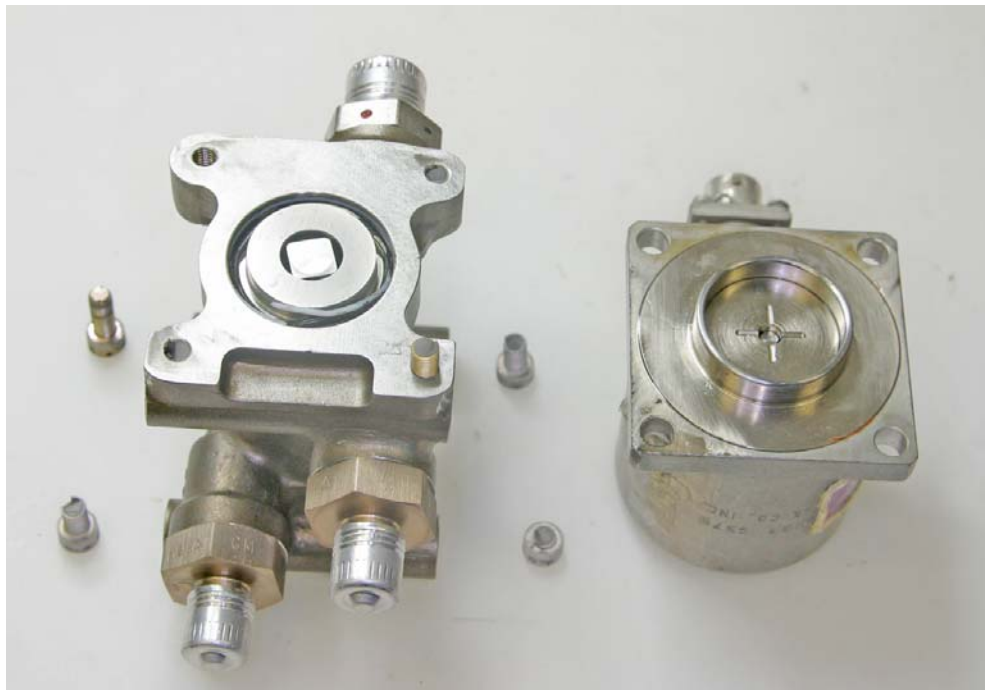
Visual examination showed that three of the four small steel socket head bolts that had clamped the solenoid and sequence valve together as an assembly, had fractured (Figure 3). Two of the bolts had fractured midway through the threaded region; the other bolt had fractured in the head-to-shank transition.

Figure 3: The solenoid-sequence valve after preliminary disassembly.

Note the three fractured bolts.

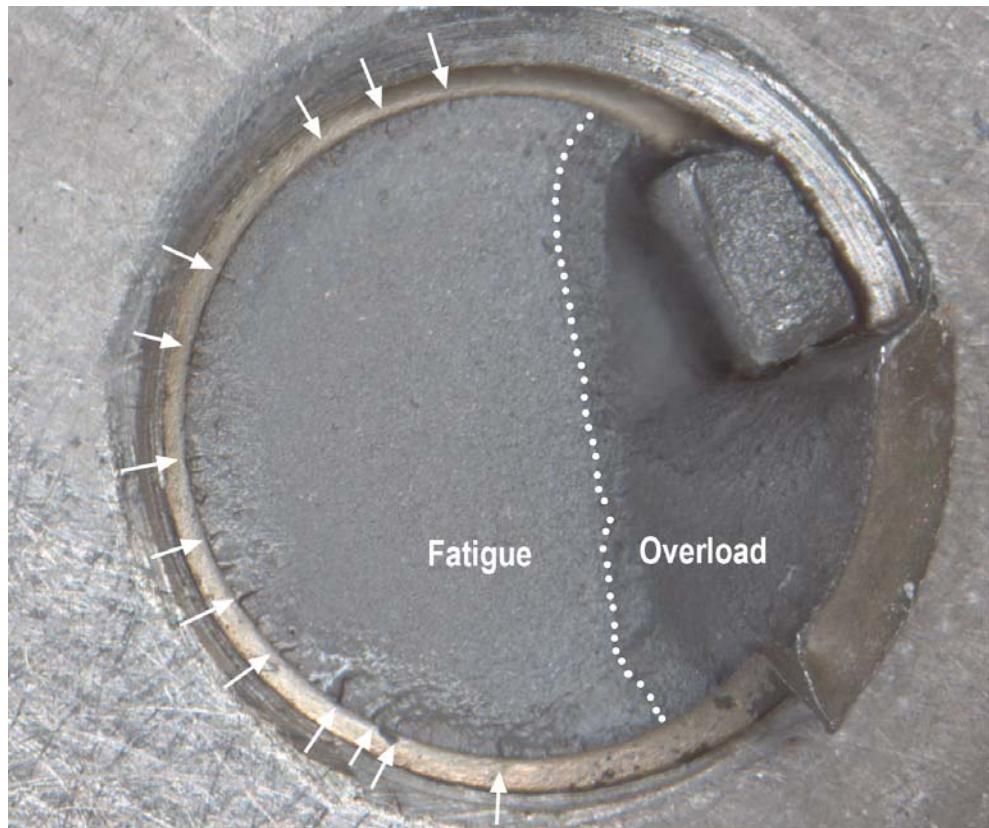
Examination of the fracture surfaces revealed characteristic features that indicated fatigue cracking had initiated and then propagated through each bolt. The origins of cracking were evident by the presence of many small 'ratchet mark' type features on each fracture (Figure 4). In each case, fatigue cracking was found to have started from the fastener thread root, and then propagated through the majority of the component cross-section. Final fracture of each socket head bolt was by overload as a consequence of the reduced cross-sectional area.

Figure 4: Close-up of the fastener fracture surface from Figure 3.

'Ratchet marks' (arrowed) at the thread root indicates multiple fatigue crack origins. The fracture regions of fatigue cracking and overload are labelled.

The examination revealed that fatigue cracking had initiated and propagated through each bolt, until overload fracture occurred as a consequence of the reduced cross-sectional area. The fatigue cracking had initiated at multiple locations in the thread root of each bolt, and had propagated slowly under high-cycle low-stress conditions.

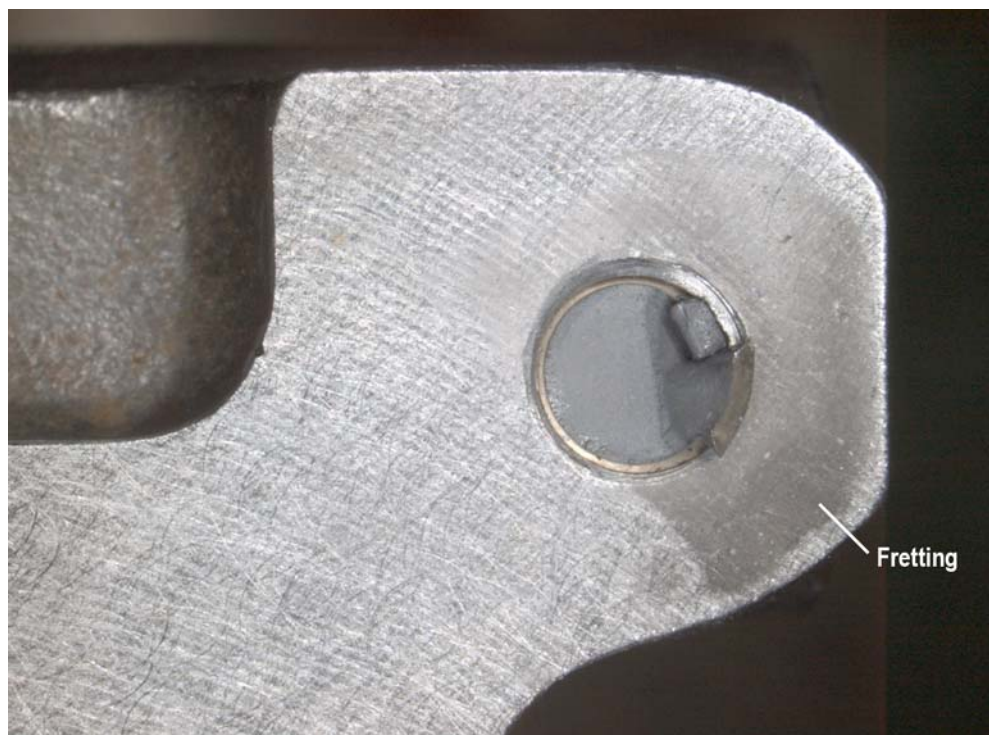
Blackening and staining from fretting damage was found on both the sequence valve and solenoid flange surfaces. Fretting is a wear process when small amplitude oscillatory movement takes place between tightly fitted metal-to-metal surfaces. In this event, the presence of fretting damage indicated that the component flange surfaces had been able to move against one another during service (Figure 5).

Figure 5: Fretting damage was found on the sequence valve flange surface, close to each of the broken fastener locations.
