ATSB TRANSPORT SAFETY INVESTIGATION REPORT

Aviation Occurrence Investigation – 200606510

**Engine power loss
28 km NE Coolah, NSW
31 October 2006
VH-KTR
Bell 206 B3 helicopter**

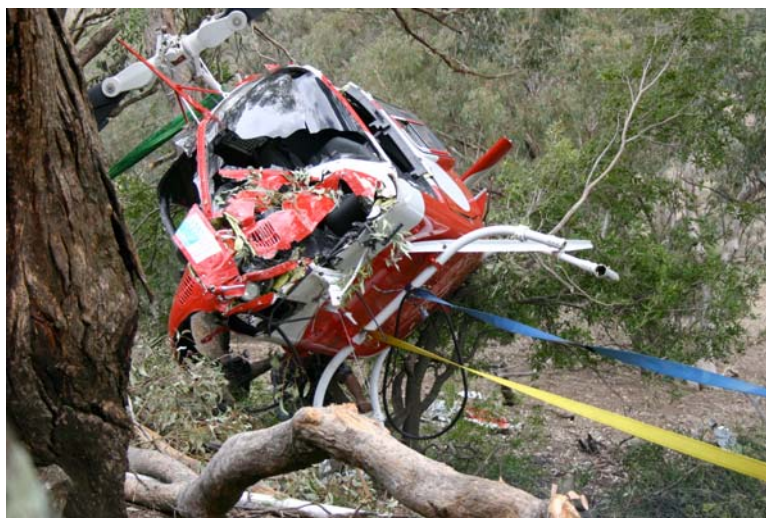
The helicopter descended into trees on the side of a steep hill and the rotors severed several large branches, before the helicopter came to rest supported by trees (Figure 1). Both occupants reported that the engine was still running after the helicopter came to rest, however, only at about idle power. The pilot reported that he shut the engine down via the throttle and both occupants exited the helicopter. The pilot sustained facial and eye injuries during the impact, while the shooter's injuries were minor.

Figure 1: The helicopter after the removal of trees

All of the damage noted to the helicopter was consistent with it having occurred during the accident sequence. The evidence indicated that the main and tail rotors were rotating at impact and the helicopter's flight controls exhibited accident damage.

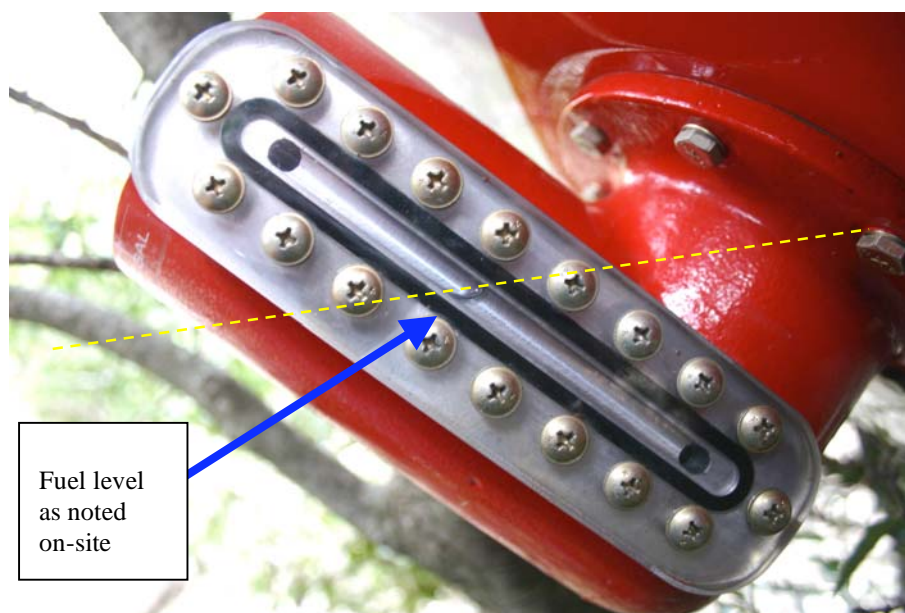
At the accident site, the fuel quantity could not be assessed accurately due to the precarious positioning of the wreckage. The attitude of the wreckage was measured at approximately 45° to 50° nose high and 30° right roll. Examination of the sight gauge on the front of the helicopter's fuel tank range extender unit³, positioned on the low side of the wreckage, indicated a level of approximately 50% (Figure 2).

Figure 2: Sight gauge reading from the range extender

The ATSB approached the helicopter's manufacturer asking for a fuel quantity remaining estimate based on the on-site reading on the range extender gauge and the approximate attitude of the wreckage. That estimated quantity was 106.4 L (28.1 US Gals).

Draining of the fuel tank after removal from the site showed that a total of 23 L remained in the helicopter. A detailed examination of the fuel tank found no holes or perforations. Examination of the airframe fuel filter and engine fuel lines found all were full of fuel.

While only 23 L of fuel was physically recovered from the helicopter's fuel tank, the assessment of the fuel remaining by the investigation determined there would have been sufficient fuel in the helicopter for continued flight at the time of the accident.

The witness accounts of liquid draining from the vertically oriented wreckage during its retrieval are consistent with fuel draining from the fuel tank vent and would explain the difference in the physical quantity retrieved from the aircraft and the amount that was calculated to be on board. The fuel calculations and estimates conducted by the pilot, the ATSB, and the helicopter's manufacturer all indicated that there was sufficient fuel onboard for continued flight.

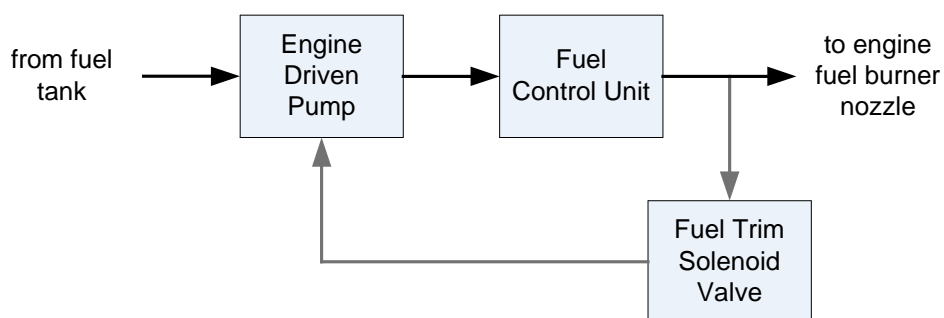
The helicopter was fitted with an IntelliStart Plus+™ system. The computer controlled system performed a dual function. One function recorded engine and flight data for download and trend monitoring purposes. Additionally, during the engine start sequence the system controlled the temperature of the engine to limit damaging thermal temperature peaks in the engine. The IntelliStart system achieved that by diverting part of the fuel supplied to the engine's fuel burner nozzle via a fuel trim solenoid valve (Figure 3). The manufacturer indicated that the system prevented inadvertent solenoid operation.

Figure 3: Connection of the Fuel Trim Solenoid Valve in the fuel system

The fuel trim solenoid valve operated normally when tested following the accident.

'Initial testing has shown that in the unlikely event the FTSV [Fuel Trim Solenoid Valve] opened during flight there would only be a 0.7% -1.07% loss of engine speed, depending on application'.

The IntelliStart system had not been working for some time prior to the accident flight. A feature of the IntelliStart system was that it had the ability to divert fuel away from the engine during start-up, via a solenoid. The system, however, had a number of safeguards to prevent that occurring during flight. The manufacturer advised that in-flight operation of the solenoid would have had a limited effect on engine operation. There was no evidence found to indicate that the IntelliStart system would have had an effect on the development of the accident.
