**ATSB TRANSPORT SAFETY INVESTIGATION REPORT**

Aviation Occurrence Report – 200606530

Preliminary

**Loss of control - 9 km south-east of Raglan, Qld  
31 October 2006  
Piper Aircraft Corporation PA31-350, Chieftain  
VH-ZGZ**

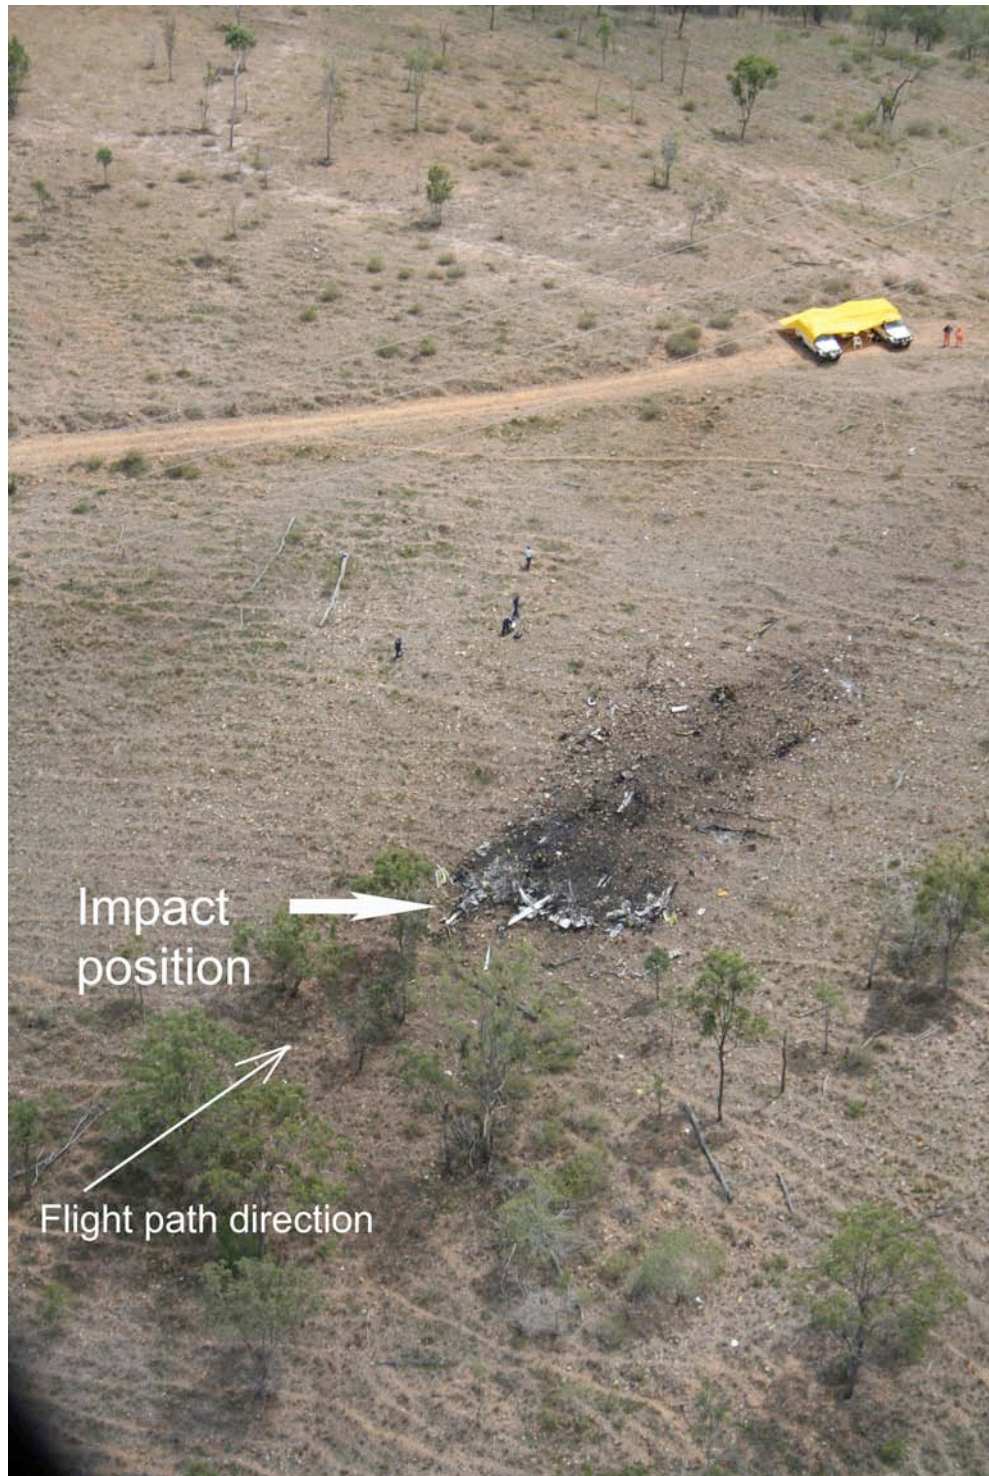
**Figure 1: Aerial view of accident site**

Examination of the accident site revealed that the aircraft had impacted open ground on the side of a hill in a very steep nose-down attitude at high speed (figure 1). The relative angle between the terrain slope and the flight path was greater than 70 degrees.

The force of the impact and the subsequent fire caused complete disintegration of the aircraft structure, except for the engines and the propellers, which had retained some structural integrity.

Examination of the wreckage confirmed that all the aircraft extremities were at the impact site. That information enabled in-flight break-up to be discounted as part of the accident sequence.

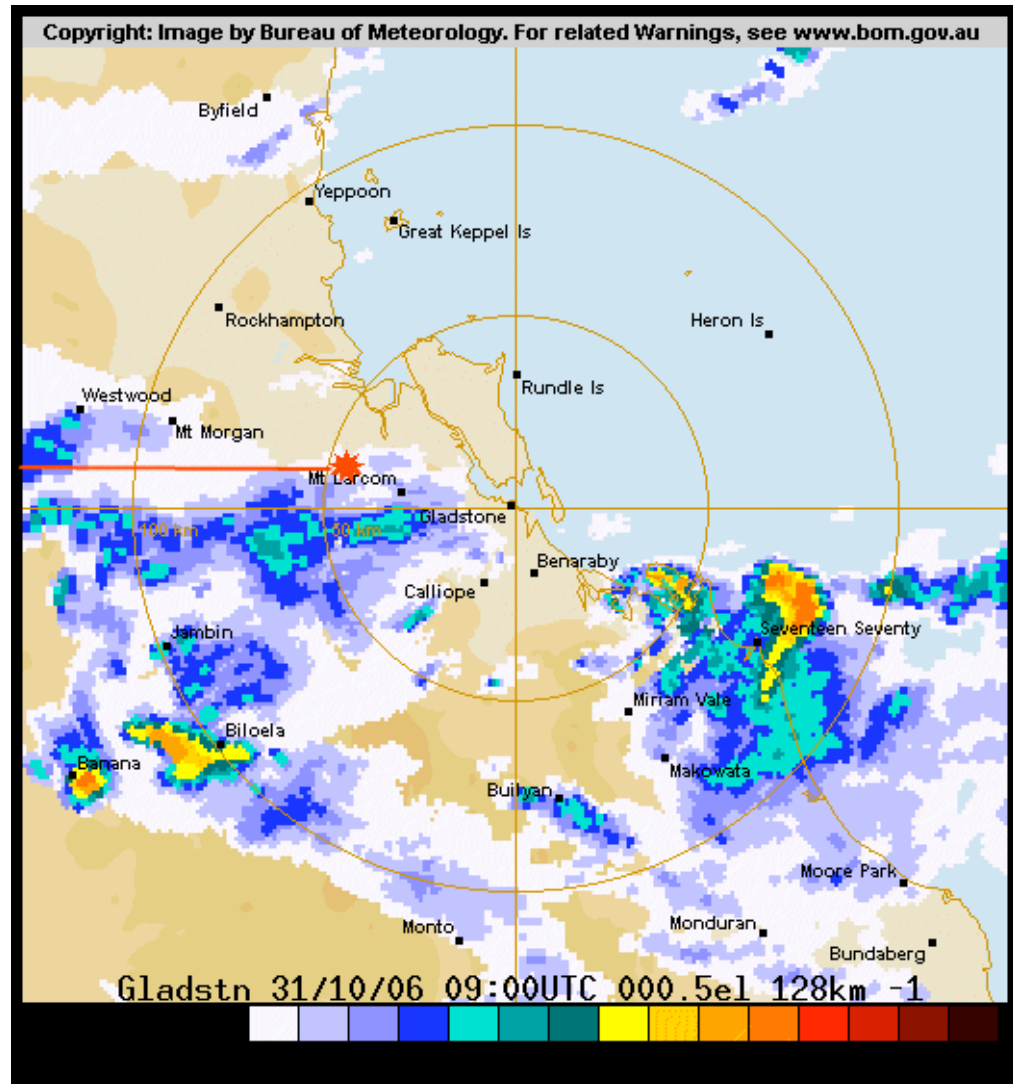
**Figure 2: Bureau of Meteorology Gladstone weather radar image, 256 km radius, recorded on 31 October 2006 at 1900 EST**

On 31 October 2006, a high pressure ridge extended along the Queensland coast and an inland trough extended north-south through central Queensland. During the afternoon, showers and thunderstorms developed east of the trough and moved towards the coast. The Bureau of Meteorology's Gladstone weather radar image recorded at 1900 is shown at figure 2. The approximate track of the aircraft and the accident location (in red) have been superimposed on that image.
