Aviation Occurrence Report – 200606530

Interim Factual

Loss of control – 9 km SE Raglan, Qld

Piper Aircraft Corporation PA31-350, Chieftain

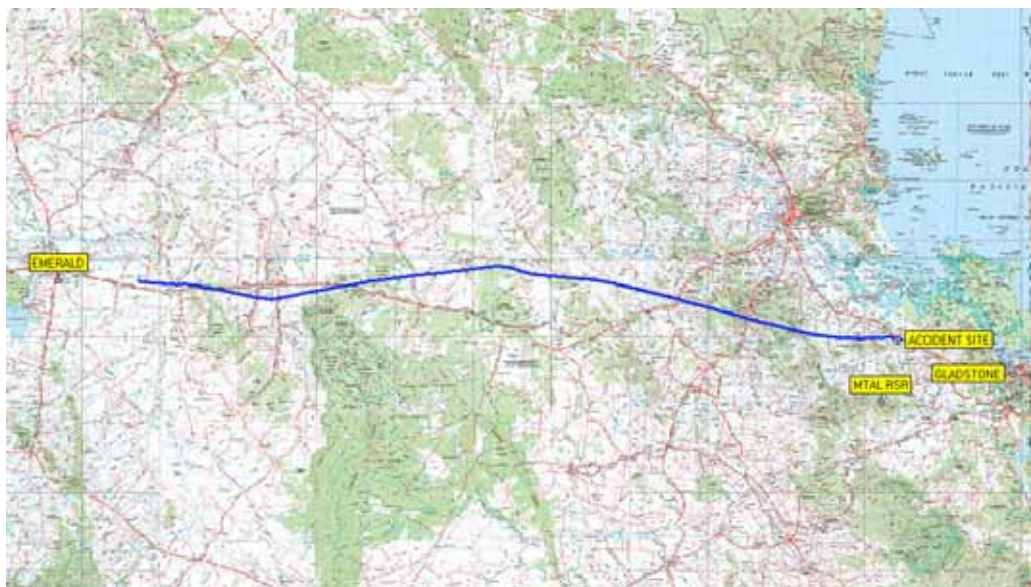
Figure 1: Recorded radar track of VH-ZGZ.

from its position when it initially entered radar coverage until radar contact was lost. The recorded altitude profile showed that the aircraft maintained a constant altitude during the cruise segments of the flight. The groundspeed profile showed speeds that were consistent with the aircraft's phase of flight. During the cruise at 9,000 ft, the aircraft maintained a groundspeed in excess of 200 kts. During the cruise phase at 7,000 ft, the aircraft groundspeed exceeded 185 kts.

The final 4 minutes of radar data showed the aircraft in a steady descent at about 600 ft per minute, with a groundspeed of about 180 kts. The last valid data record showed an altitude of about 5,400 ft and a groundspeed of 177 kts. Throughout those 4 minutes, the recorded track remained steady on about 191 degrees magnetic.

The last recorded position of the aircraft was within 1 km of the accident site.

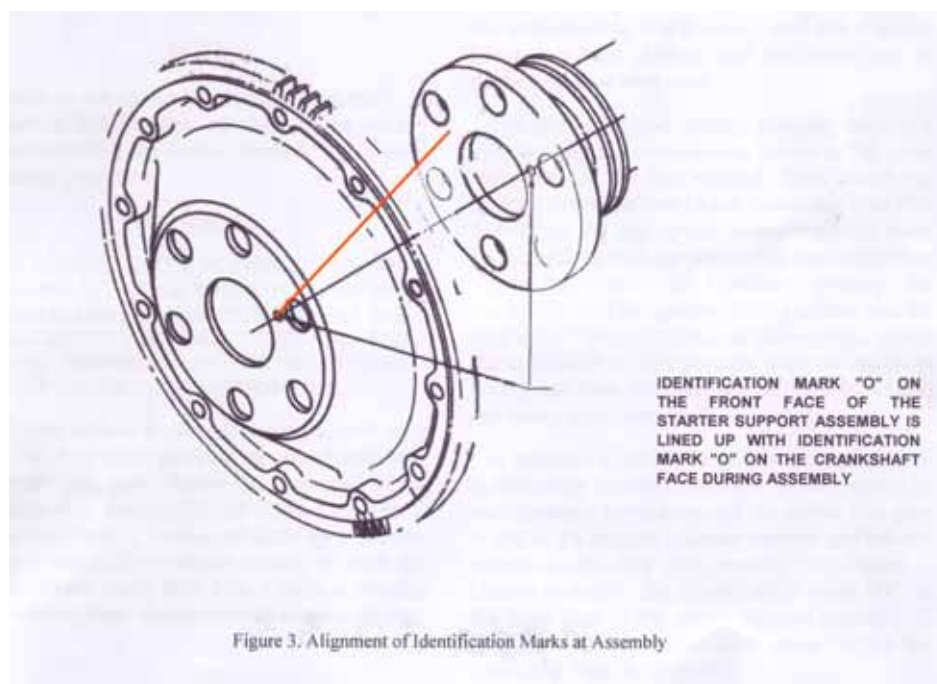
Figure 2: Showing starter support assembly and crankshaft face.

The Emerald LAME then used a timing light to check the ignition timing set up. He noticed that the starter support timing marks appeared to be in the incorrect position. To investigate further, the propeller was removed and it was found that the identification marks on the starter support assembly did not line up with the identification marks on the crankshaft face. They were displaced by approximately 120 degrees (see Figure 2⁵). The LAME checked the starter support for damage, reassembled the components in the correct alignment, and refitted the propeller. The engine then ran normally during a ground run.

Note: The red line indicates the alignment found when the propeller was removed at Emerald.

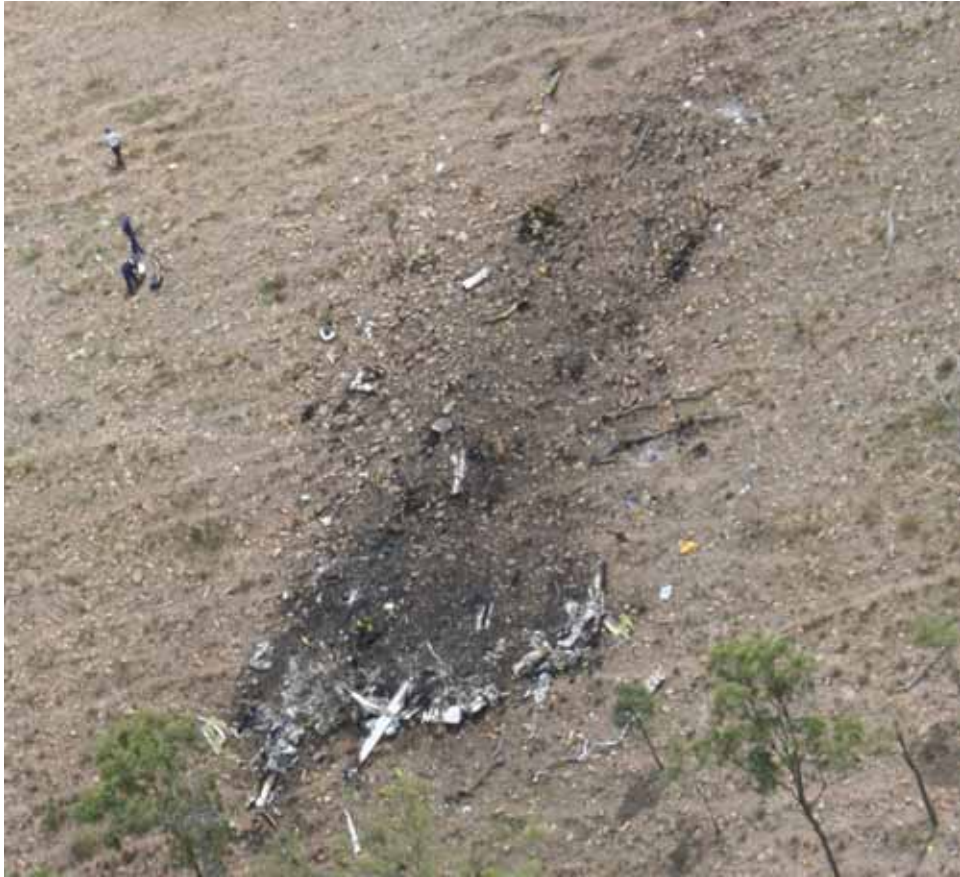
Figure 3. Aerial view of accident site.

Examination of the accident site revealed that the aircraft had impacted open ground on the side of a hill at high speed in a very steep nose-down attitude (Figure 3). The relative angle between the terrain slope and the flight path was greater than 70 degrees.

The force of the impact and the subsequent fire had caused the disintegration of much of the aircraft structure.

Examination of the wreckage confirmed that all the aircraft extremities were at the impact site. That information enabled in-flight break-up to be discounted as part of the accident sequence.

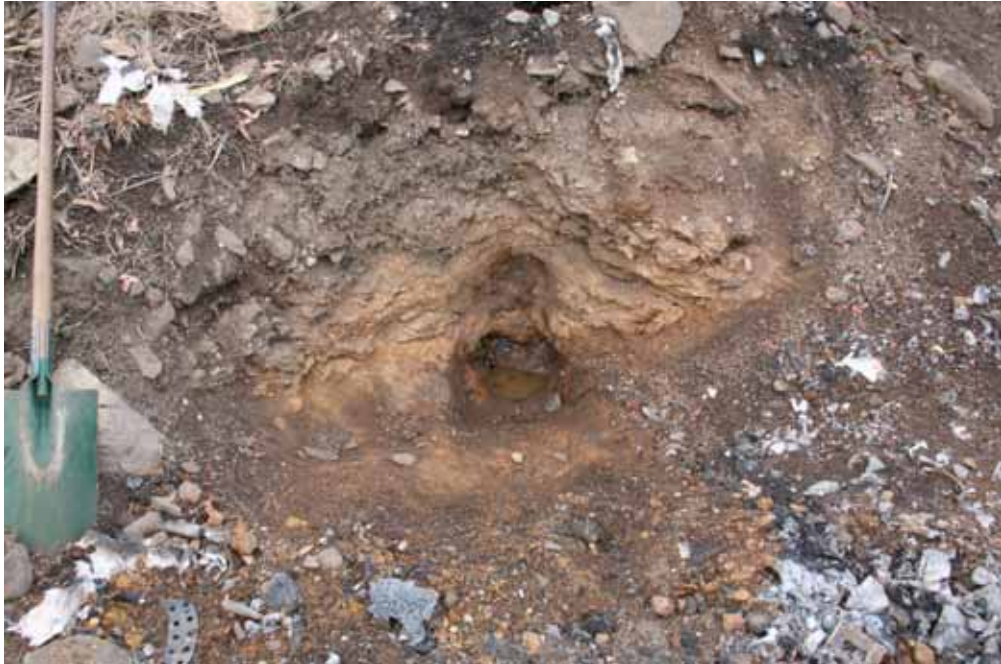
Figure 4: After excavation of the left engine/propeller.

Both propeller/engine combinations were embedded in hard, dry, rocky earth at the accident site. Excavation of the propellers revealed marked differences in the impact signature of each propeller. (Figures 4 and 5).

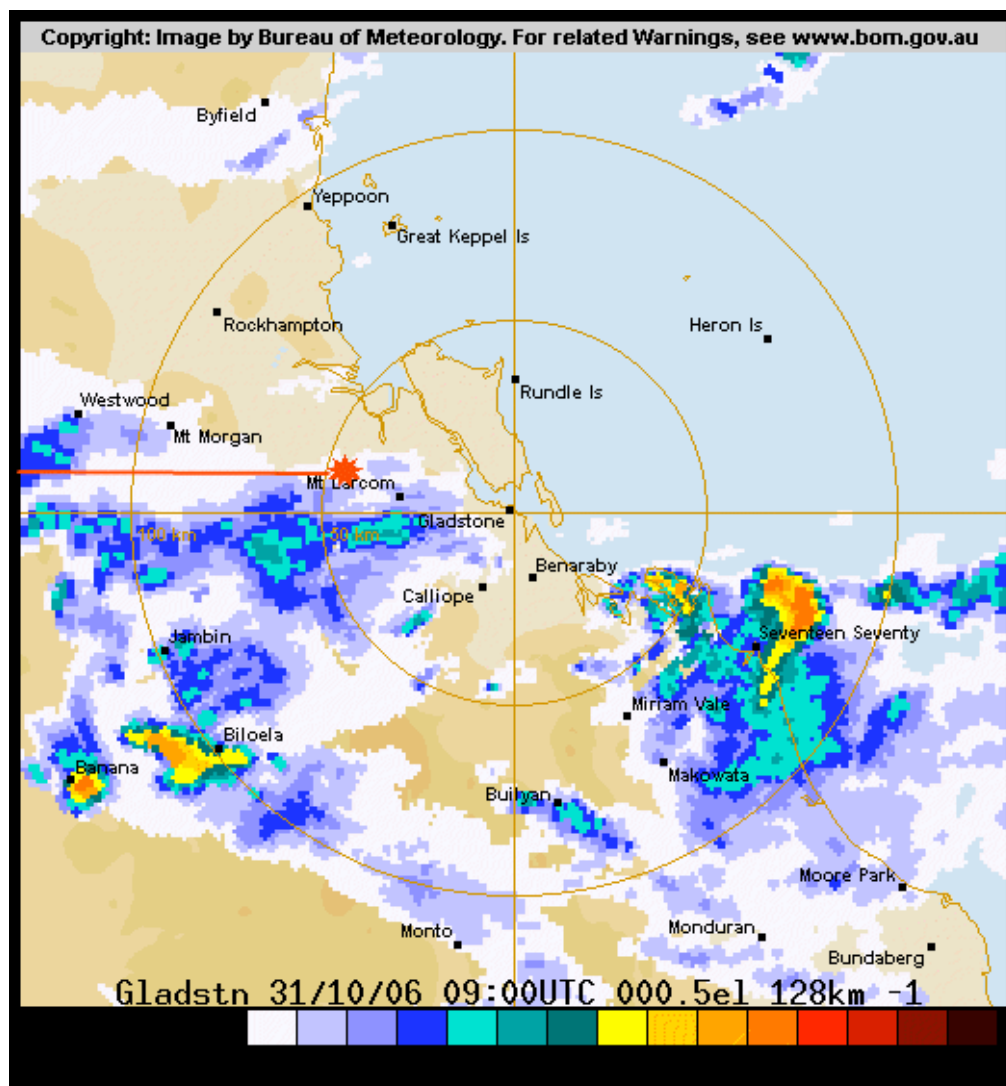
Figure 6: Bureau of Meteorology Gladstone weather radar image, 256 km radius, recorded on 31 October 2006 at 1900 EST.

The Bureau of Meteorology's Gladstone Weather Watch Radar image recorded at 1900 is shown at Figure 6⁷. The approximate track of the aircraft and the accident location (in red) has been superimposed on that image.

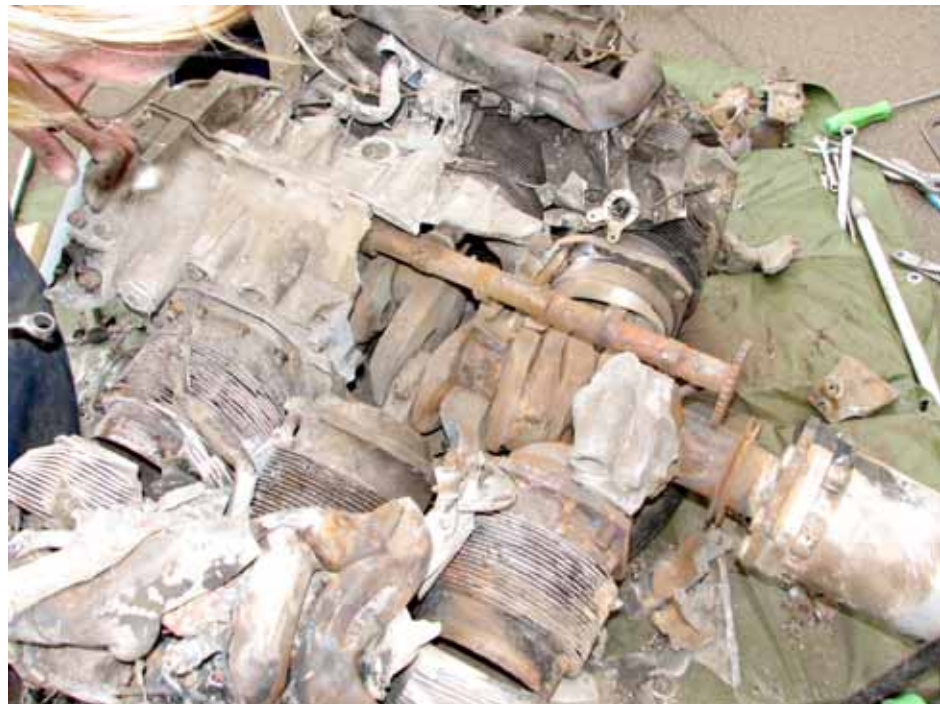
Figure 7: The left engine.

- The pilot's attitude indicator was a gyroscopic instrument. The gyroscope was air driven. The remains of the instrument contained fragments of the gyro case and the gyro rotor. Examination of those parts showed signs of rotational scoring on both the inside of the gyro case and on the gyro rotor.
- Impact forces destroyed the integrity of the left engine structure. The engine had also sustained substantial fire damage (Figure 7). The crankshaft was bent and compressed axially along its forward length.

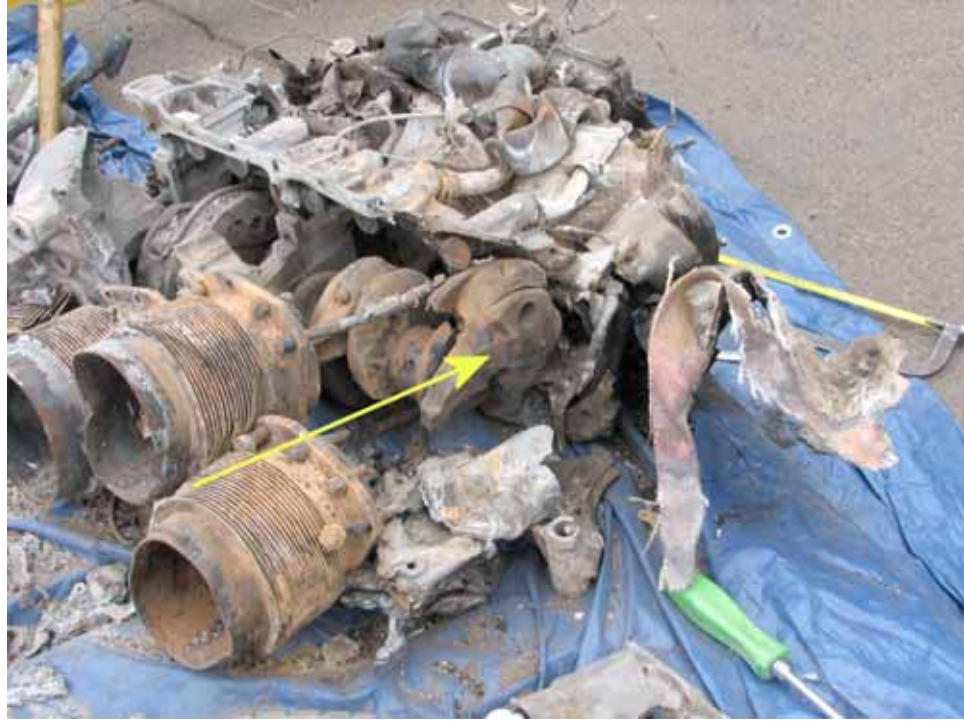
Figure 8: The right engine and fractured crankshaft (arrowed).

- Impact forces destroyed the integrity of the right engine structure to a greater extent than sustained by the left engine. The engine was substantially fire damaged. The crankshaft of the right engine had fractured adjacent to the first (forward-most) connecting-rod throw (Figure 8). The forward section of the crankshaft remained connected to the propeller flange. The nature of the crankshaft failure was consistent with the forces sustained during the impact of the aircraft and the engine with the terrain. There was no evidence that any latent defects, such as fatigue cracking or material flaws, were present with the crankshaft or associated forward big-end connection; nor was there any evidence of any defects or deficiencies within the crankshaft that had

contributed to the failure. Checks against the engine manufacturer's service bulletins confirmed that the right engine crankshaft was not included in the range of components identified by the manufacturer for mandatory replacement.
