**ATSB TRANSPORT SAFETY INVESTIGATION REPORT**

Aviation Occurrence Investigation – 200606542

**Engine failure – Townsville Airport, Qld  
1 November 2006  
VH-UBX  
Cessna Aircraft Company 207**

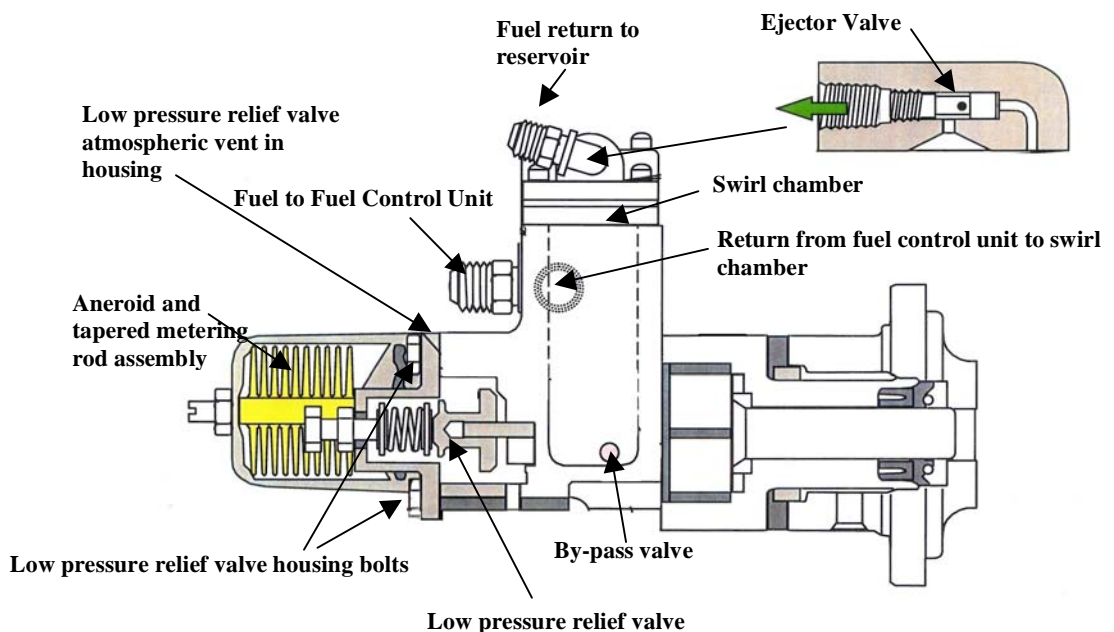
**Figure 2: Typical engine fuel pump with aneroid assembly**

Testing of the EFP was conducted at a component repair facility. During this test, several abnormalities were noted. During test at low speed, the EFP made cavitating noises and produced a mixture of fuel and air at the outlet port. At high and mid-speed, the pump leaked fuel from the body seals and produced significantly higher pressure than was required for the engine installation.

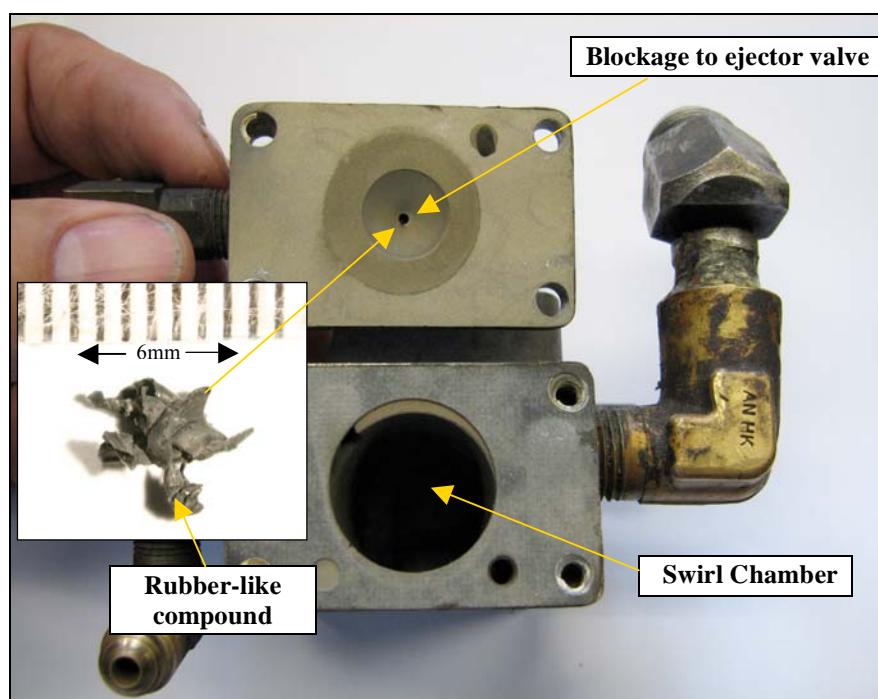
**Figure 3: Rubber-like debris found in the ejector valve**

The ejector valve (Figure 3) was removed and was found to be blocked with rubber-like debris. The ejector valve operates on a vacuum principle through a venturi that ejects any air that accumulates in the swirl chamber. Excess fuel from the EFP is also returned to the swirl chamber. Excess fuel is then returned to the respective fuel reservoir tank through the same ejector valve (Figure 4). With the ejector valve blocked, excessive fuel from the EFP could not return to the reservoir tank.

Between the electric fuel pump and the EFP, there was a fuel strainer (Figure 1) that was designed to capture particles/debris in the fuel. That fuel strainer was inspected and very fine debris was found. The debris was consistent with what could be expected from using drum stock fuel and from the local operating environment over time. The rubber-like debris found in the ejector valve was greater in size than the mesh fuel strainer.

The physical size of the rubber-like debris was insufficient to conduct tests that may have determined its origin.

The manufacturer advised that if the ejector valve was blocked, the EFP would run 'rich'; that is, there would be a high fuel to air mixture.

There were a number of defects identified in the EFP, with the primary defect being a blockage of the ejector valve. That prevented the fuel pump returning excess fuel back to the fuel tank and probably caused an over rich fuel /air mixture during the landing approach.

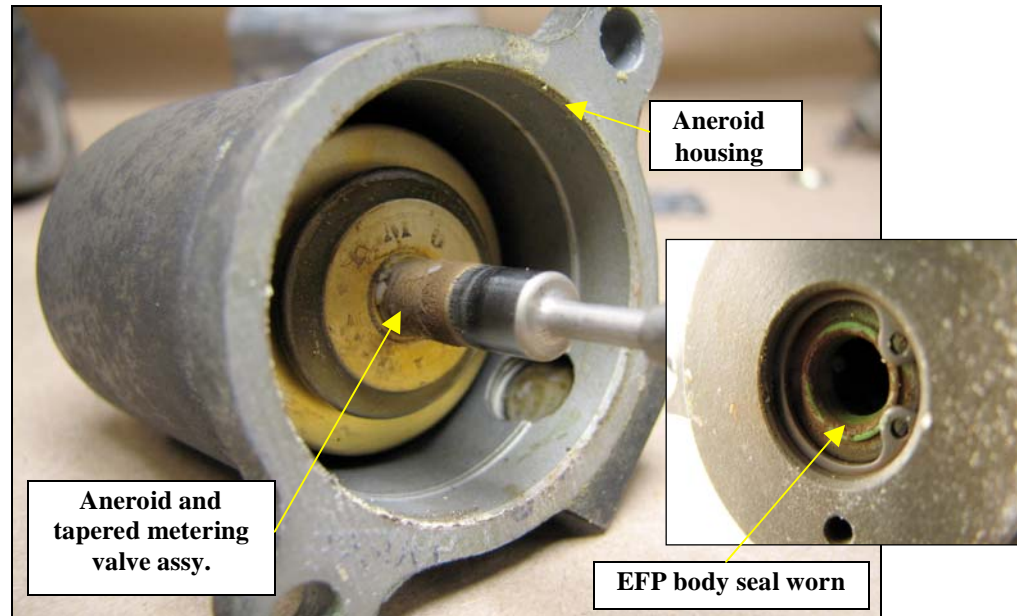
**Figure 5: Aneroid and tapered metering valve, housing and EFP body seal**

The aneroid assembly was removed from the EFP and inspected. That inspection found that the tapered metering rod was extended and stuck in the EFP housing, but released easily with a small amount of force. There was an accumulation of debris on the tapered metering rod shaft (Figure 5) and the main body seal that received the tapered metering rod, was worn. The aneroid housing was also full of fuel.

The manufacturer advised that if the tapered metering rod was stuck in the fully extended position, it would lead to an increased internal bypass that would reduce the output pump pressure, unless the blockage due to the debris reduced the bypass. A blockage would lead to an increased output pump pressure.

The manufacturer also advised that if the aneroid housing was full of fuel then the engine fuel/air mixture would be 'rich'.

The other defects found (the aneroid housing full of fuel, the blocked aneroid housing air vent hole and the tapered metering valve extended and jammed in the fuel pump housing) were secondary defects, in that they may have contributed to the engine stopping by supplying incorrect fuel metering for the selected power settings.

The debris on the tapered metering rod may have contributed to the accelerated wear of the EFP body seal that is designed to prevent fuel from entering the aneroid housing. That wear probably enabled fuel to leak into the aneroid housing and to fill the housing, eventually leaking out of the air vent hole. This may have prompted maintenance personnel to fit the additional seal in an effort to stop the fuel leak. The addition of the seal was an unapproved repair.

The build up of debris on the tapered metering valve shaft may have also contributed to the shaft being stuck in the body seal. The extended shaft would have reduced the fuel pressure at sea level. However this reduction may have been insignificant as the aircraft had most probably been operated for some time in this condition, with no apparent anomalies.

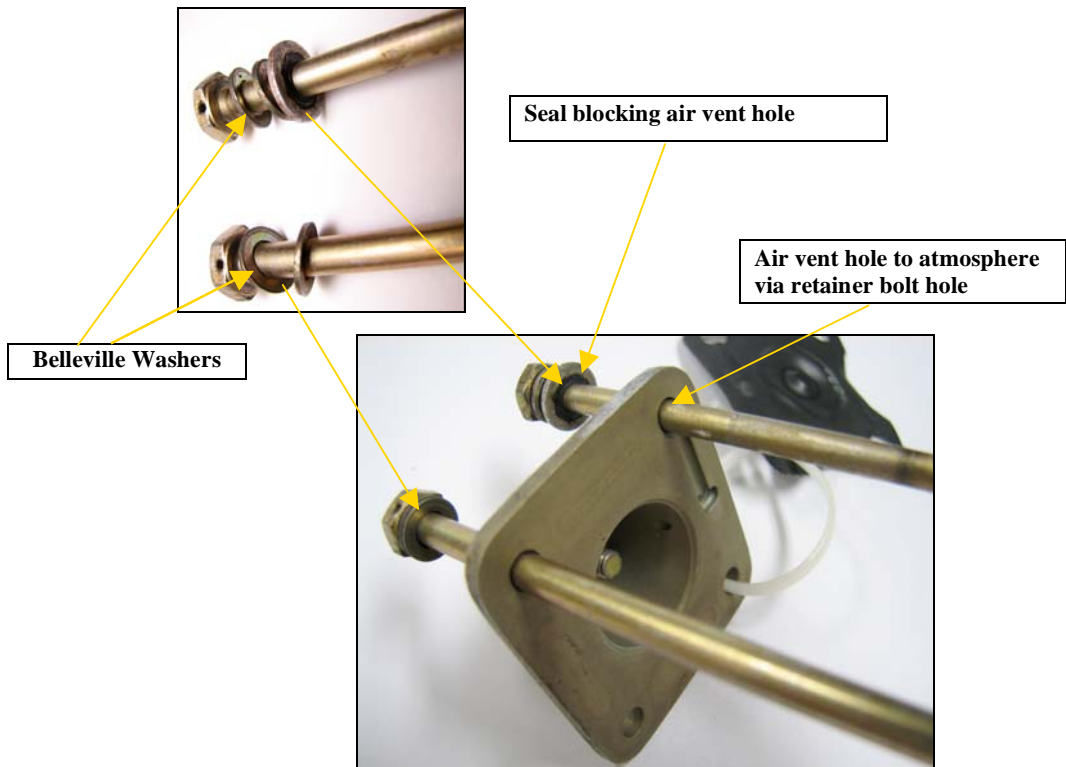
**Figure 6: Low pressure relief valve housing**

The low pressure relief valve housing was attached to the main pump body by four through bolts. This assembly would normally have a set of Belleville washers<sup>6</sup> fitted under each bolt head as a locking device to retain the correct bolt tension. When inspected, it was found that an additional seal had been fitted under the head of one of the bolts (Figure 6). That bolt corresponded to the air balance hole. The non-standard installation of that seal had covered the air balance hole and prevented the low pressure relief housing from venting to atmosphere. The manufacturer advised that this would also have restricted the rate of movement of the diaphragm and hampered the operation of the low pressure relief valve.

Note: The Belleville washers, air vent hole and the seal fitted under the bolt head adjacent to the air balance hole.

During the life of the engine installation, the aircraft had been maintained by several different maintenance providers. There was no record found in the operator's maintenance log books of an EFP fuel leak or of any maintenance being performed on the EFP that would have indicated the reason for, or the time of the fitting of the non-standard seal on the housing through bolt.

The manufacturer advised that blocking of the air vent hole on the low pressure relief valve would cause the engine fuel / air mixture to be 'rich'.
