**ATSB TRANSPORT SAFETY INVESTIGATION REPORT**

Aviation Occurrence Report – 200607478

Preliminary

**Collision with terrain – Collymongle, NSW  
09 December 2006  
VH-CJZ  
Air Tractor AT-802A**

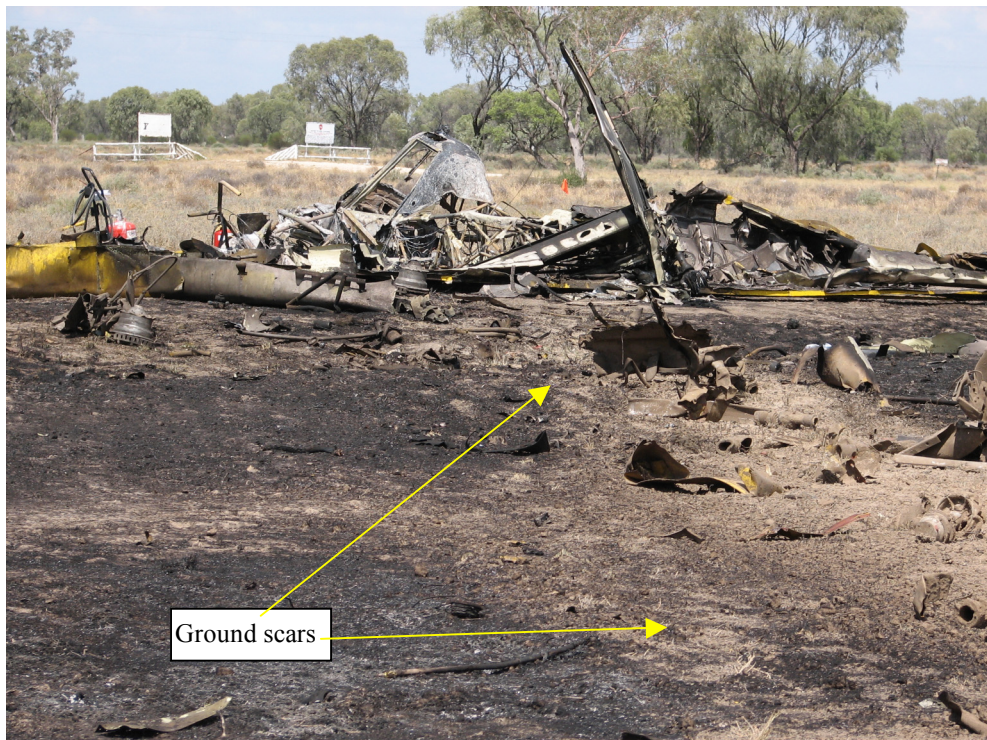
**Figure 2: Aircraft wreckage**

The wreckage was contained in a small area that showed that the aircraft impacted the ground with a significant nose-down attitude. A ground scar indicated that the aircraft impacted with the left wing down and remained in that attitude while sliding for approximately 45 m (figure 2). The aircraft’s flaps were estimated to be at approximately the 10 degrees down position. There was no evidence of a wire strike or of any foreign object damage. Damage to the propeller blades indicated that engine power was being transmitted through the propeller at impact.
