**ATSB TRANSPORT SAFETY INVESTIGATION REPORT**

Aviation Occurrence Investigation – 200607801

**Wirestrike - Nelson, Vic. - 24 December 2006**

**Auster Aircraft Co. J1/A1**

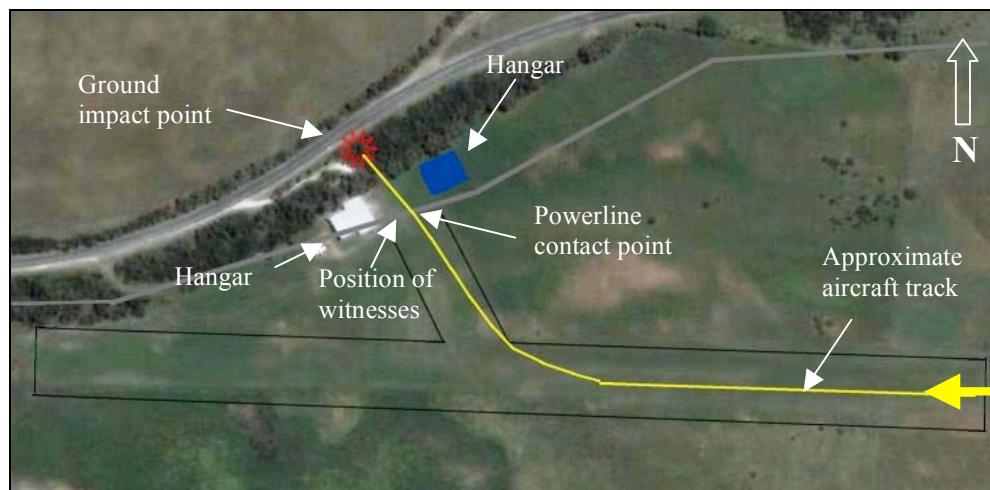
**Figure 1: Aerial view of the aircraft flight path**

Figure 1 depicts the aircraft's approximate track, which was derived from the witness information, overlaid in yellow on a satellite photograph of the airstrip. One of the hangars, which is highlighted in blue, had not been constructed when the satellite photo was taken.

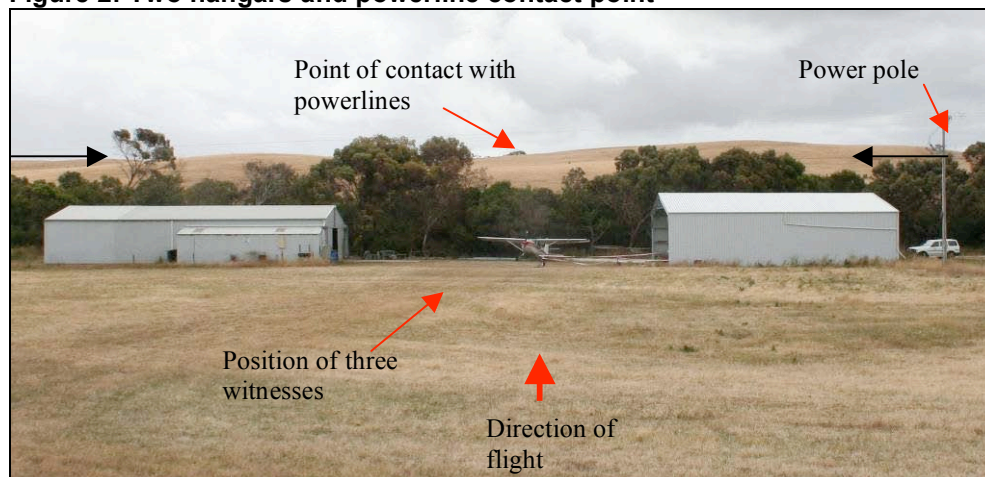
**Figure 2: Two hangars and powerline contact point**

Figure 2 shows the aircraft contact point with the powerlines. The three witnesses were located between the two hangars, almost directly beneath the powerlines. The aircraft impacted the ground directly behind the trees seen between the two hangars. The powerlines are indicated by black arrows.

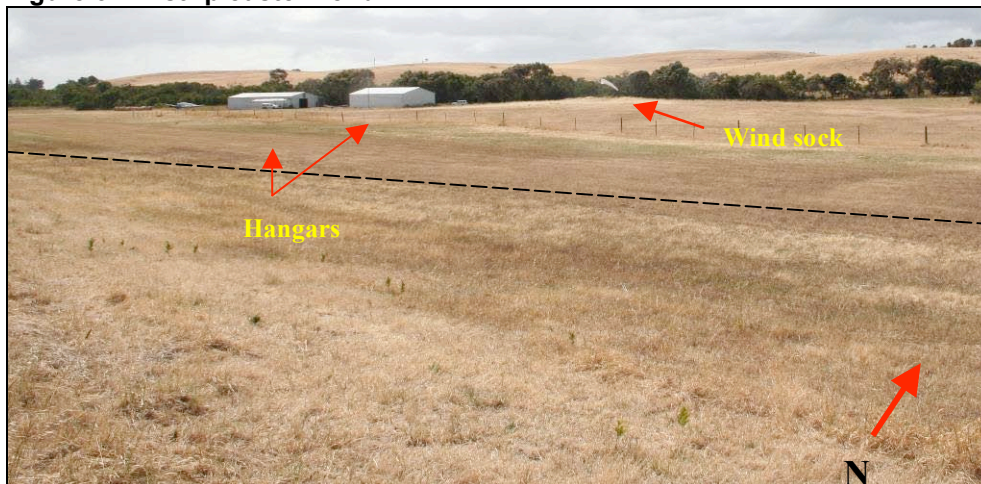
**Figure 3: Airstrip eastern end**

Figure 3 is a picture taken from the airstrip's eastern end with the hangars and wind sock in the background, the powerlines ran directly in front of the two hangars. The airstrip centreline has been highlighted with black dashes.

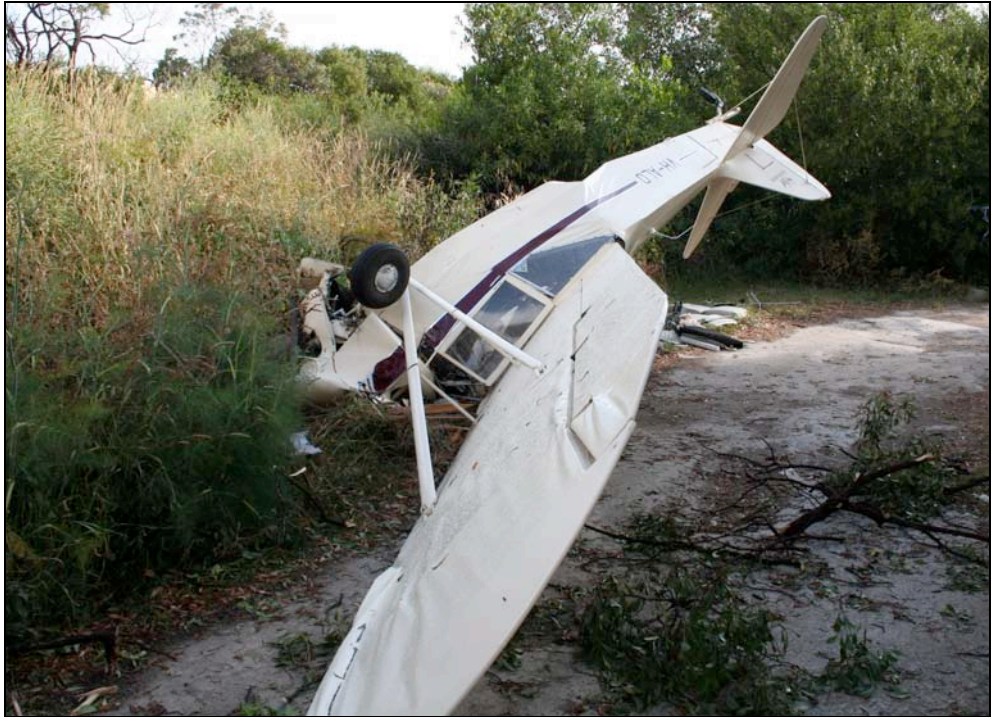
**Figure 5: Aircraft wreckage**

The aircraft impacted the ground inverted at an angle of approximately 60 degrees nose down (Figure 5). An examination of the engine and flight control cable runs indicated that they were continuous with no anomalies. The aircraft was examined with no pre-impact defects evident and all of the aircraft components and flight controls surfaces were accounted for at the accident site. There were no indications of wirestrike damage on the airframe, with the only indications of a wirestrike found on the propeller.

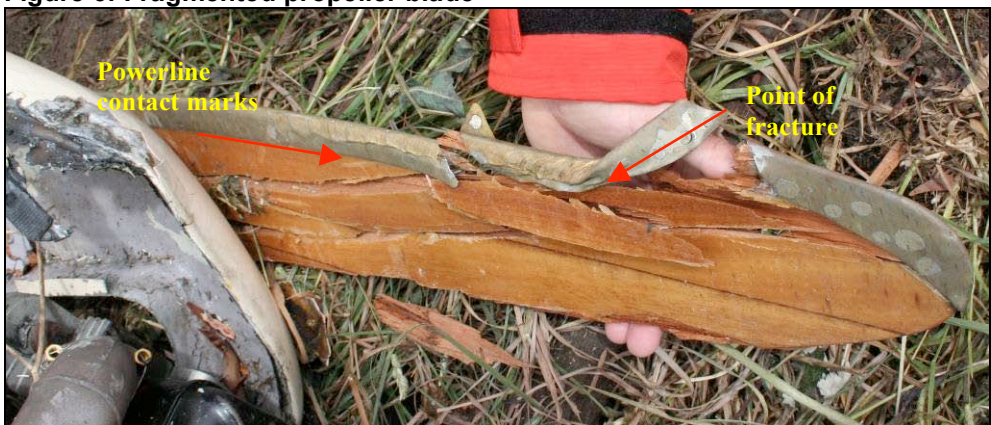
**Figure 6: Fragmented propeller blade**

Fragmented sections of the wooden propeller were found in close proximity to the section of powerline that it struck. Powerline impact marks on the propeller indicated that the engine was generating significant power when the propeller blade came in contact with the powerlines. The engine was inspected externally on-site with no faults evident.

Figure 6 shows the reassembled pieces of the propeller blade. Note the powerline contact marks along the leading edge and the leading edge section that is bent forward, indicating the point where the power line caused the propeller blade to fracture.
