Aviation Safety Occurrence Report – 200607801

Wirestrike

Nelson, Victoria

Auster Aircraft Co. J1/A1, VH-ALO

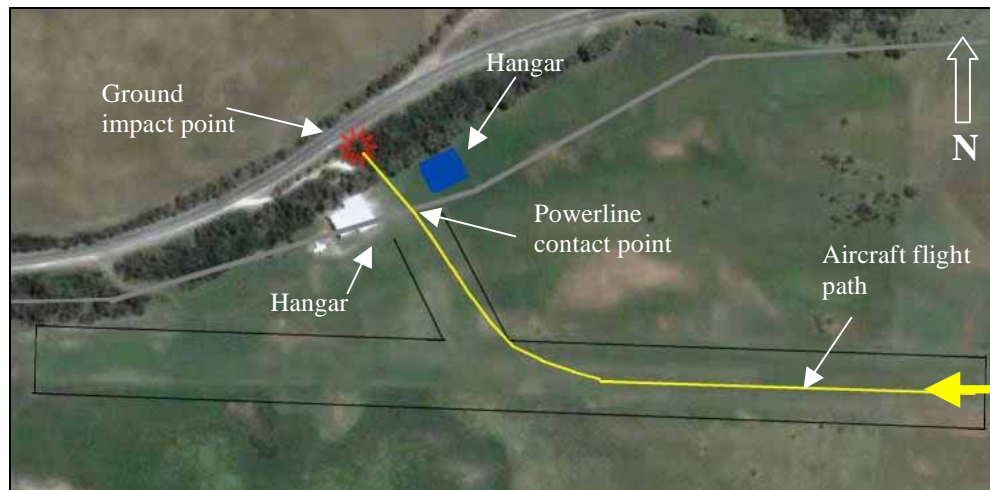
Figure 1: Aerial view of the aircraft flight path

At approximately 0930 Eastern Daylight-saving Time¹, the pilot commenced a takeoff towards the west. Three people were standing between two hangars that were to the north of the airstrip and they observed that the aircraft became airborne before it reached the taxiway leading from the hangars to the runway (figure 1). When the aircraft was adjacent to the taxiway, it made a low level right turn towards the hangars.

At the time of the accident, the weather was reported to be fine with a 15 kt wind from the west. The approximate flight path of the aircraft is shown in figure 1.

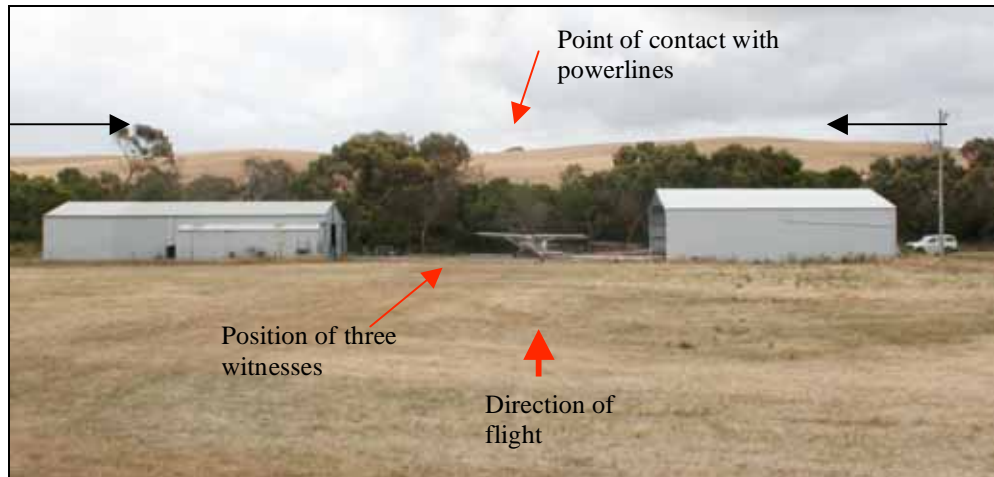
Figure 2: View of the two hangars and power line contact point

The witnesses reported that the engine sounded normal and the aircraft appeared to be in controlled flight before the wire strike. The powerline consisted of two wires running parallel to each other. Only one of the wires was struck and it detached from the adjacent pole but was not cut. The other wire remained in place.

The three witnesses were standing almost directly beneath the powerline contact point. The aircraft impacted the ground directly behind the trees located beyond the two hangars (figure 2).

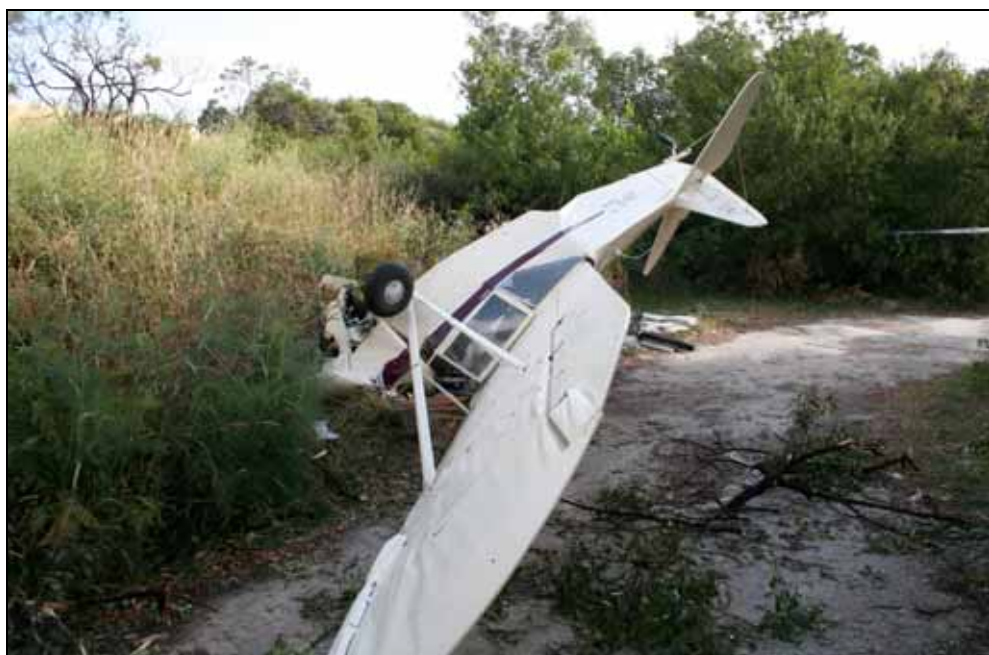
Figure 3: Aircraft wreckage

The aircraft impacted the ground inverted at an angle of approximately 60 degrees (figure 3). The aircraft was examined, with no pre-impact defects evident and all of the aircraft components accounted for on the accident site.

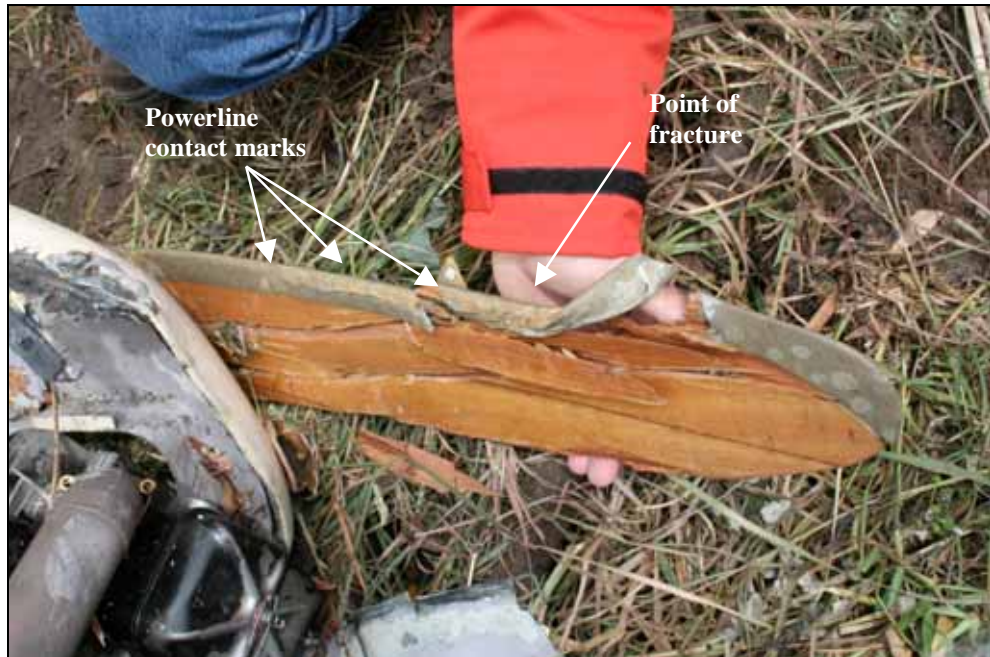
Figure 4: Fragmented propeller blade

Fragmented sections of the wooden propeller were found in close proximity to the section of powerline that was struck. Powerline contact marks on the propeller indicated that the aircraft engine was generating significant power when the propeller blade came in contact with the powerlines.

The propeller blade pieces were reassembled at the accident site. Powerline contact marks were evident along the propeller leading edge and a section of the leading edge was bent forward, indicating the point where the powerline contact resulted in the propeller blade fracture (figure 4).
