**ATSB TRANSPORT SAFETY INVESTIGATION REPORT**

Aviation Occurrence Investigation – 200700357

**Engine failure – 28 km WSW of Warialda NSW**

**VH-HRT Bell Helicopter Company 407**

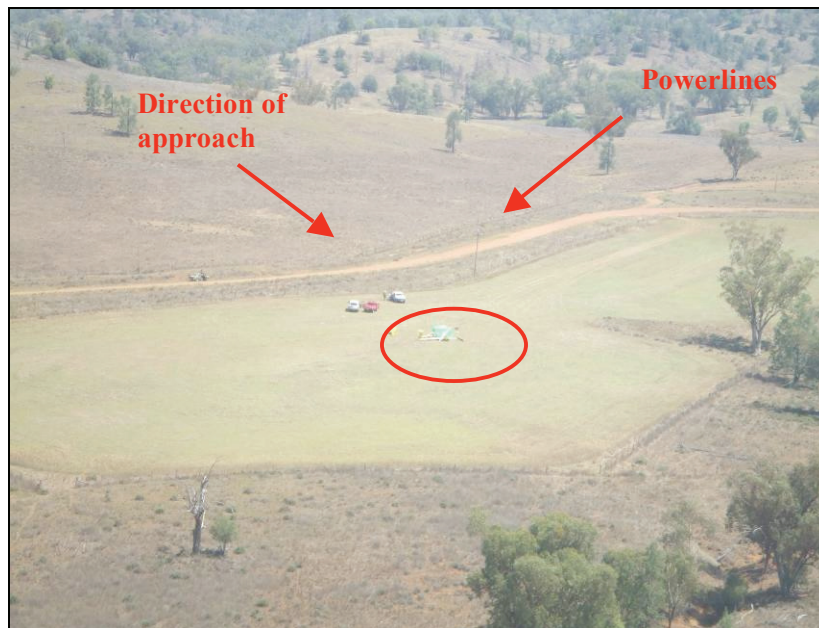
**Figure 1: Helicopter emergency landing site**

During the emergency landing, the helicopter sustained major damage. The occupants exited the helicopter and were uninjured. The elevation at the site of the emergency landing was about 1,100 ft AMSL (Figure 1).

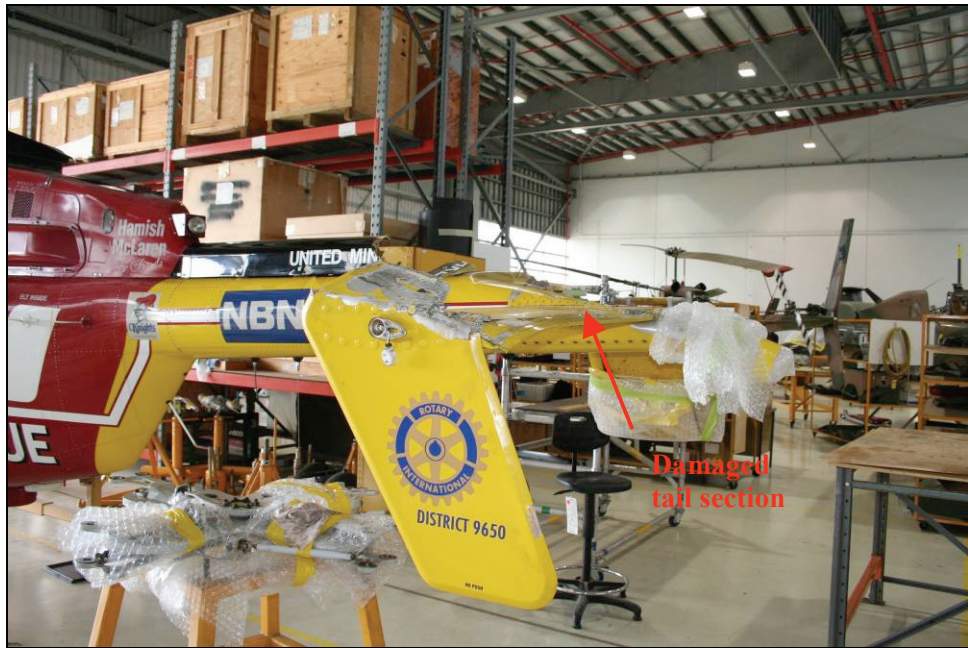
**Figure 2: Wreckage examination**

The helicopter, serial number 53042, was taken to an authorised repair facility for further examination. At the time of the occurrence, the helicopter had completed 3,203.0 hours total time since new (TTSN). The front passenger's windscreen was broken and the landing gear was destroyed. The main rotor and tail rotor blades had sustained significant impact damage. The main rotor head assembly, main rotor transmission, tail rotor gearbox and all main and tail rotor drive components were removed for sudden stoppage inspection<sup>9</sup>. The helicopter tail boom and horizontal stabilisers were impact damaged and the tail section had separated from the helicopter (Figure 2).

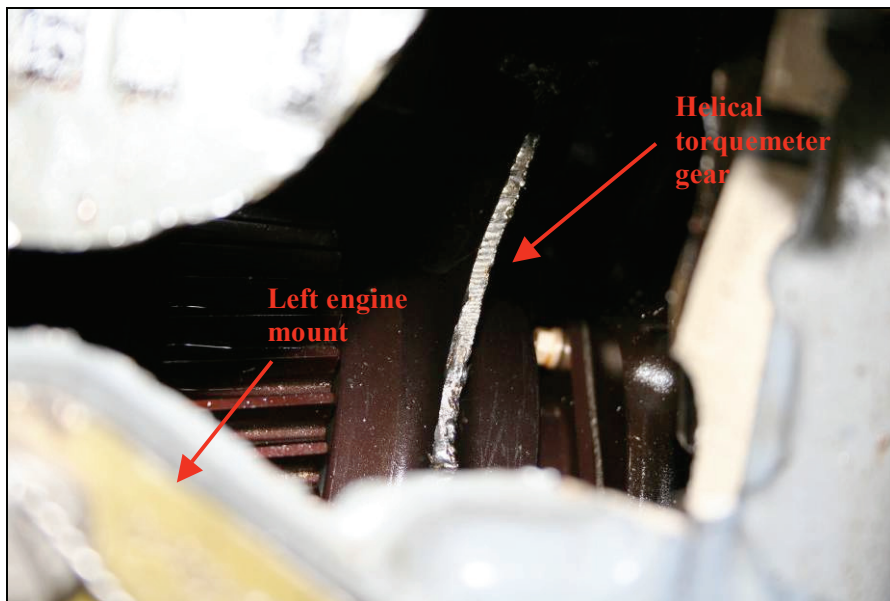
**Figure 3: Engine gearbox cover damage**

The helicopter was powered by a single Rolls-Royce Corporation model 250-C47B turboshaft engine, part number 23063393, serial number CAG-47048. Initial examination of the engine gearbox case revealed a 5 cm diameter hole in the case above the left side engine mounting pad. A section of the separated portion of the gearbox case was found on the engine deck, along with bearing material. The internal gear train components were visible through the hole, and it appeared that the helical torquemeter gearshaft (helical torquemeter gear) had fractured (Figure 3).

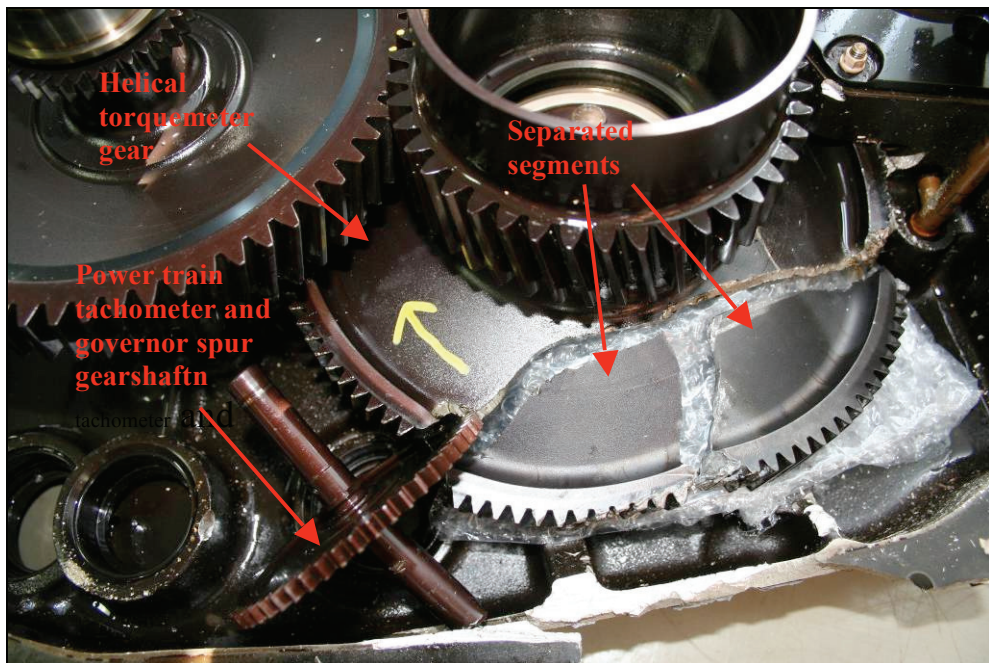
**Figure 4: Separated segments of the helical gear<sup>14</sup>**

The engine was disassembled and examined with the assistance of a representative of the engine manufacturer. Disassembly of the compressor and turbine sections of the engine were unremarkable. Disassembly of the engine gearbox confirmed that a catastrophic failure of the helical torquemeter gear (Figure 4) had caused severe internal damage to the gearbox that included:

- metal contamination of the gearbox, gearbox chip detectors and engine oil sump
- damage to the power train tachometer and governor spur gearshaft<sup>13</sup> and bearing
- damage to teeth of the turbine shaft to pinion gear coupling
- damage to the power turbine shaft to pinion gear coupling
- shearing of the turbine to compressor driveshaft
- damage to several ancillary gears
- shearing of the engine 28 volts direct current permanent magnetic alternator driveshaft.

The damage was indicative of a sudden stoppage during operation.

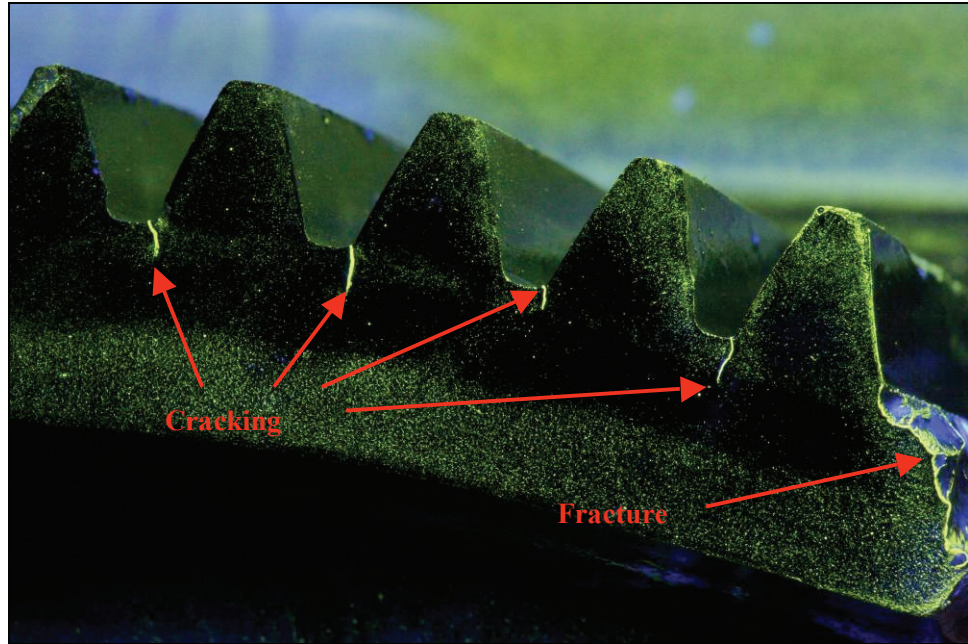
**Figure 5: Cracking at the roots of gear teeth**

The components from the gearbox were initially examined by the ATSB. Fracture surface appearance suggested the failure had developed from the radial and chordwise growth of fatigue cracking from an origin at the root region of a rim gear tooth. Evidence of localised gear tooth spalling and uneven surface contact patterns were also observed, suggesting a possible misalignment condition (uneven loading) between the helical torque meter gear and the N1 input spur adapter gearshaft. Magnetic particle inspection showed evidence of cracking at the roots of several other gear teeth adjacent to the location of the fracture (Figure 5).

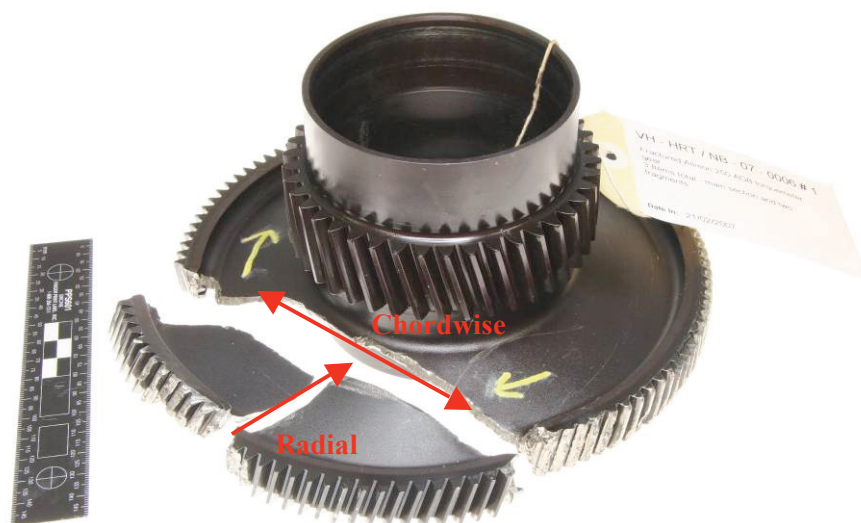
**Figure 6: Helical torquemeter gear examination**

In order to enlist specialist opinion, the removed components were sent to the engine manufacturer for further examination under the supervision of the US Federal Aviation Administration (FAA). That examination confirmed radial growth of fatigue cracking from an origin at the root region of a rim gear tooth and subsequent chordwise growth at the flange (Figure 6).

- the case hardness, core hardness, microstructure and chemistry of the helical torquemeter conformed to the requirements of engineering drawings
- the effective case depth at the tooth root conformed to the requirements of engineering drawings
- the dampening ring groove width and depth dimensions met the minimum engineering drawing requirements
- the measured tooth root radii on three consecutive teeth were less than the minimum engineering drawing requirement of 0.021 inch (0.015 to 0.016 inch on the driven side and 0.018 to 0.019 inch on the coast side)
- the oil delivery tube showed no evidence of blockage or obstruction
- the damage to the other components examined was considered secondary.

On 17 August 2007, the engine manufacturer released Commercial Engine Bulletin (CEB) 72-6061 which outlined the replacement of several engine gearbox gears with new part number gears, including the helical torque-meter gear. These replacement gears included ‘superfinished<sup>23</sup>’ gear/teeth and silver plating of the gears and a helix lead angle change to account for web deflection under high loads, to improve gear reliability.

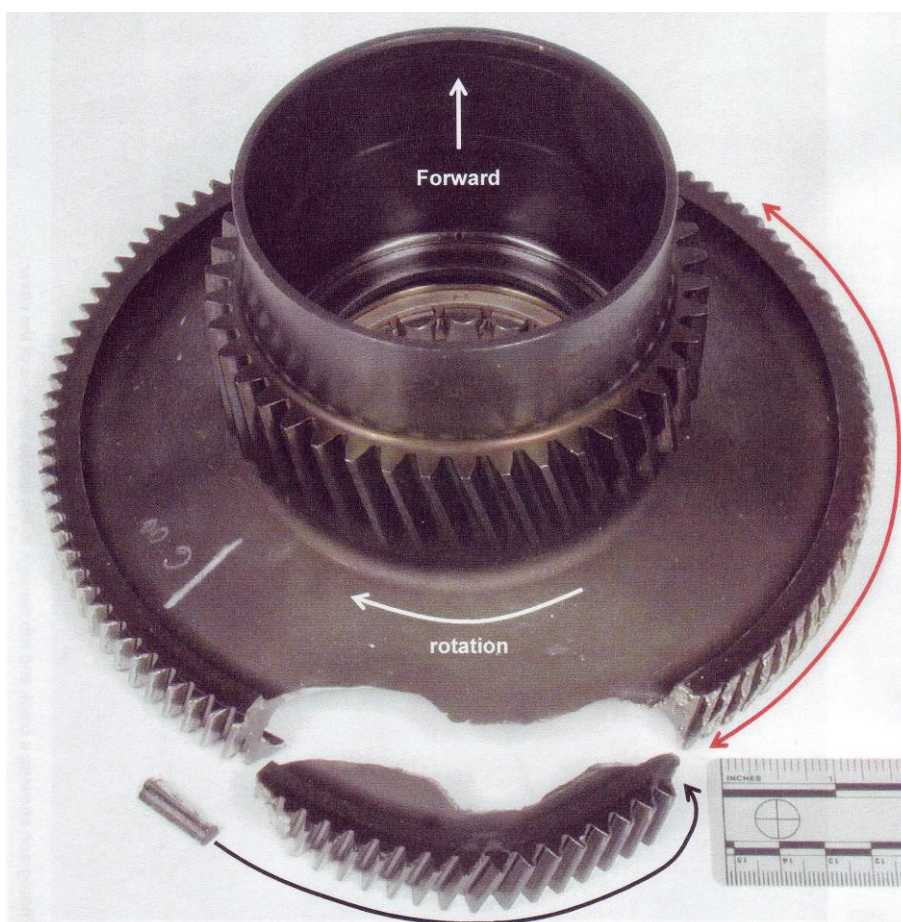
**Figure 8: Goose Bay gear**

The engine manufacturer also advised that on 3 June 2007, a Canadian registered model B407 helicopter (model 250-C47 engine) sustained an in-flight engine failure. The pilot conducted a successful autorotation emergency landing near Goose Bay, Labrador, Canada. The helical torque meter gear in that engine gearbox had also failed.

The ATSB contacted the Transportation Safety Board (TSB) of Canadian regarding the Goose Bay occurrence to understand if there were common factors involved in the events. The failure modes of the helical torque meter gear and damage to ancillary gears in both occurrences appeared to be similar. The failed gear in that occurrence had accumulated 4,476 hours TTSN and one section only had separated. The engine manufacturer later advised the ATSB that they did not consider that the occurrences were related<sup>20</sup> (Figure 8).
