ATSB TRANSPORT SAFETY INVESTIGATION REPORT

Aviation Occurrence Investigation – 200700358

**Engine power loss
15 km SE Gold Coast Airport, Qld
4 February 2007**

VH-DIC

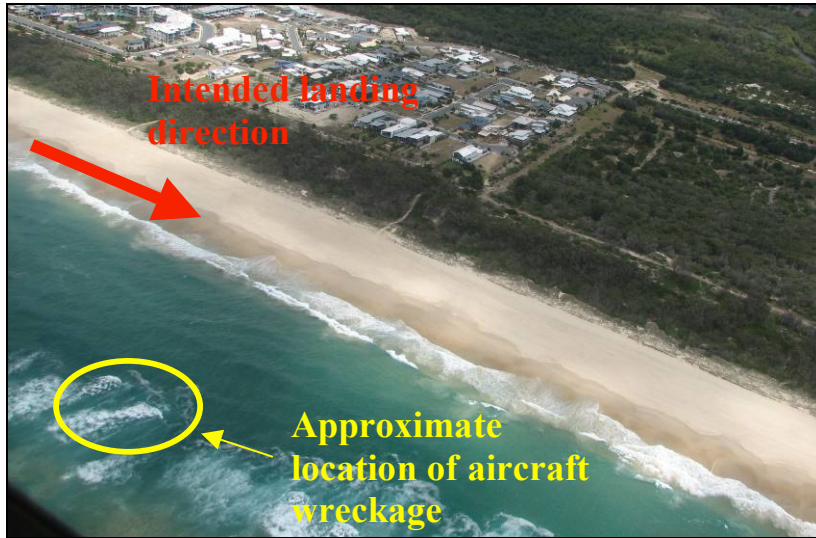
Figure 2: Aerial view of the accident site

The aircraft remained banked to the right and descended steeply into the water, just beyond the wave zone/shore break (Figure 2). Weather in the area at the time of the accident was generally fine, with no cloud and wind from the south-east at 19 kts.

Examination of the aircraft structure indicated that the aircraft initially impacted the water with the right wing, and broke up while cart wheeling. The main landing gear and flaps were retracted.

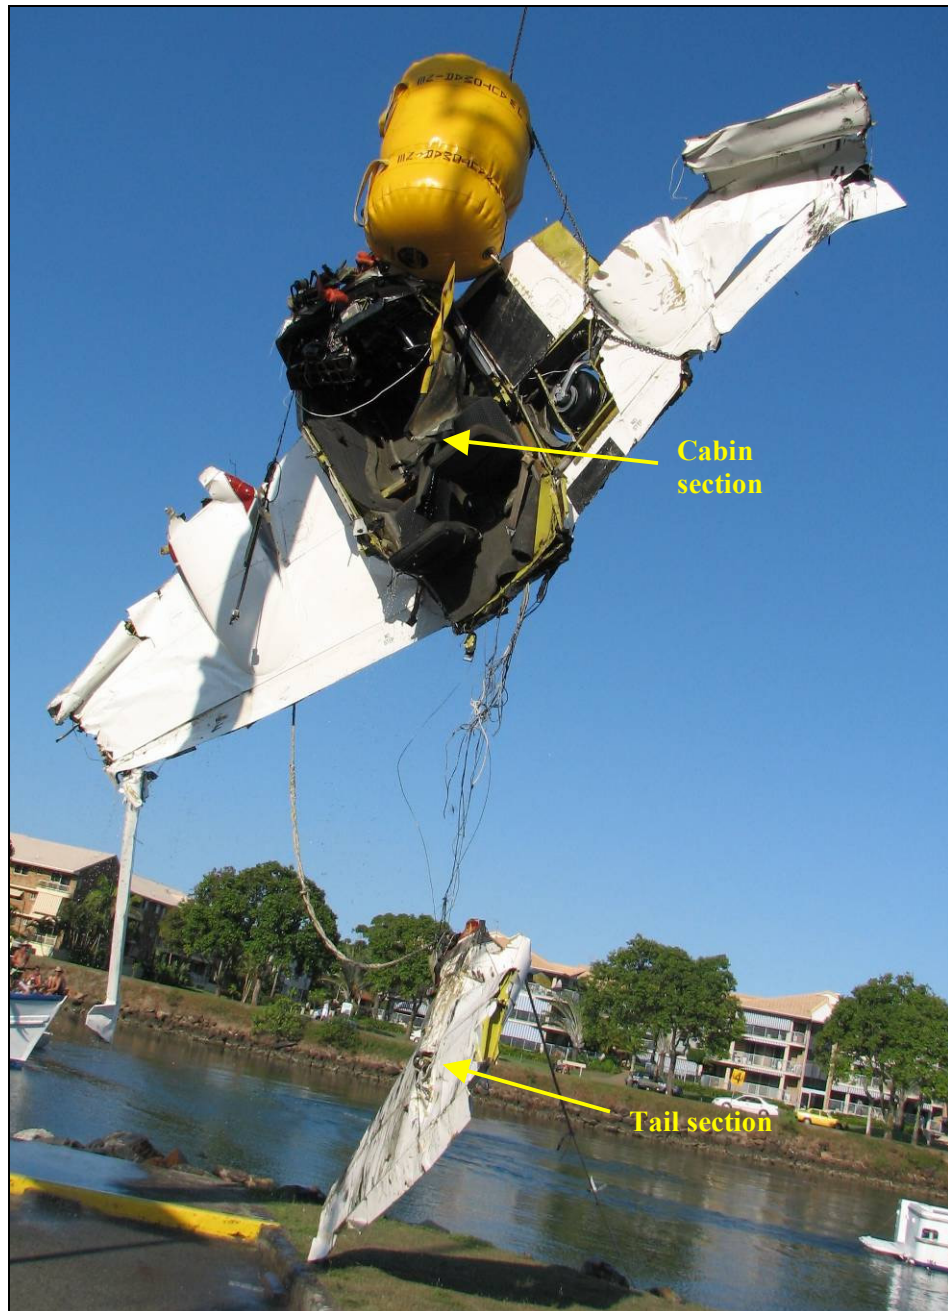
Figure 3: The aircraft as recovered

With the assistance of New South Wales Water Police Divers, the Australian Transport Safety Bureau (ATSB) recovered the aircraft engines and main wreckage and transported these items to a secure facility for further examination. The wreckage recovered consisted of most of the lower centre fuselage, the wings, the remains of the tail section (Figure 3) and both engines with propellers.

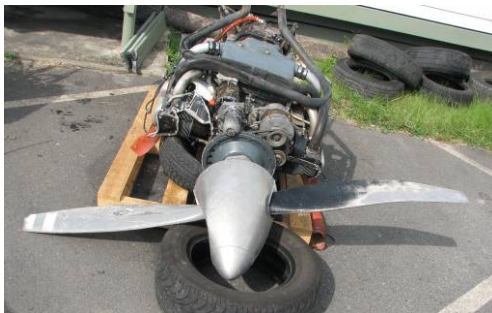
Right engine/propeller

Because of fuselage disruption, the position of the engine and propeller controls at the time of impact could not be confirmed. The right engine and propeller were recovered with the blades in the feathered position⁴, with minimal deformation of the blades. The left engine and propeller were recovered with the propeller blades in the normal operating range with deformation consistent with power being applied at the time of the impact with the water. Additionally, the left propeller spinner had impact crush damage indicating rotation at the time of impact (Figure 4).

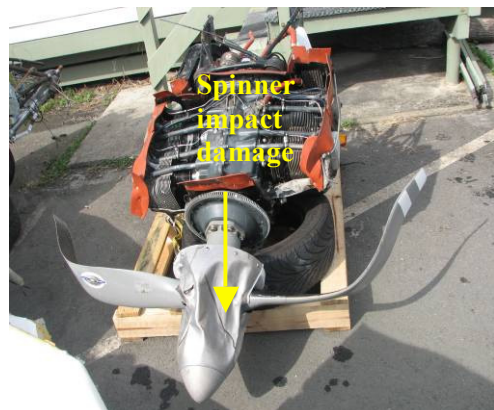
Left engine/propeller

Examination of the left engine did not indicate any problems that would have affected its operation and propeller blade damage confirmed the application of power at the time of impact. Given that the left engine was capable of operation, the investigation considered why the pilot was unable to maintain altitude and return to the Gold Coast Airport.

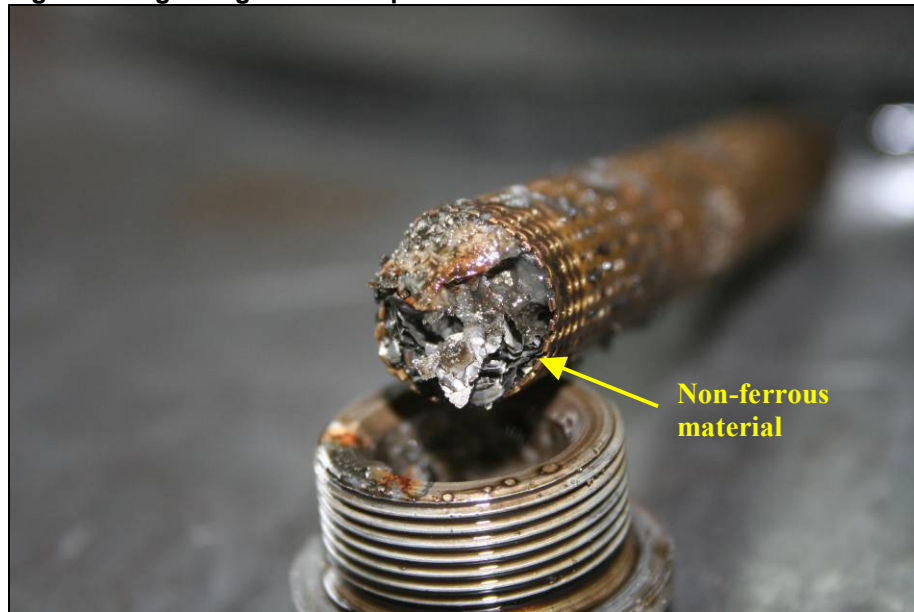
Figure 6: Right engine oil sump suction screen

- the engine starter was found engaged into the ring gear, the position for motoring the engine
- the number-4 connecting rod crankshaft journal had surface damage
- the oil was discoloured (very dark) and had metal contamination
- the oil filter element contained normal minor non-ferrous debris
- the engine oil sump suction screen was obstructed due to metal contamination
- the material present in the suction screen was non-ferrous in nature (Figure 6).

Several components from both the left and right engines were removed for further examination by the ATSB. The right engine sump suction screen was found to be blocked with debris consisting of a large number of small, metallic flakes, along with a substantial amount of other material¹⁴. The debris was washed from the screen and separated into like constituents. The constituents were then analysed using energy dispersive x-ray spectroscopy. The metallic flakes were found to be consistent with the aluminium-tin and lead-tin, low-friction bearing layers.

The right engine propeller most likely sustained an uncommanded feathering because of a loss of oil pressure due to the sump suction screen blockage/obstruction. The right engine starter was found in a position which may indicate that the pilot was attempting to motor the engine for an attempted restart. However, the investigation could not confirm that this was the case.

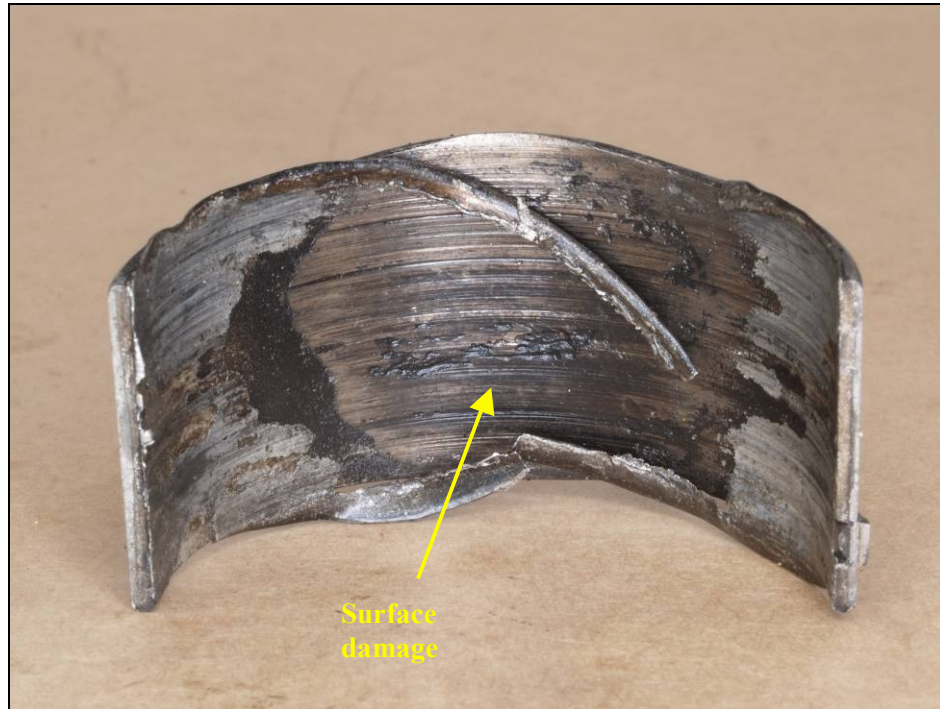
Figure 7: Right engine number-4 connecting rod crankshaft bearing (upper)

and lower number-4 connecting rod crankshaft bearings exhibited wear consistent with the damage seen on the crankshaft (Figure 7).

The upper bearing half was the most severely damaged, showing substantial loss of the wear layers from the steel backing. The backing also exhibited visible plastic deformation, and material at the edges of the bearing had begun to peel away. Parts of the bearing surface on the lower bearing half had the appearance of being melted.

The oil pathways to the bearing were clear of debris, indicating no isolated oil starvation. The appearance of the right number-4 bearing and journal surface was generally indicative of a high-friction condition. However, the fact that only one bearing was affected indicated that it was likely that a general lubrication issue was not the cause and that the bearing had begun to break down independently.

The right engine oil and the number-4 connecting rod crankshaft bearing insert displayed evidence of overheating. Metallurgy examination indicated that the bearing wear surface was heat-affected indicating bearing distress. No blockage was found of the number-4 bearing galleys. No other bearings displayed evidence of overheating, indicating that the loss of oil pressure/lubrication did not exist long enough for internal engine damage.

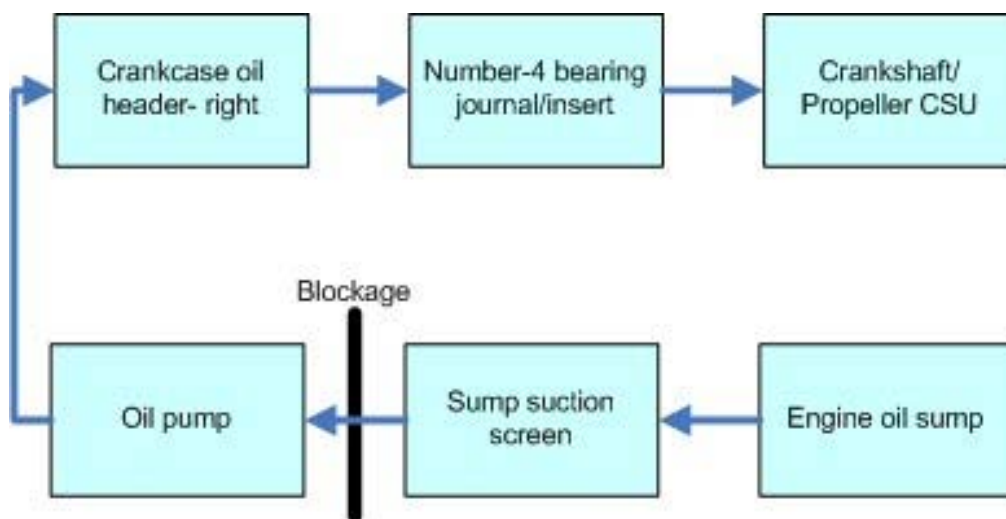
Figure 8: Condensed engine lubrication flow diagram

The engine lubrication flow diagram (Figure 8) shows that blockage of the sump screen would starve the engine oil pump of oil and result in subsequent engine damage. The sump suction screen was directly in the flow path to 'pick up' engine oil from the sump and supply that oil to the input side of the engine driven gear-type oil pump for onward delivery to the push rods, tappets, crankcase oil header, main bearings and the propeller constant speed unit (CSU)¹⁵. The CSU uses engine oil

pressure to adjust propeller pitch position during engine operation to maintain selected engine RPM. Oil starvation of the CSU would result in the propeller feathering.
