ATSB TRANSPORT SAFETY INVESTIGATION REPORT

Aviation Occurrence Investigation – 200700510

Depressurisation

Beech Aircraft Corporation 300, VH-MLG

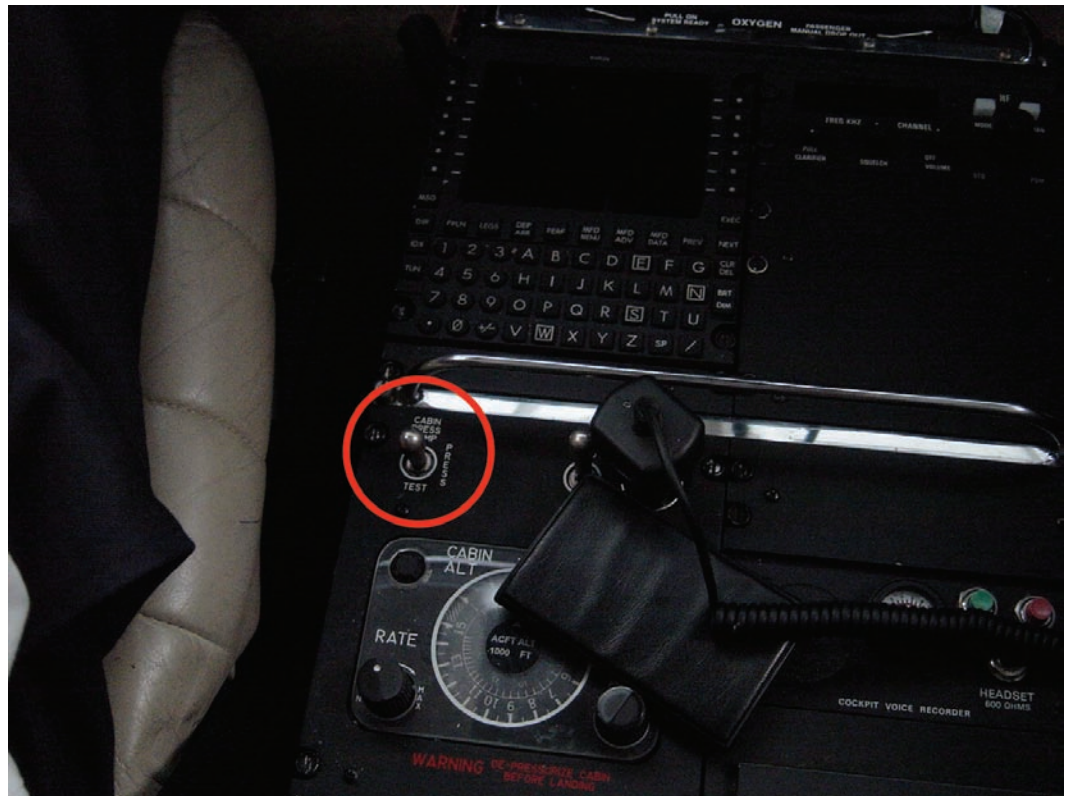
Figure 1: Pressurisation, dump and test switch location

During the descent, the pilot scanned the aircraft system panels to see if he could identify any problems and noticed that the pressurisation dump and test switch was in the DUMP position (Figure 1).

The pressurisation dump and test switch is located on the cockpit centre console, immediately to the right of the pilot's seat. The switch is mechanically gated, requiring the pilot to lift the switch prior to selecting the desired position.

The pilot reported that it is possible that, while adjusting his seat position prior to top of descent, he inadvertently activated the switch to the DUMP position.
