ATSB TRANSPORT SAFETY INVESTIGATION REPORT

Main rotor blade skin separation

VH-HPI

Robinson Helicopter Company R22 Beta II

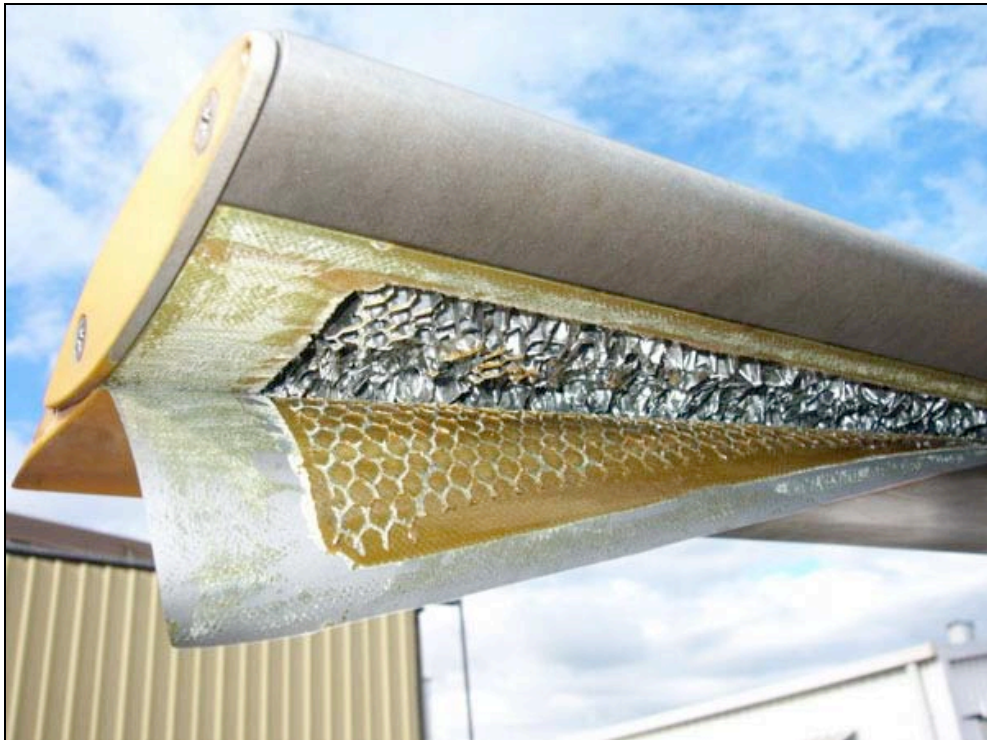
At approximately 1500 Eastern Standard Time¹ on 15 March 2007, a student helicopter pilot and accompanying flight instructor were conducting an instructional flight test in a Robinson Helicopter Company (RHC) model R22 Beta II helicopter, registered VH-HPI. While passing 300 ft during an unpowered autorotational descent, the student and instructor noted an unusual mechanical noise, followed by an increase in vibration from the main rotor assembly. The student immediately re-applied power and landed the helicopter safely, after which it was noted that the main rotor speed (RPM) could no longer be raised above 80% with the available engine power. After shutting down and exiting the helicopter, it was found that a length of aerofoil skin had separated and peeled back from the underside of one of the main rotor blades (Figure 1).

Figure 1: Separation of the main rotor blade lower skin, VH-HPI

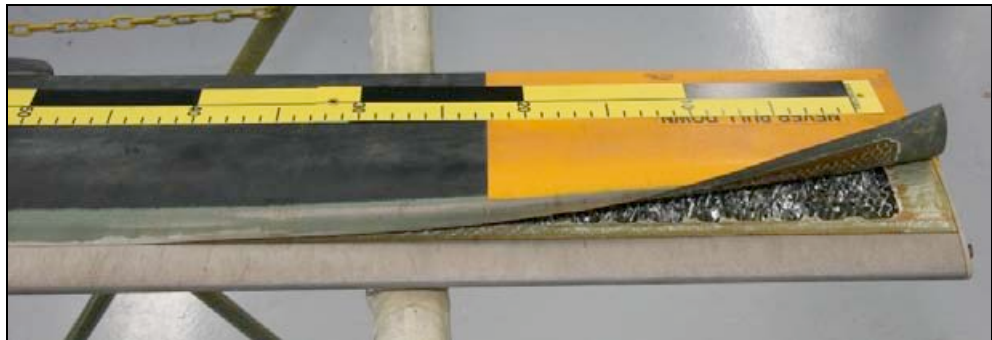
The lower (underside) aerofoil skin of rotor blade 3584E (Figure 3) had separated for approximately 450 mm inboard from the blade tip, and for around 65 mm chordally towards the trailing edge (measured at the blade tip). The skin had visibly disbonded along the spar bond line and curled backward, forming a triangular flap of material that projected approximately 60 to 70 mm beneath the normal aerofoil surface (Figure 4). A tap-test⁵ of the remaining bond line revealed no evidence of the disbond extending further inboard towards the blade hub; nor was there any evidence of disbond along the spar upper skin bond line.

Figure 3: Extent of lower skin separation on blade 3584E

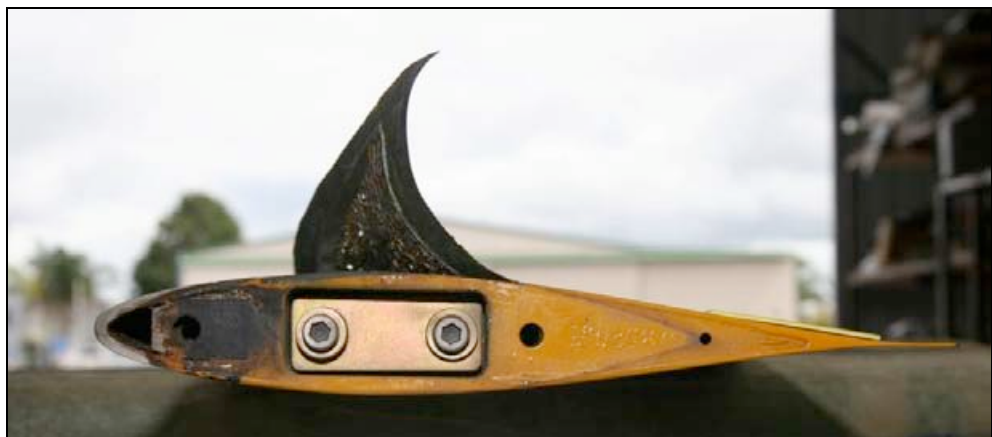
Figure 4: Extent of lifted skin projection from the aerofoil profile (blade upside-down)

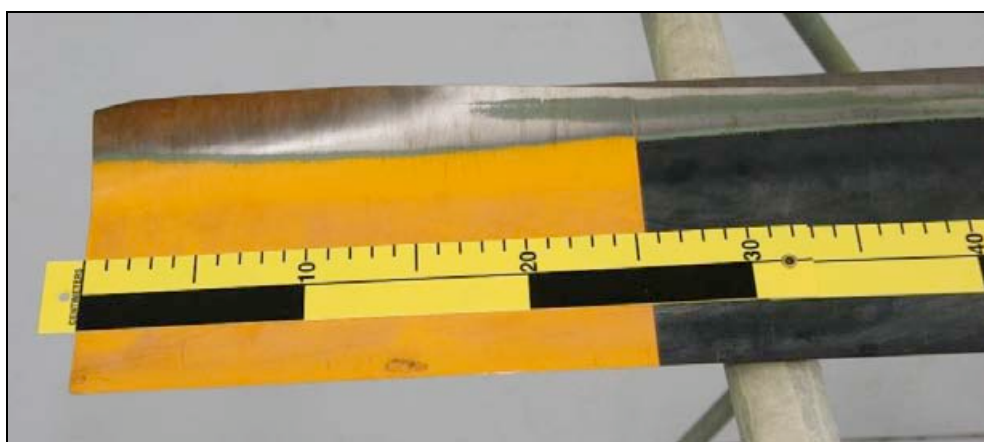
The leading edge and lower blade aerofoil skin in the area of separation was characterised by the complete abrasive removal of the surface paint and primer along and behind the bond line (Figure 5). Bare skin metal had been exposed for 35 mm back from the bond line at the blade tip, reducing to 5 mm back from the bond line at the inboard end of the lifted skin. The appearance of the abraded area was typical of the surface wear that occurs along the outer leading edges of rotor blades operated in rain or dusty environments.

Figure 5: View from the trailing edge of blade 3584E, showing the extent of surface erosion across the bond line

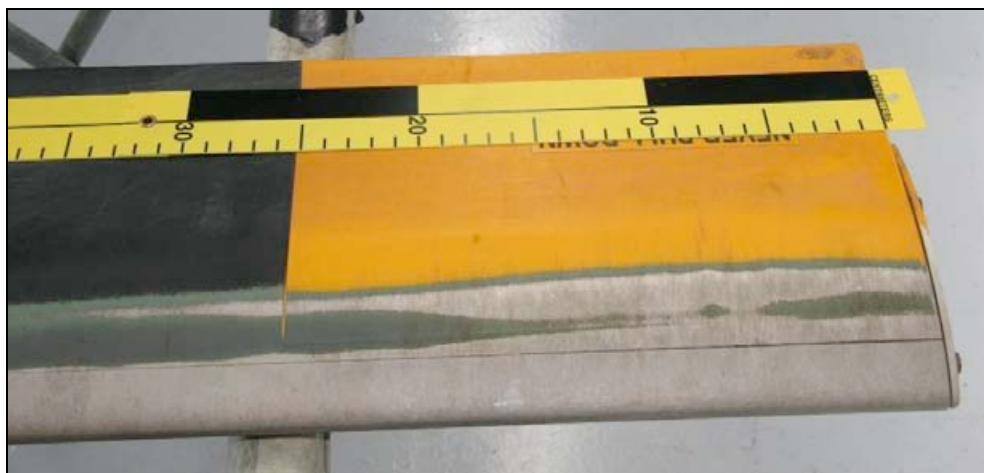
Rotor blade 3519E showed a similar degree of leading edge paint abrasion, extending to approximately 800 mm from the blade tip and 35 mm beyond the bond line (Figure 6). There was no evidence of skin separation and a tap-test conducted for the length of the abraded area showed no indication of disbonding.

Figure 6: Erosion on the opposite blade (3519E) lower surface

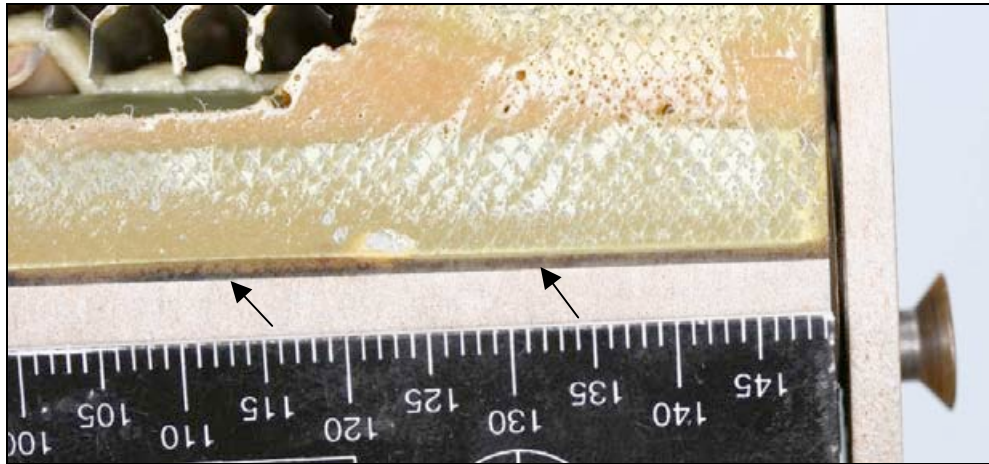
The separated bond between the skin and leading edge spar of blade 3584E was examined under low-power magnification. A line of local erosion and channelling of the adhesive was evident along the forward edge of the bond line; typically 1 to 1.5 mm in width (Figure 7). The corresponding edge of the lifted skin showed a similar 'feathered' appearance, with localised metal erosion leaving a thin and irregular edge (Figure 8). Examination of the bond line adjacent to the point of skin

Figure 7: Erosion and channelling of the adhesive along the external bond line of blade 3584E

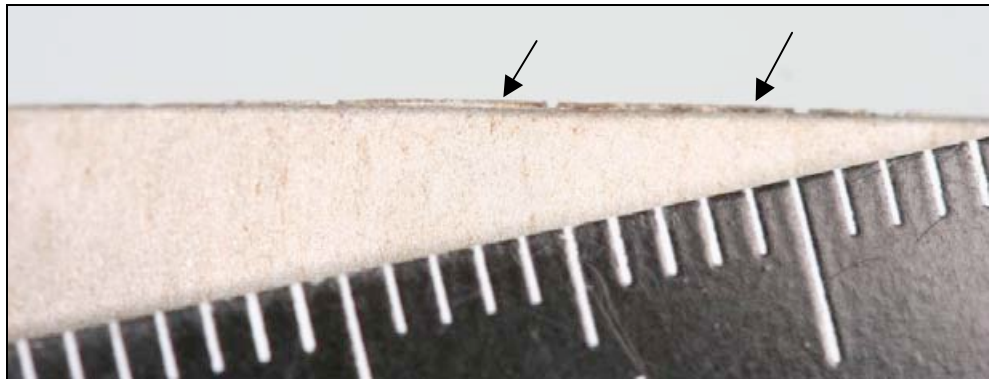
Figure 8: Erosion and feathering of the forward skin edge along the bond line of blade 3584E

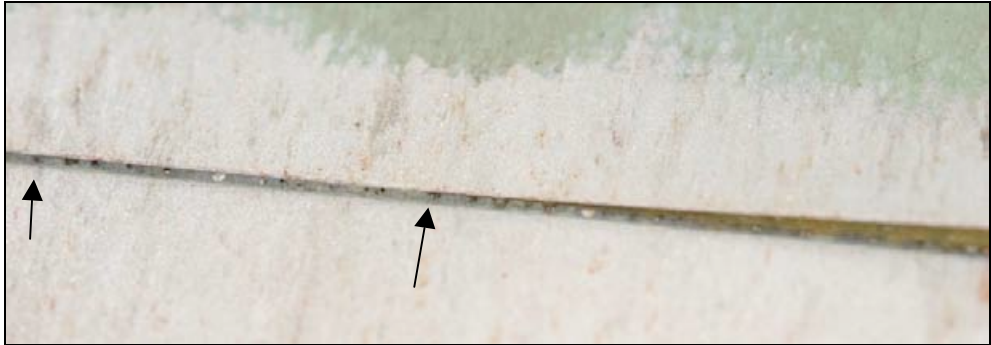
separation showed a variation in the width of the adhesive-filled gap between the skin edge and the spar recess corner. Voids and gaps in the line of adhesive were noted (Figure 9), with some evidence of localised erosion around those areas. The lifted skin at the blade tip was characterised by the abrasive rounding of the corner, and evidence of surface corrosion and environmental ingress suggested by the discolouration of the lifted adhesive in that area (Figure 10). Beyond the area of corrosion, the separated skin surface presented a mixture of cohesive⁶ and adhesive⁷ failure in the bonded region (Figure 11). The corresponding spar bond surface showed a uniform colouration, with no suggestion of pre-existing bond failure or skin separation.

Figure 9: Voids and pores along the bond line, inboard of the lifted section

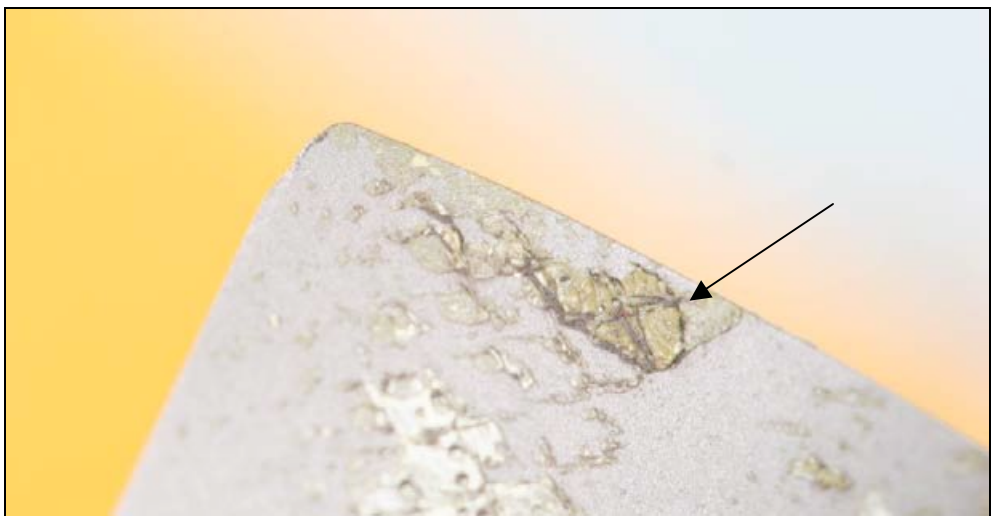
Figure 10: Eroded skin corner and evidence of disbond along the tip edge due to corrosion/ingress of moisture or contaminants (arrow)

Environmental ingress and the development of corrosion beneath the blade skin, particularly at the tip edges was also identified as a possible factor contributing to the commencement of skin disbond. The presence of voids in the adhesive along the bond line could also promote the ingress of moisture or contaminants. Stresses developed at the bond interface due to the growth or corrosion products, and the degradation of the adhesive material under environmental exposure were both potentially influential in the disbond failure affecting VH-HPI.

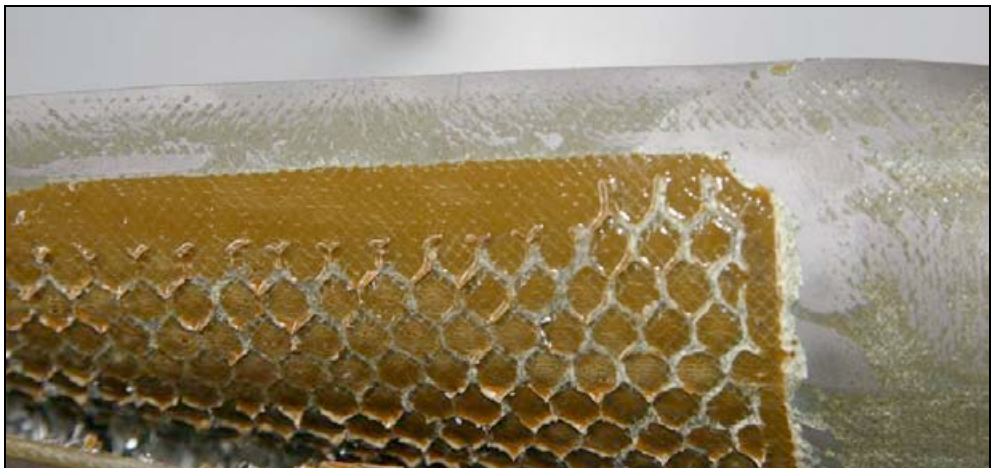
Figure 11: Disbonded skin surface, showing patchy adhesive and cohesive failure modes

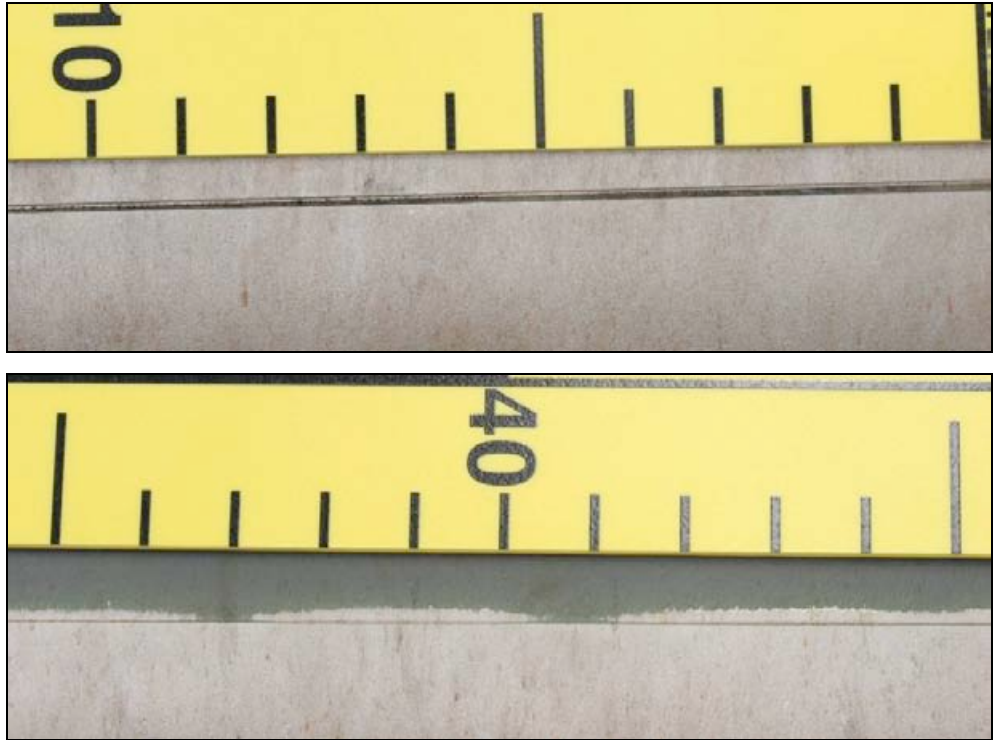
The external bond line towards the tip of blade 3519E, although not separated, showed the local erosion and undercut of the adhesive line and forward skin edge. Again, the width of the gap between skin and spar edges varied (Figure 12), and was at a maximum of approximately 1.5 mm at the tip end (Figure 13). Numerous

Figure 12: Comparison of bond line gap at the tip (upper image) and around 40 cm inboard of the tip (lower image), blade 3519E

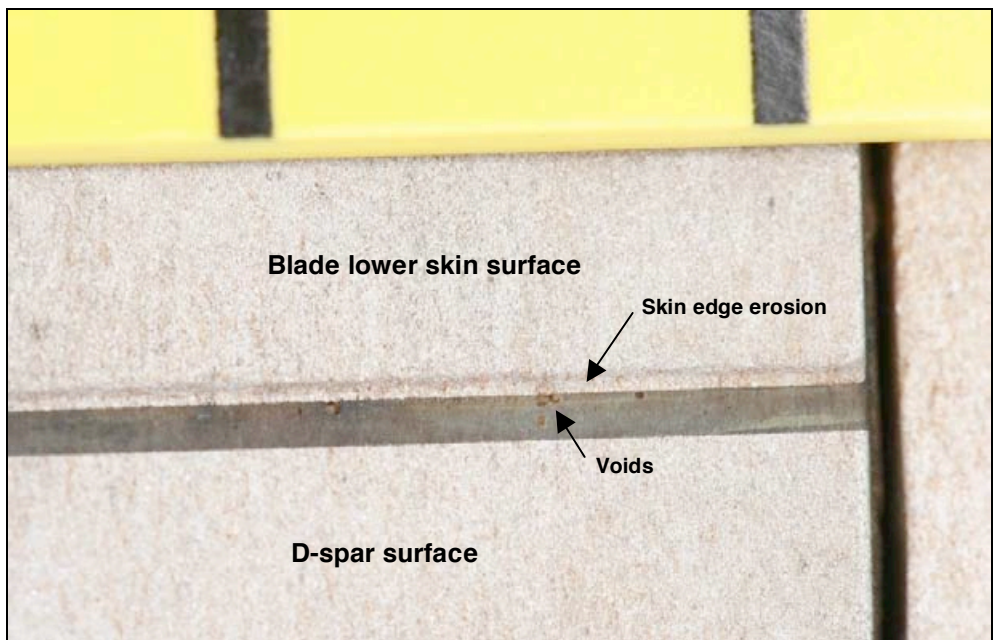
Figure 13: Closer view of the bond line at the blade tip. Note the small voids in the adhesive and the eroded skin edge

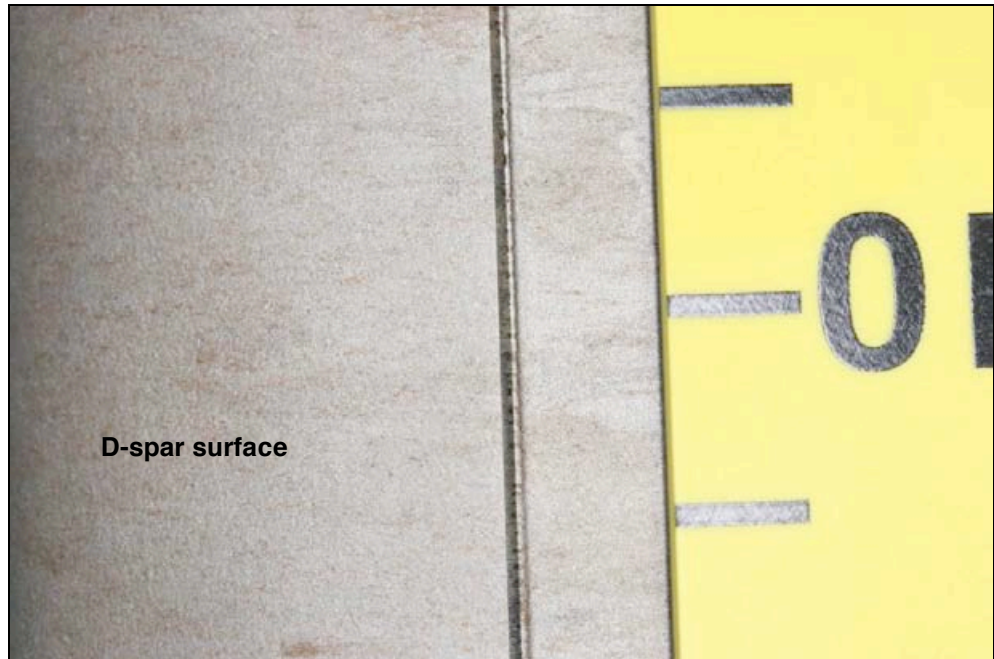
discontinuities were noted in the abraded length of the adhesive line (Figure 14), with evidence of increased skin erosion and edge undercutting associated with the larger voids (Figures 15, 16).

Figure 14: Distribution of voids and discontinuities and the erosion of the skin edge along the bond line of blade 3519E

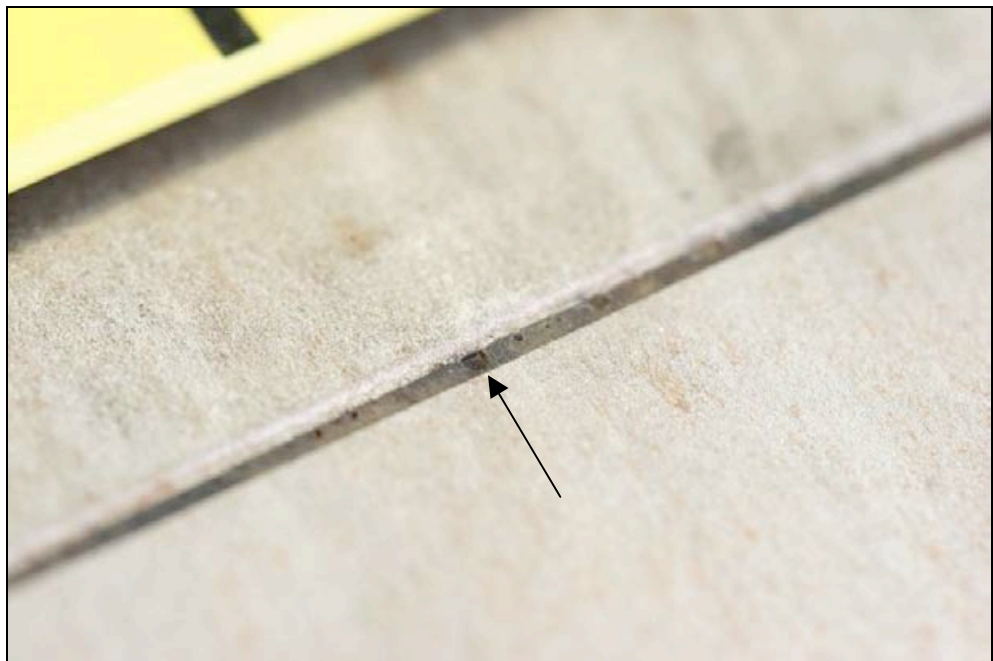
Figure 15: Closer view of voids and eroded areas along the bond line, blade 3519E. Larger void arrowed

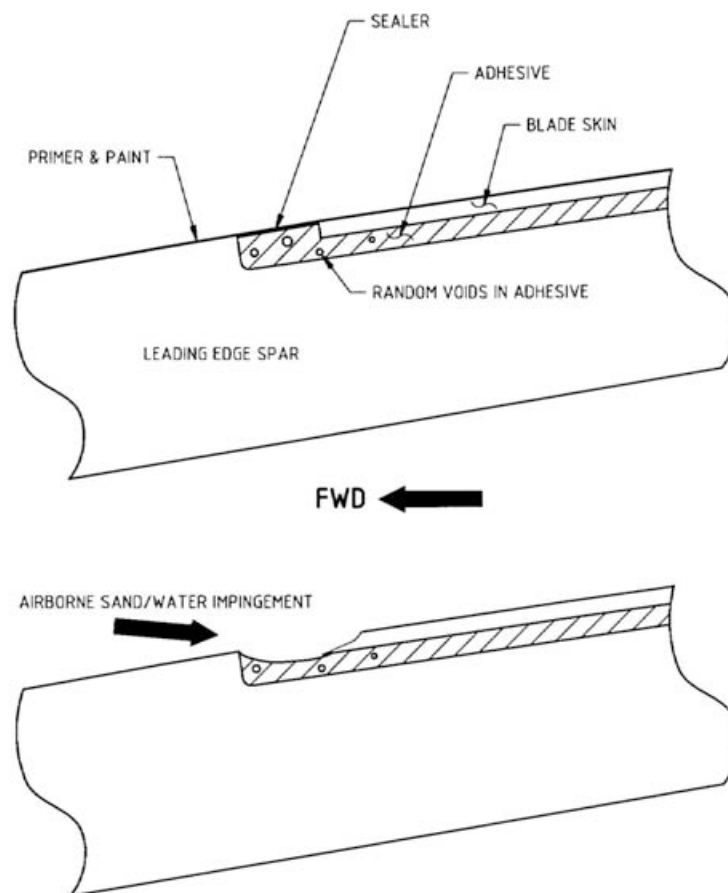
Figure 16: Illustration of as-manufactured (top) and erosively damaged spar-skin bond line (bottom), as observed
