ATSB TRANSPORT SAFETY INVESTIGATION REPORT

Aviation Occurrence Investigation – 200702219

**In-flight engine failure
9km NE Wagga Wagga, NSW
de Havilland Canada Dash 8, VH-TQY
11 April 2007**

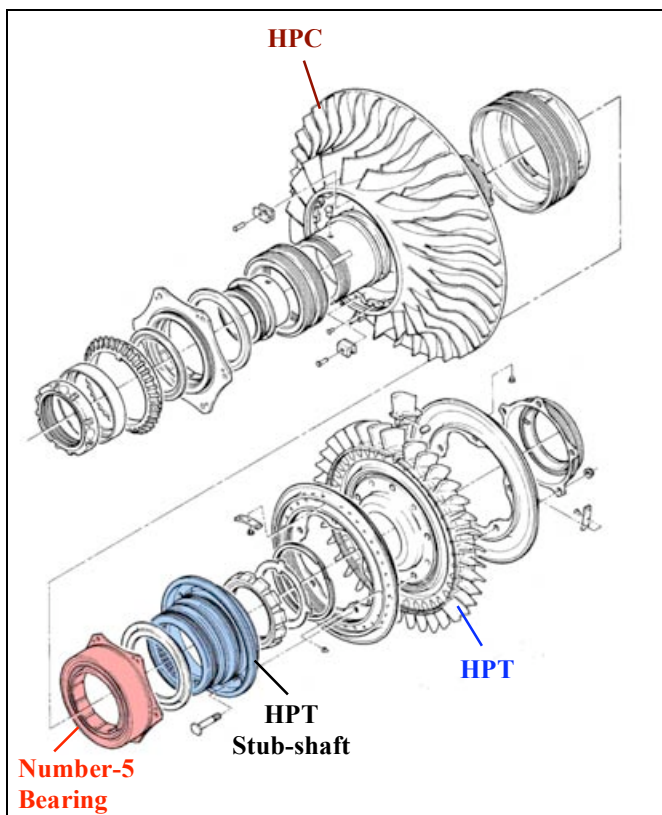
Figure 2: High pressure section

under the supervision of the Transportation Safety Board of Canada. The examination found that the number-5 bearing, the high pressure turbine disc and stub-shaft had failed (Figure 2). These components were sent to the ATSB for further examination.

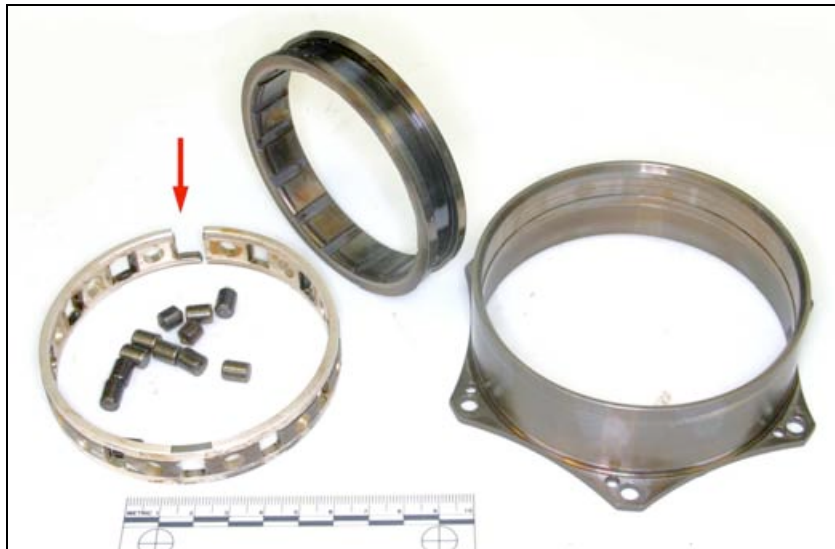
The examination found that the roller cage had fractured axially at the rails of one of the roller pockets (Figures 3 and 4). High magnification examination of the cross member fractures showed that the cage had failed due to fatigue cracking at the cage pocket corners.

Figure 3: Bearing components ESN AW0015 (fracture of cage pocket arrowed)

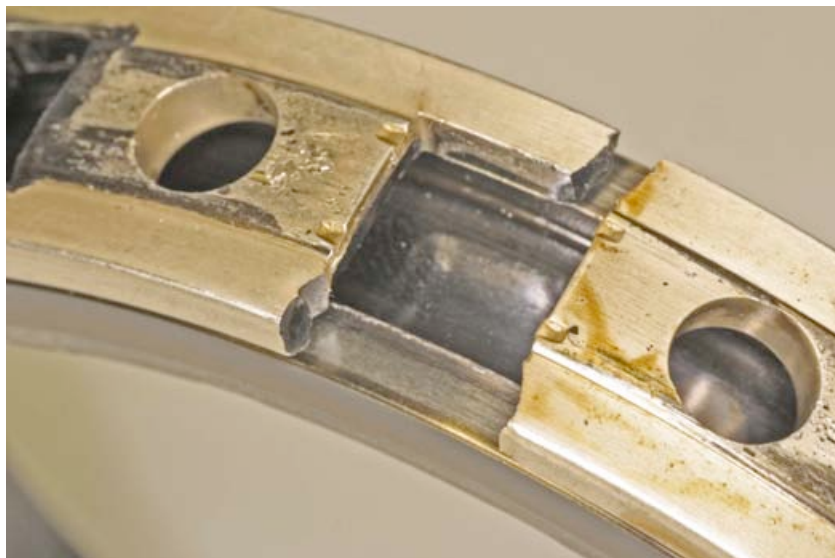
Figure 4: Fracture of cage pocket

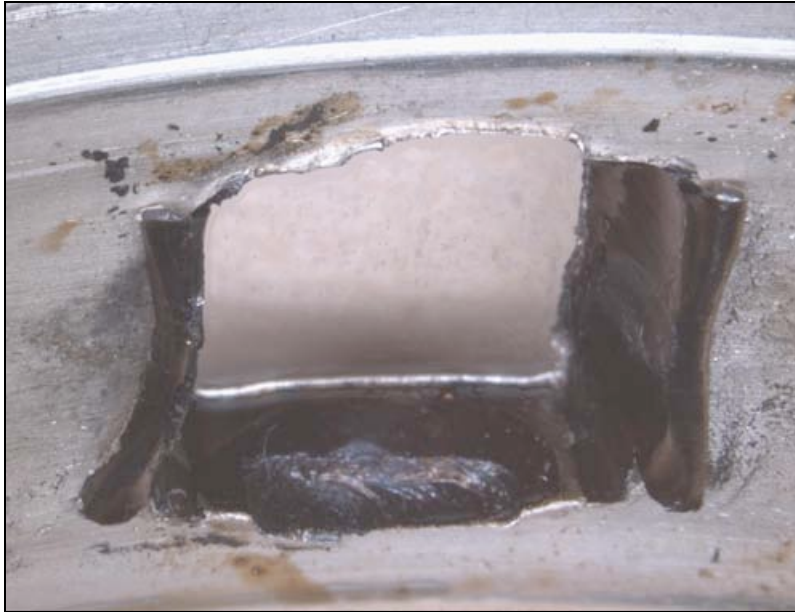
Most of the cage pockets had been enlarged with evidence of the rollers skewing and rotating up to 90 degrees within some pockets (Figure 4).

Figure 4: Elongation of cage pocket

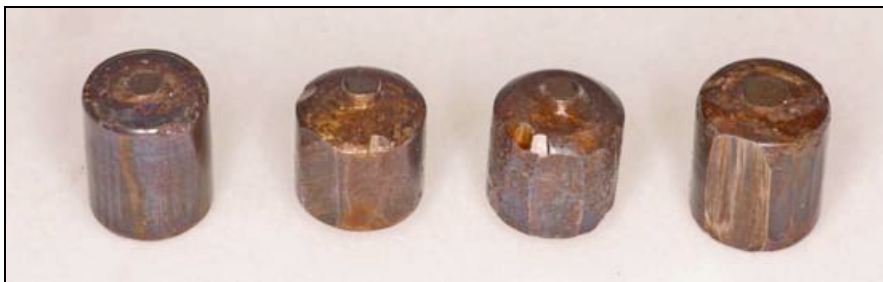
All 12 bearing rollers were accounted for. However, several had rotated within their pockets, with some displaying longitudinal skid wear and others spalling¹ damage to their outside diameters. All rollers had reduced dimensions and contained bluish discoloration, some rollers displayed evidence of coning (Figure 5).

Figure 5: Selection of bearing rollers showing damage sustained

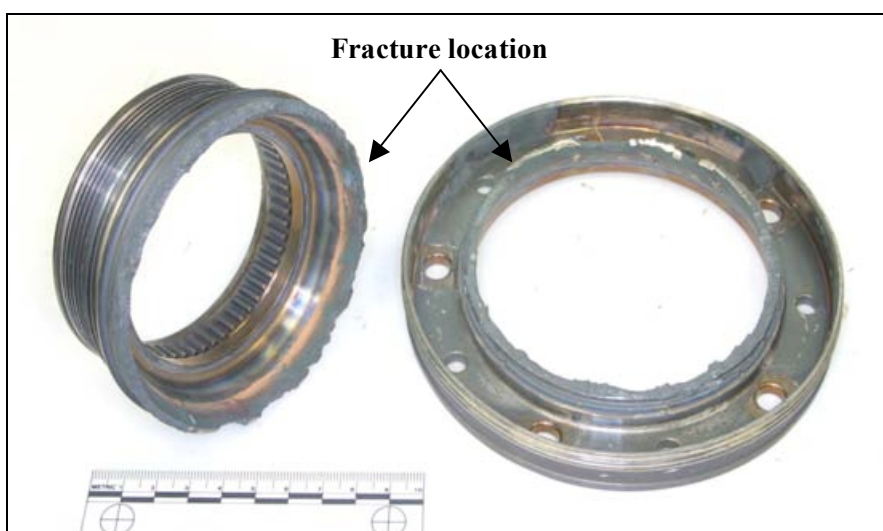
Figure 6: The fractured stub-shaft

The HPT assembly had separated from the HPC assembly at its stub-shaft. The stub-shaft's flange remained attached to the HPT disc by its retention bolts with the stub-shaft failing through overload at a change in section thickness close to the shaft-to-flange transition point (Figure 6). No evidence of pre-existing defects or evidence of progressive cracking that might otherwise have explained the shaft failure were identified. There was evidence of rubbing contact between the HPT stub-shaft and the stepped air-seal (Figure 7).

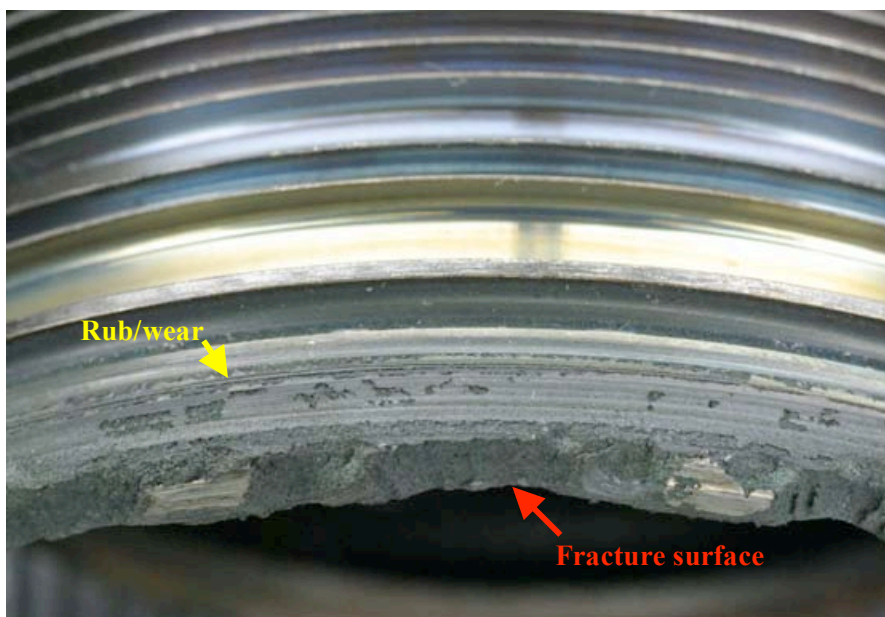
Figure 7: Close-up of the fractured HP stub-shaft showing abrasion and wear (labelled) from rotational contact with stub-shaft stator air-seal

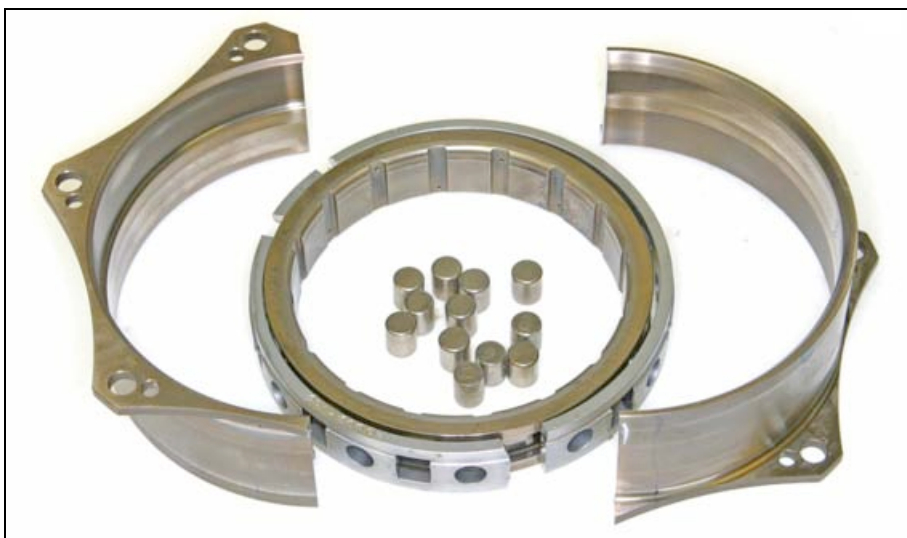
The bearing was received at the ATSB with both the cage and the outer race destructively sectioned. The inner raceway was intact (Figure 8). The bearing was identical to the bearing from ESN AW0015, with part number 3121706-01A and had been manufactured by the FAG Company. Other identifiers indicated that the ESN AW0021 bearing was consecutively numbered to the failed ESN AW0015 bearing, having serial number FCN171485.

Figure 8: Number-5 bearing from ESN AW0021 as received by the ATSB

A visual examination showed that the roller cage had fractured at two locations. The failure mode was determined to be fatigue related, with each of the cracks initiating at the corner of the roller pocket. Due to instability of the rollers within their cage pockets, four of the cage pockets were enlarged. Early stages of spalling was found on four rollers and the bearing outer raceway.
