ATSB TRANSPORT SAFETY INVESTIGATION REPORT

Aviation Occurrence Investigation – AO-2007-066

Controlled flight into terrain
Lake Liddell, NSW – 7 December 2007
VH- LIS
Air Tractor Inc. AT-802

Collision with terrain – Lake Liddell, NSW, 7 December 2007, VH-LIS, Air Tractor Inc. AT-802

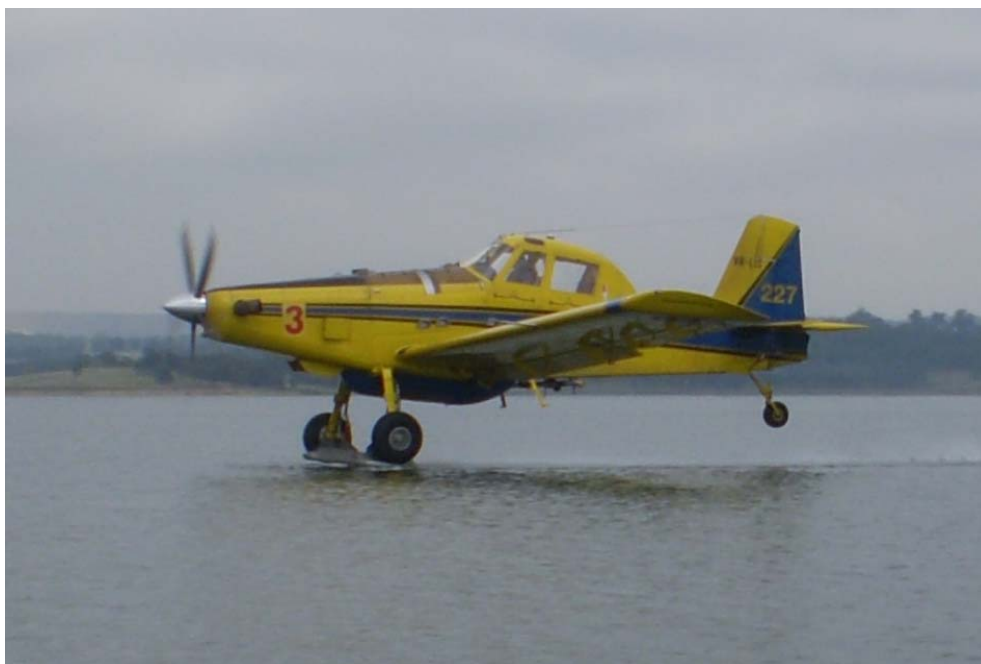
Figure 1: A previous water collection test flight on 6 December 2007

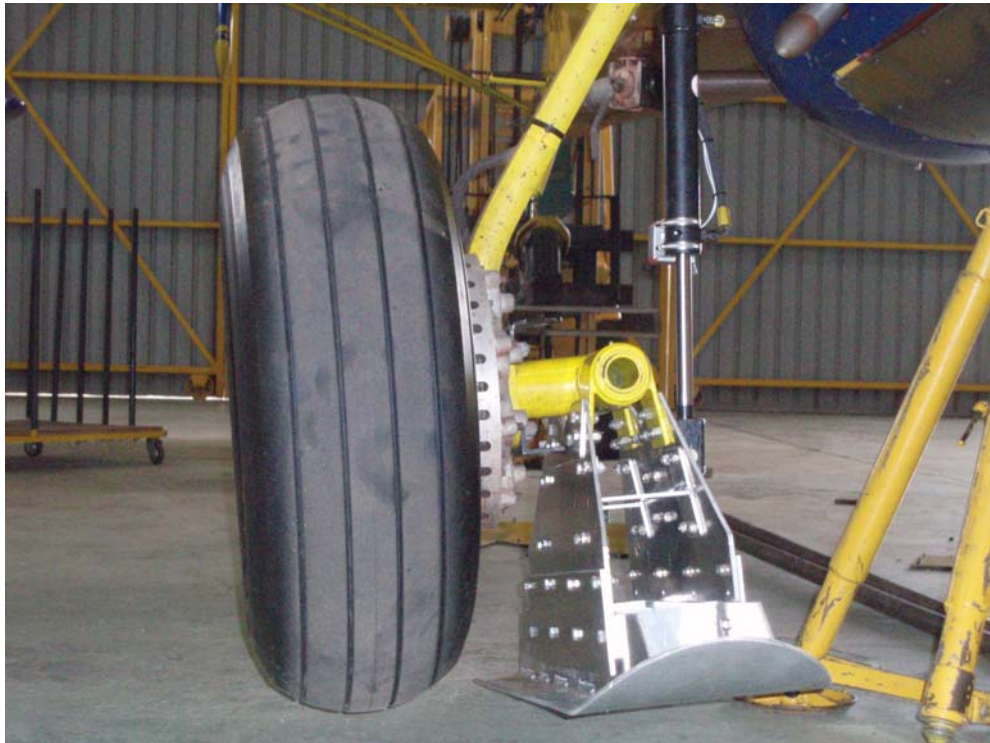
Before those skis were fitted to VH-LIS, they were fitted to another company Air Tractor AT-802 aircraft, registered VH-LII (Figure 2). That aircraft was used to ground test the installation and the operation of the hydraulically activated extension and retraction of the skis.

Figure 2: Ski fitted to VH-LII in the extended position

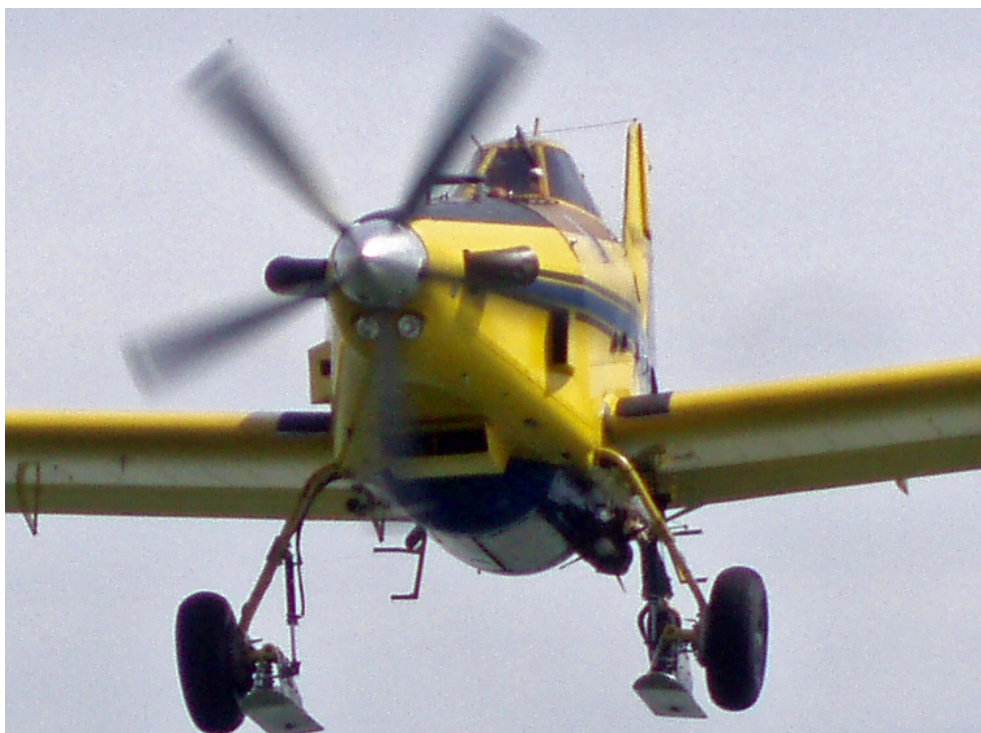
It was reported that VH-LII was also used to flight test the skis to ensure that the aircraft could be safely operated and landed with the skis attached (Figure 3). The pilot had reported that he considered that there was no change in the aircraft’s performance with the skis fitted, including no evidence of increased drag or vibration.

Figure 3: Initial flight testing in VH-LII

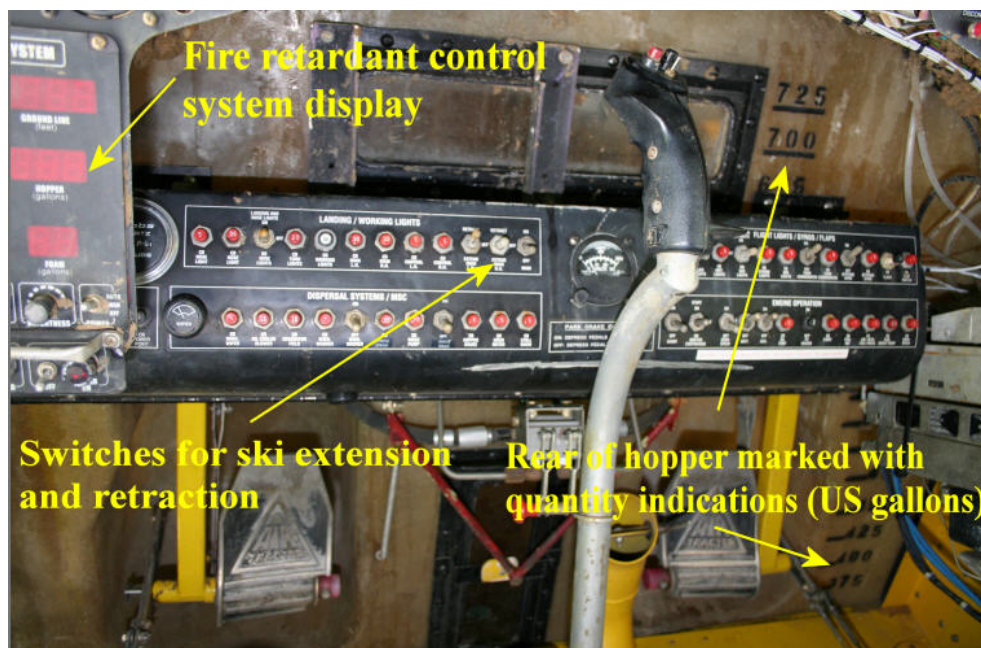
Other separate discussions by the pilot, with both company staff and the aeronautical engineer, also considered the need to monitor the amount of water collected during a run. In the absence of any other indications, the pilot was required to look inside the cockpit at the fire retardant control system panel, or the markings on the rear of the translucent aircraft hopper, to see the amount of water collected in the hopper (Figure 4). Discussions relating to an aural indication of the

hopper content levels took place, but nothing had been installed or implemented at the time of the flight testing.

Figure 4: Cockpit of VH- LIS

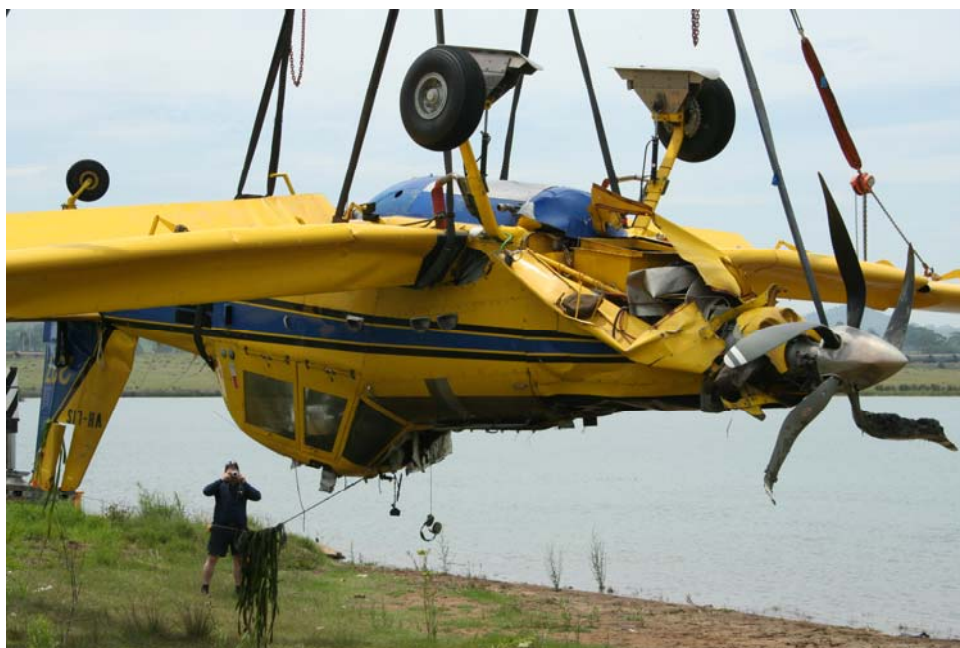
The aircraft was recovered from Lake Liddell with the assistance of New South Wales Police divers (Figure 5).

Examination of the aircraft by Australian Transport Safety Bureau (ATSB) investigators showed crush damage to the leading edges of the entire left wing and the inboard section of the right wing. The damage was primarily on the upper surface of those sections. Substantial distortion and disruption of the engine cowling was observed. The lower surfaces had been forced to the left with rippling observed on the upper cowls. The cockpit canopy had been torn away and the windscreen had been smashed. It was not able to be determined if those were as a result of the impact sequence or the recovery process. The cockpit was partially filled with clay from the lake bed.

Figure 5: Recovery of the aircraft wreckage

The impact damage observed on the wings and engine cowls, together with the directional movement of the skis, was consistent with the aircraft pitching sharply nose-down about its right main landing gear, while rotating to the right. Information gathered from the examination of the wreckage, together with witness statements, indicated that the aircraft most likely impacted the water with the propeller and nose cowling while pitching downwards, followed by the left wing and then the right wing.
