ATSB TRANSPORT SAFETY INVESTIGATION REPORT

Aviation Occurrence Report –200605133

**Loss of control
Mt Vernon Station, WA
CESSNA 172L, VH-RIL
1 September 2006**

Preliminary

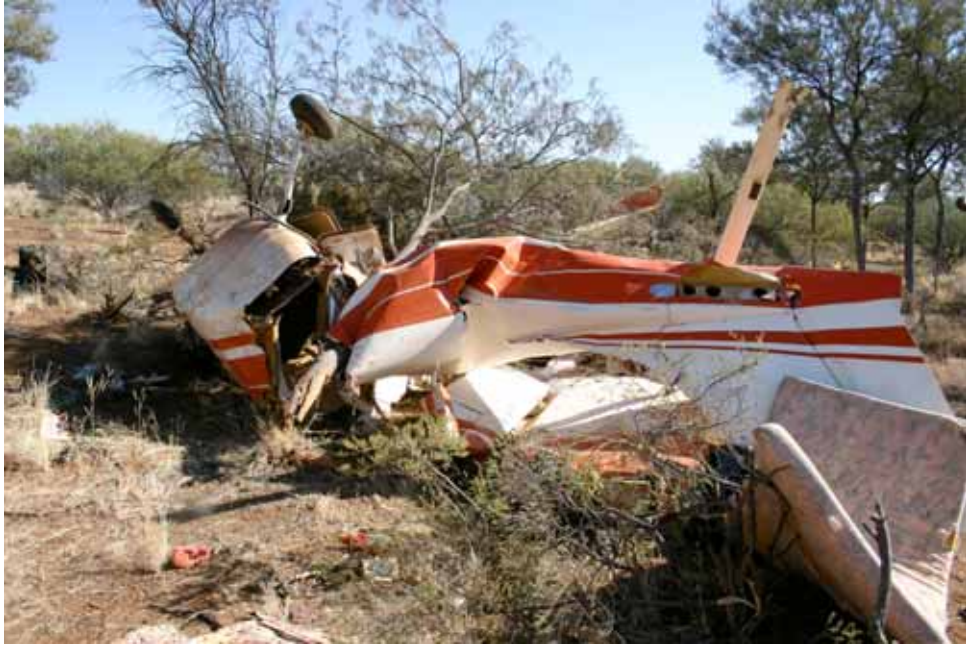
angle of 4 degrees, with a left wing-low attitude. The wreckage trail extended for 70 metres with evidence of the aircraft impacting a number of trees. The impacts resulted in the right main landing gear, right wing and right horizontal stabiliser being torn from the fuselage. Before coming to rest, the aircraft rolled to the right and collided with a tree, which split the fuselage at the rear of the cabin (Figure 1).

Figure 1. Right wing, horizontal stabiliser and main landing gear torn away, fuselage breached at the rear of cabin.
