# Engineering examination Cracked McCauley propeller hub

ATSB-Nov10/ATSB138

A McCauley Propeller Systems propeller hub, originating from a Cessna Aircraft Co. model U206G aircraft, was received by the Australian Transport Safety Bureau (ATSB) from the Civil Aviation Safety Authority (CASA), with a request for an engineering examination of cracking within the lower body of the hub. The propeller was a model D3A34C404-C constant-speed unit; serial number 930046.

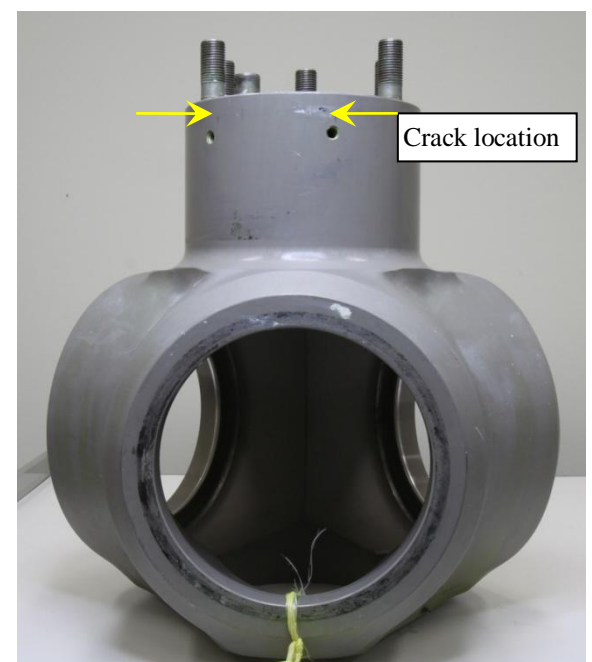
**Figure 1: Propeller hub**

The propeller hub presented with a crack visible to the naked eye on the exterior of the hub. The crack was approximately 50mm in length and was oriented circumferentially around, and parallel to, the propeller mounting boss (Figure 1). One of the threaded hub mounting studs adjacent to the crack had been removed prior to the ATSB's examination. Minor abrasion was observed

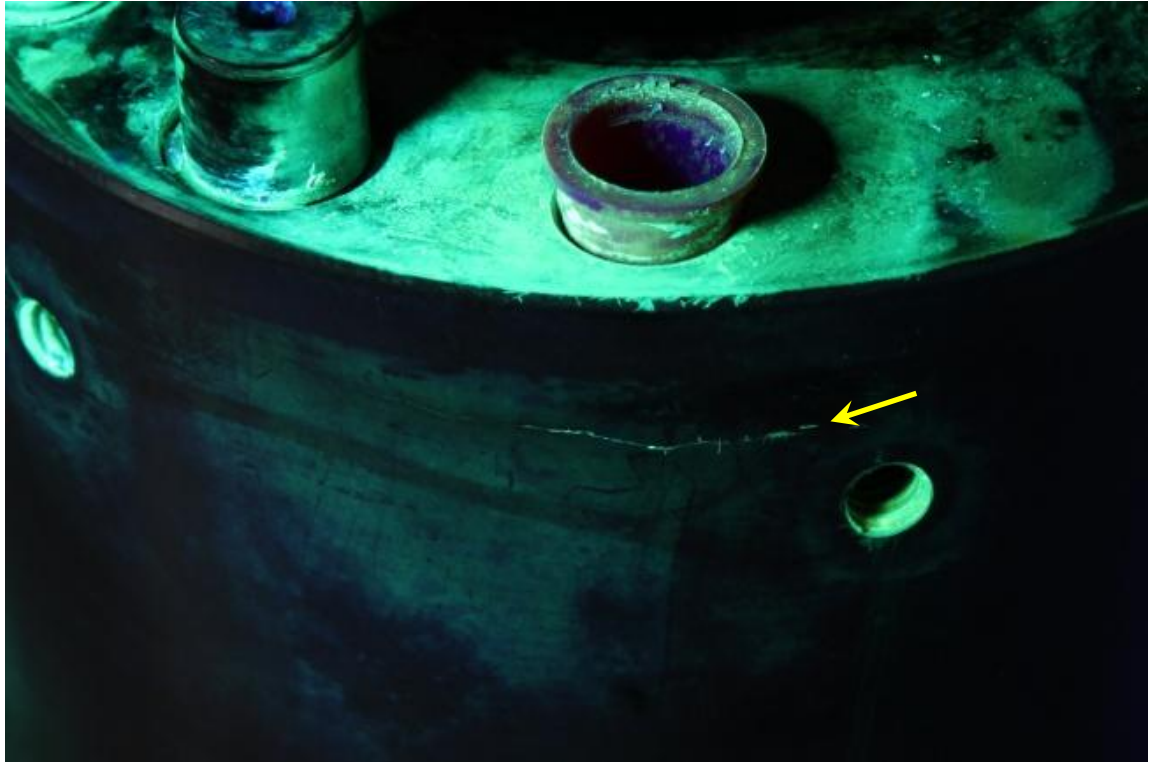
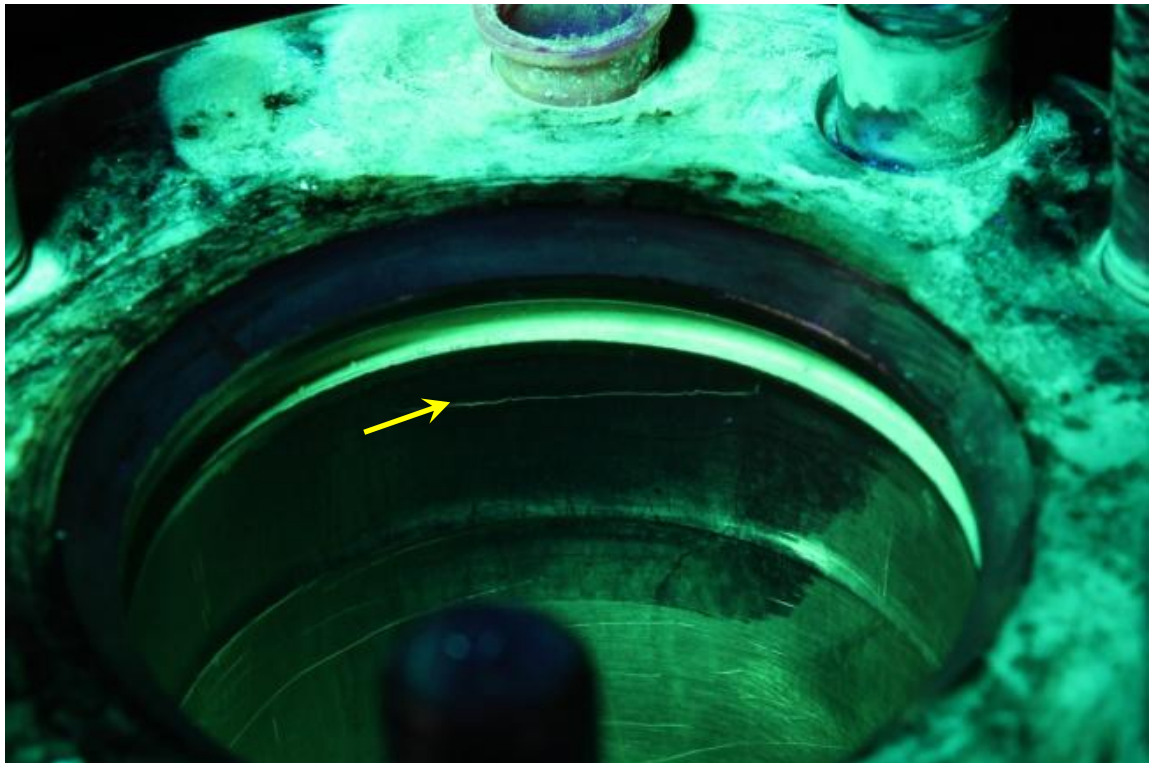
adjacent to one end of the crack, with no evidence of other defects or anomalies. Fluorescent penetrant inspection indicated that the crack was also open to the interior wall of the hub (Figure 2).

Figure 2: Fluorescent penetrant inspection with crack indications on the hub exterior (top) and interior (bottom)

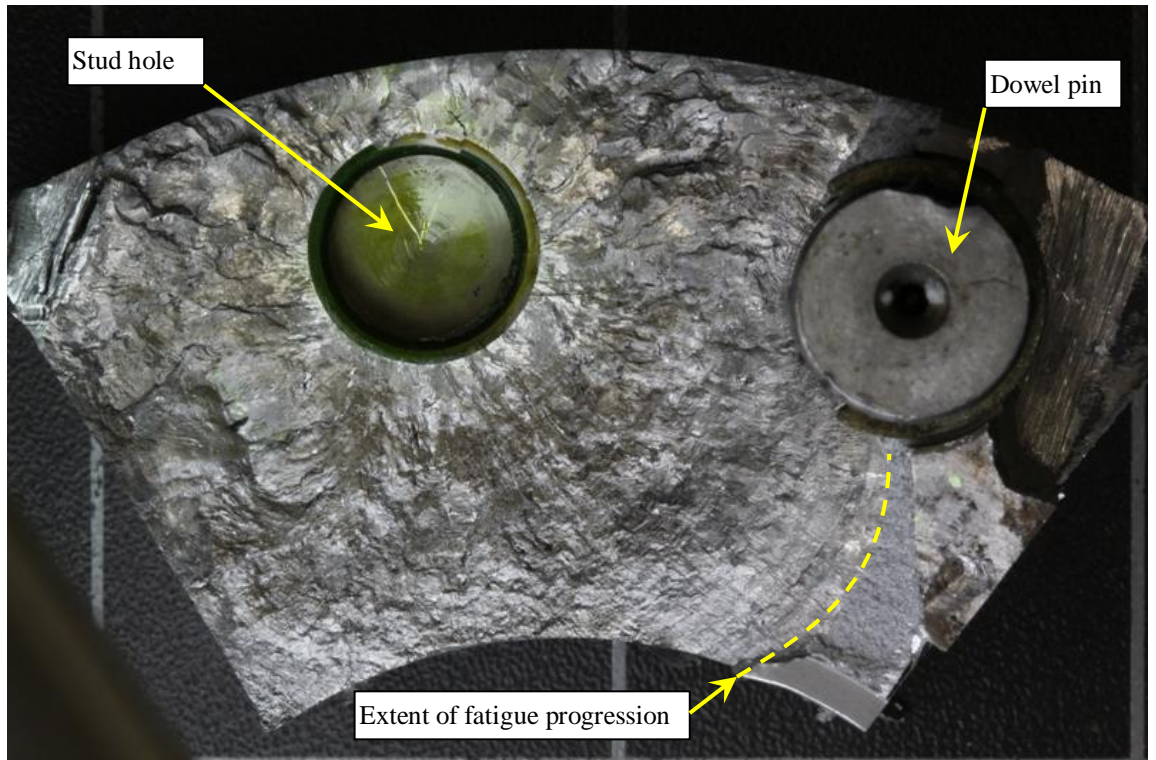
The hub was sectioned to excise the portion containing the crack. A laboratory fracture was then performed to expose the crack faces (Figure 3). The crack surface presented as a faceted, quasi-cleavage fracture, radiating outward from the threaded mounting stud hole.

Figure 3: Crack surface after laboratory fracture

The fracture surface morphology and presence of crack progression marks was consistent with the initiation and propagation of a high-cycle, low-stress fatigue cracking mechanism from the internal bore of a single mounting stud hole within the propeller hub boss.

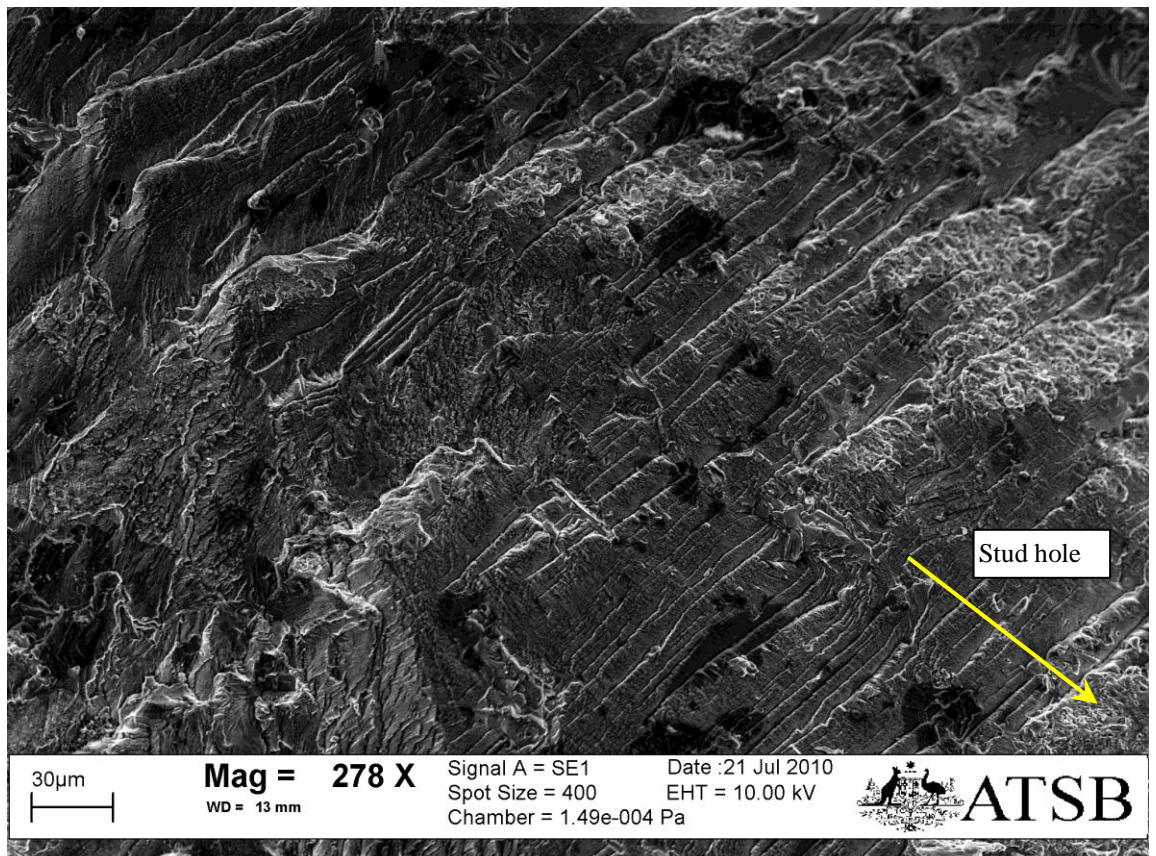
Optical microscopy revealed step-like indications, consistent with a progressive crack growth (fatigue) mechanism. The marks were concentric and radiated away from the mounting stud hole origin (Figure 4).

Figure 4: Step-like crack progression marks

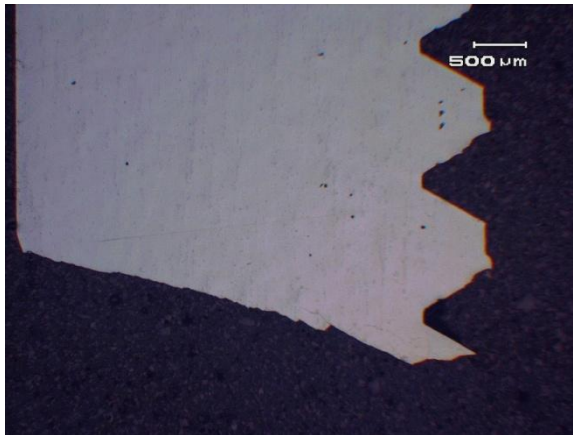
A section through the stud hole threads showed the thread-form to be in good general condition, with no significant defects (Figure 5).

While there was no direct evidence of the factors that had contributed to crack initiation from this area, the absence of any product deficiencies, such as gross material defects or pre-existing thread-form damage (stress concentrators), suggested that crack formation may have been related to installation of the hub mounting stud, and/or the level of tension maintained within the stud during its operational life.

Figure 5: Section through stud hole threads

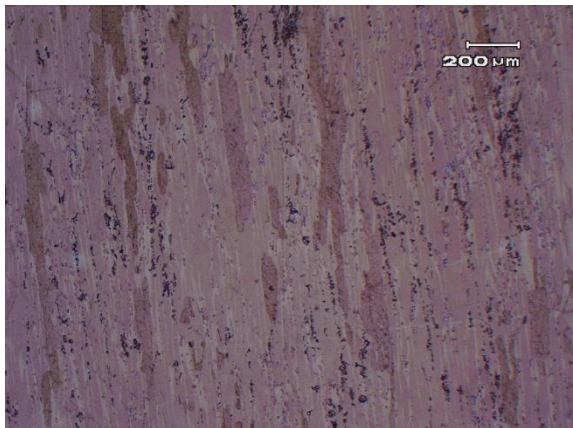
Figure 6: Alloy microstructure

Energy Dispersive Spectroscopy (EDS) of the hub material confirmed its production from an aluminium alloy, with key additions of copper, manganese, magnesium and silicon. The chemistry was consistent with the nominal composition of a 2xxx series aluminium alloy. A metallographically-prepared cross-section, taken through the stud hole, presented an elongated grain structure, interspersed with two characteristic precipitates - most likely aluminides ( $\text{CuAl}_2$ , light-etching, and  $(\text{FeMn})_3\text{SiAl}_{12}$ , dark-etching). The microstructure was typical of this type of alloy in the wrought condition (Figure 6). No unusual microstructural constituents, physical defects or other anomalous metallurgical features were observed.
