Aircraft control cable terminal fittings – ATSB technical examination

ATSB Transport Safety Report
Aviation External Investigation
AE-2012-028
Final – 9 April 2013

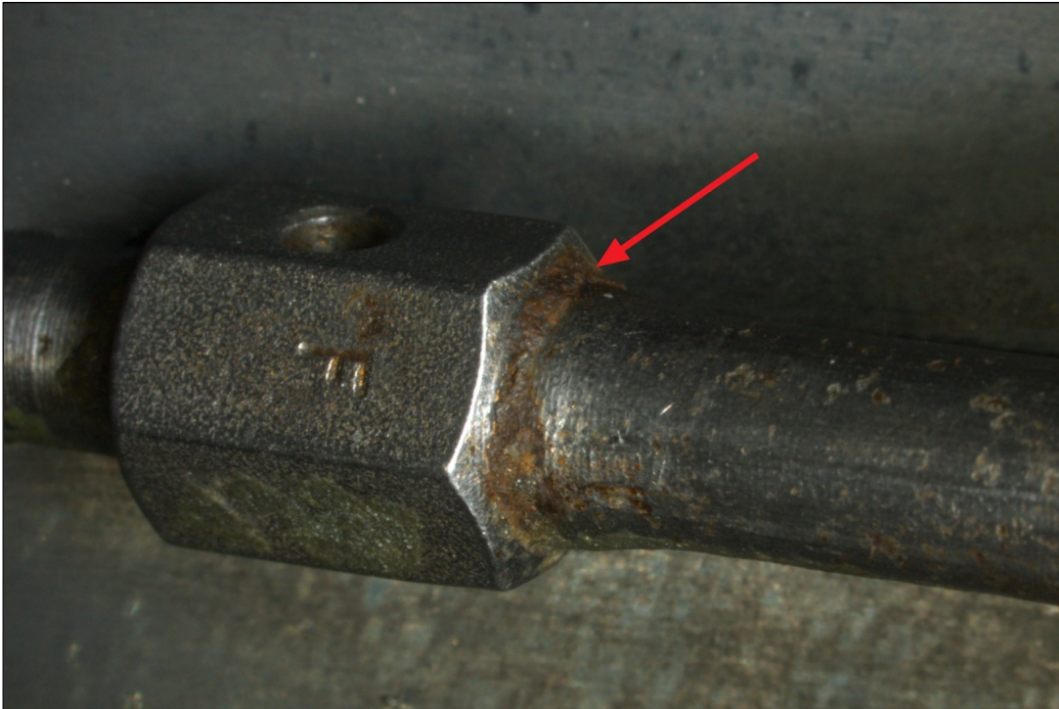
The wrench flats and centre sections of some of the terminals showed a rough, discoloured appearance, and appeared to have progressed to mild pitting corrosion in a number of cases (Figure 3 & 4).

Figure 3: Discolouration / corrosion (arrowed) and rough surface finished on the wrench flats of an 'F' terminal.

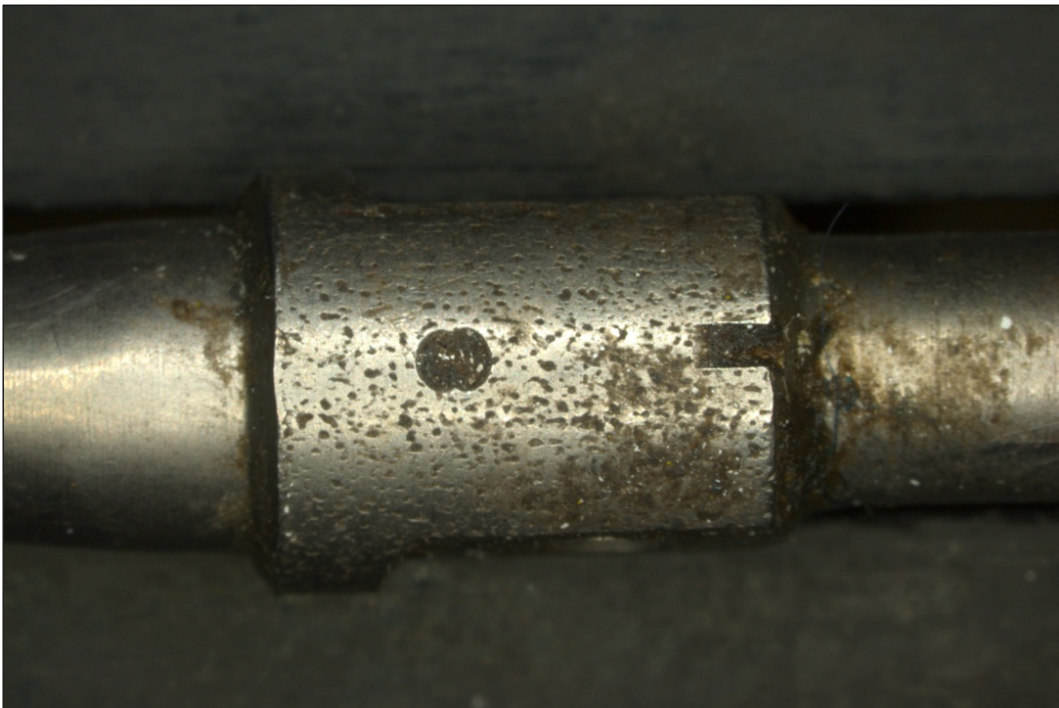
Figure 4: 'OO' terminal with discolouration and rough/pitted surface on the centre section.

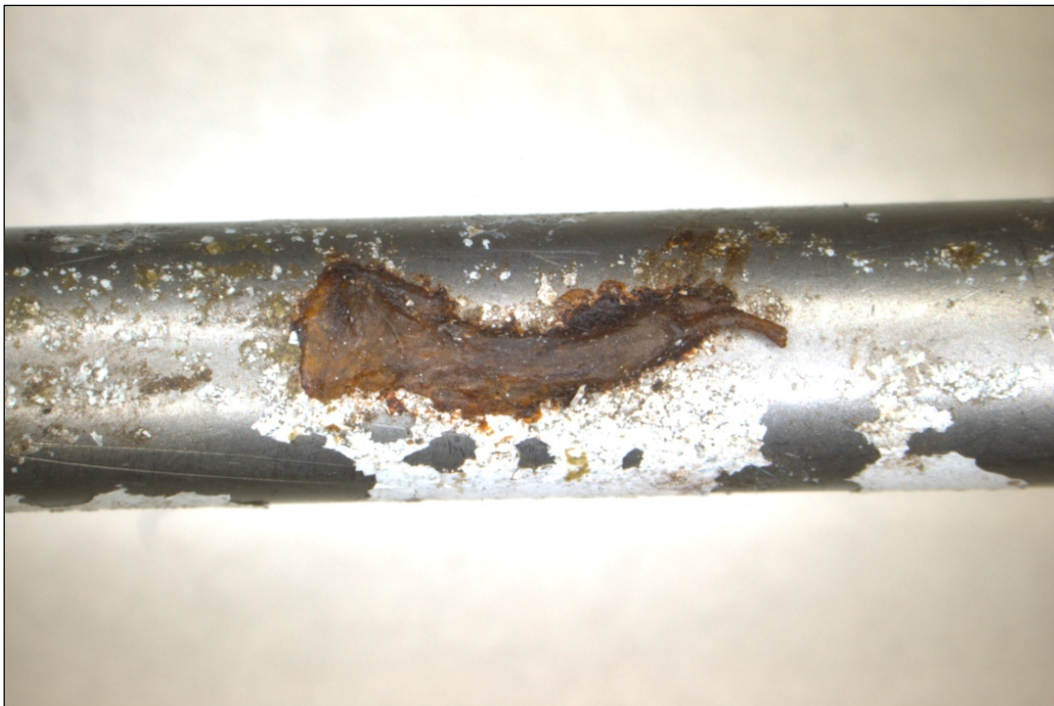
Sample 4 had a localised orange/brown deposit on the surface (Figure 5). Removal of the deposit showed that the surface of the terminal underneath was stained (Figure 6) and further cleaning with an abrasive cloth revealed the presence of widespread small corrosion pits (Figure 7). No evidence of cracking was observed on any of the submitted cables.

Figure 5: Deposit on the surface of sample 4; a 'bell' MS21260 terminal

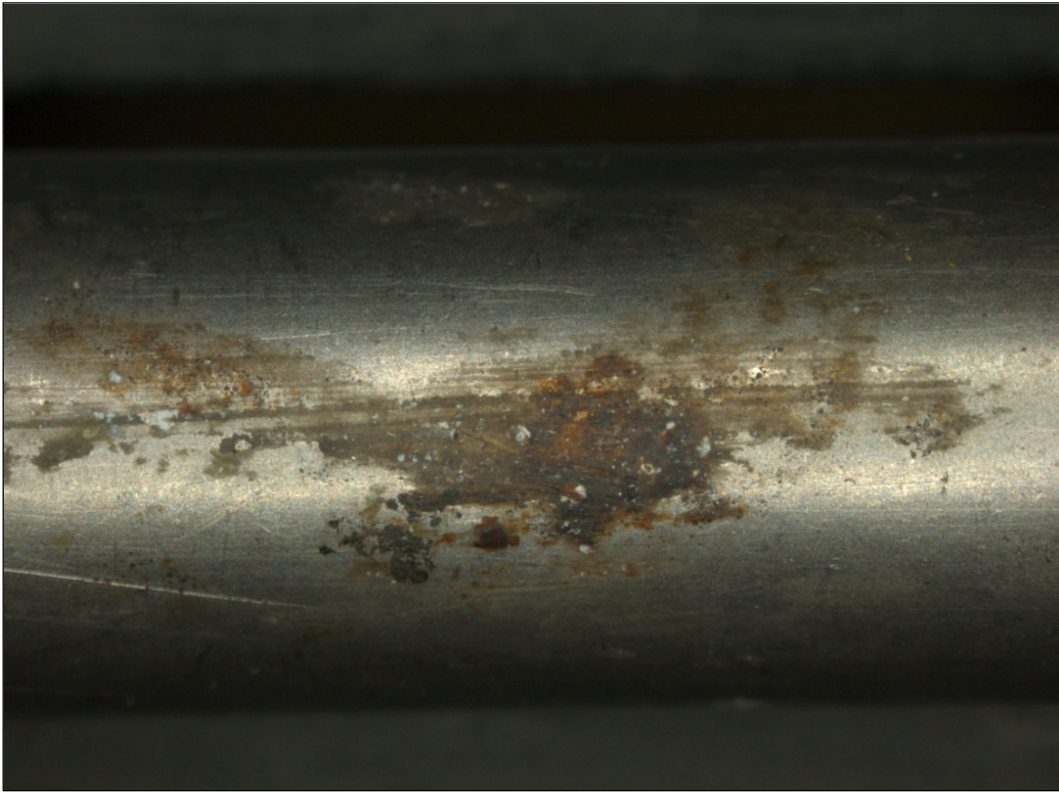
Figure 6: Surface of sample 4 following removal of deposit in Figure 5

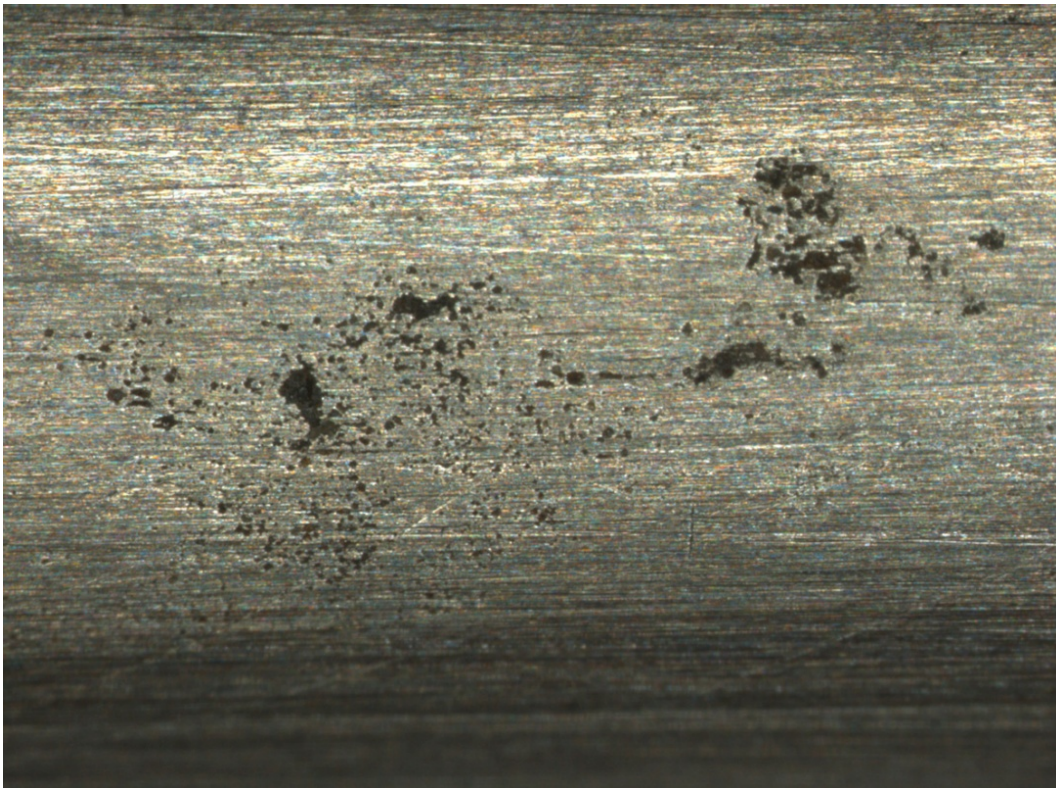
Figure 7: Pitting observed on sample 4 in area shown in Figure 6 after cleaning

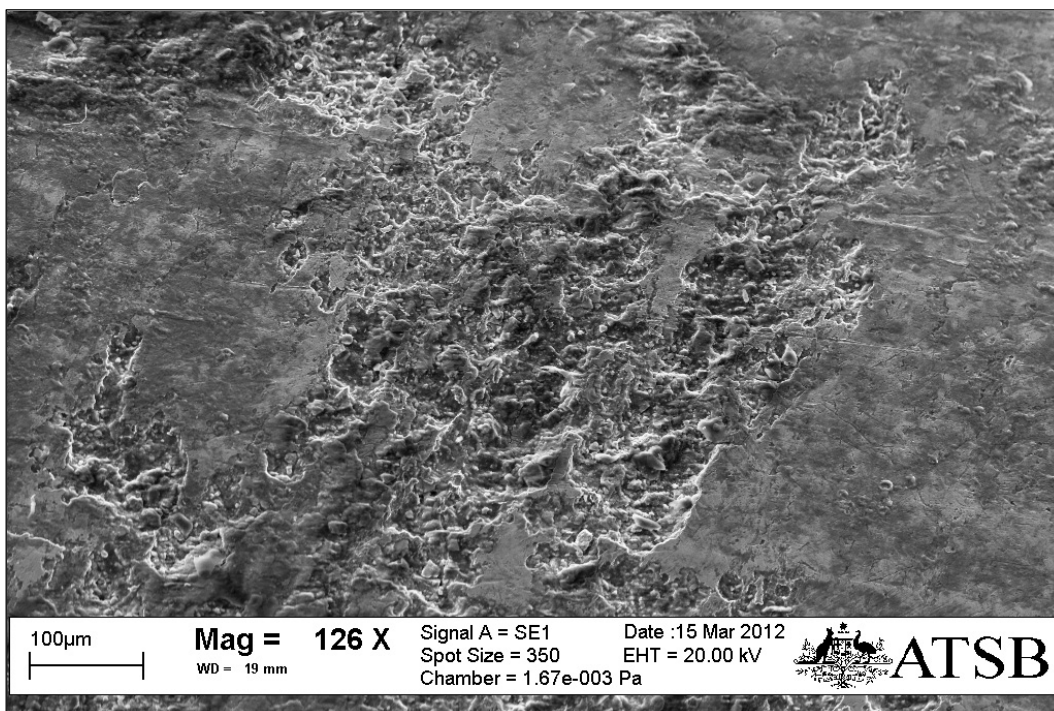
Examination of the four selected samples in Table 1 using the scanning electron microscope (SEM) confirmed the presence of widespread shallow pits (Figure 8). The use of energy dispersive x-ray spectroscopy (EDS) confirmed the base alloy type as a 303 Se stainless steel, and identified the presence of chlorides within and around the pits (Figure 9).

Figure 8: Magnified view of the widespread pitting on sample 4 as shown in Figure 7

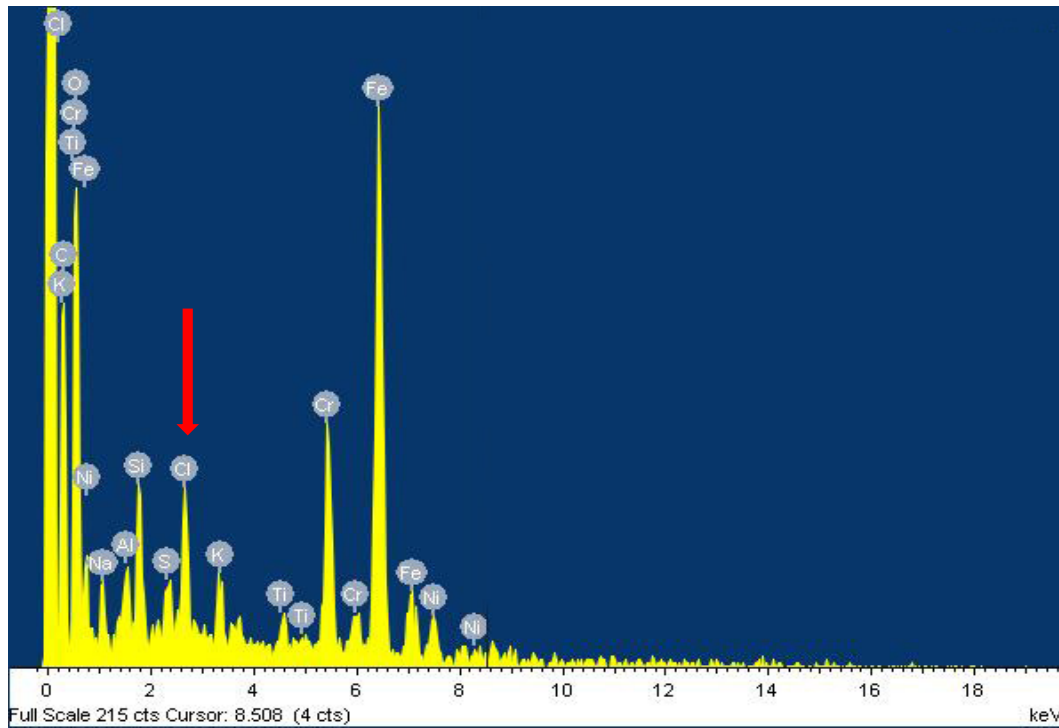
Figure 9: Energy dispersive X-ray spectrum of the corrosion product (chloride peak arrowed)

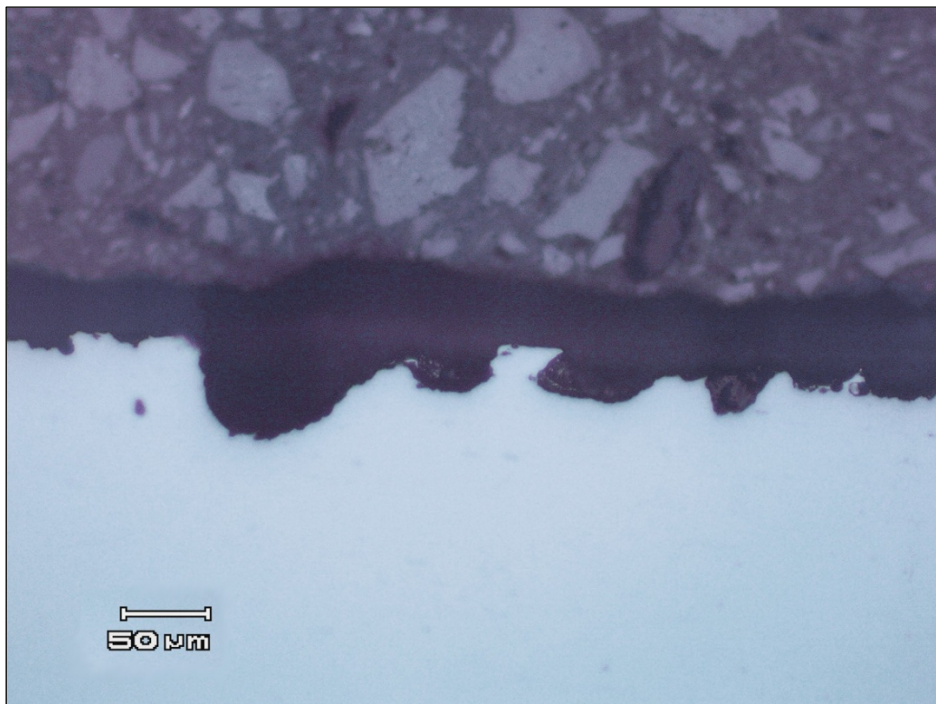
A cross section was removed from sample 4 and prepared for microstructural examination. The polished cross section confirmed the presence of a large number of wide, shallow pits along the sample length. The nature of the pits was consistent with chloride pitting in stainless steel (Figure 10). There was no observed evidence of any associated cracking from the pits or other features consistent with stress corrosion cracking.

Figure 10: Surface pitting observed during the microstructural examination

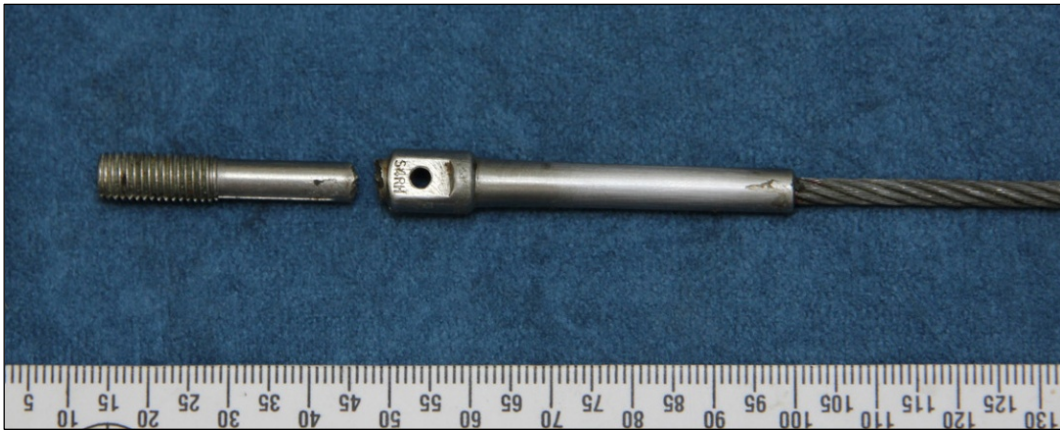
The terminal had fractured through the shank on the threaded end in the region adjacent to the wrench flats (Figure 11). The terminal had the ‘bell’ manufacturer’s mark and was part number MS21260.

Figure 11: Failed terminal submitted to the ATSB

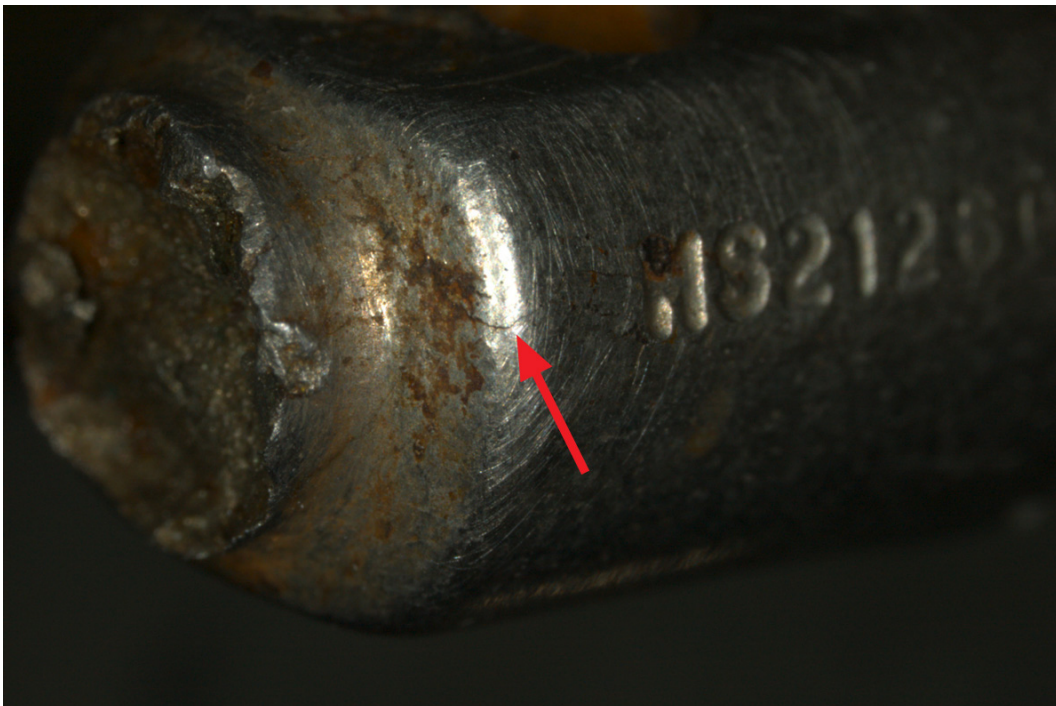
The fracture surface and surrounding area was discoloured, and exhibited a rough appearance. The appearance of the fracture face, together with branched, secondary cracking extending from the primary fracture face into the wrench flats (Figure 12) was indicative of a stress corrosion cracking failure mechanism.

Figure 12: Widespread discolouration and secondary cracking (arrowed) on failed terminal

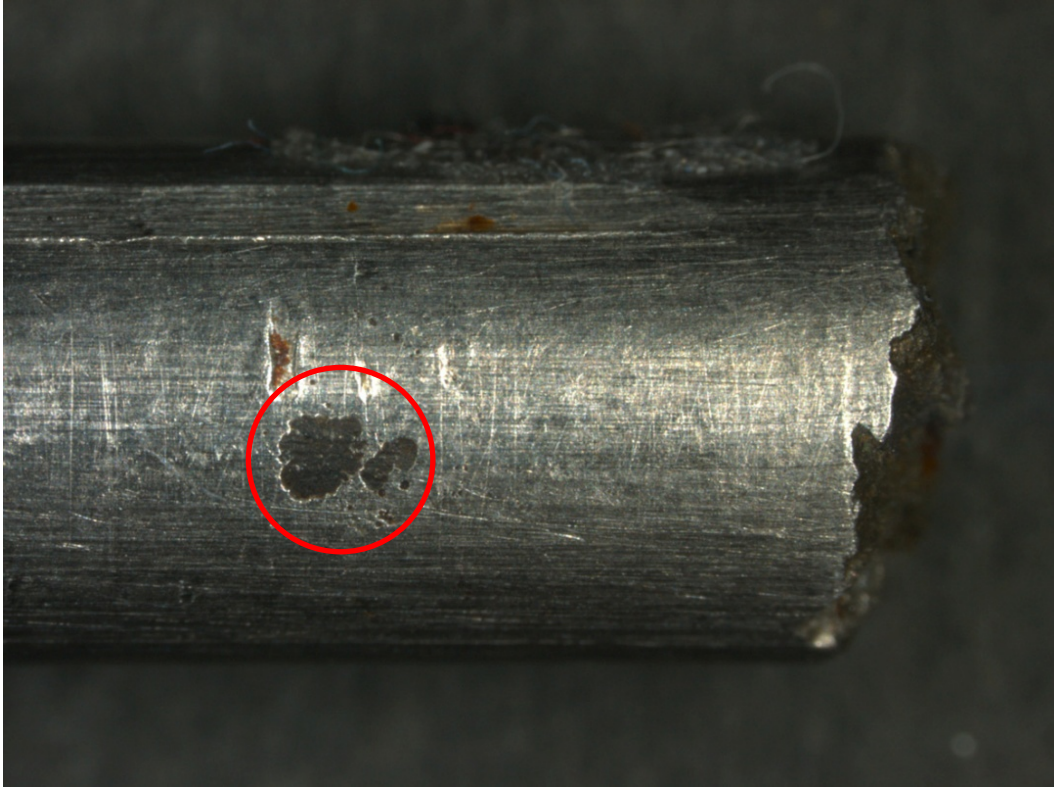
An area of discolouration was observed on the shank on the threaded side of the fracture, approximately 3mm from the fracture face (Figure 13). Closer examination revealed shallow pits, similar to those observed on the previously submitted samples.

Figure 13: Failed terminal showed similar pitting (circled) to the previously inspected samples

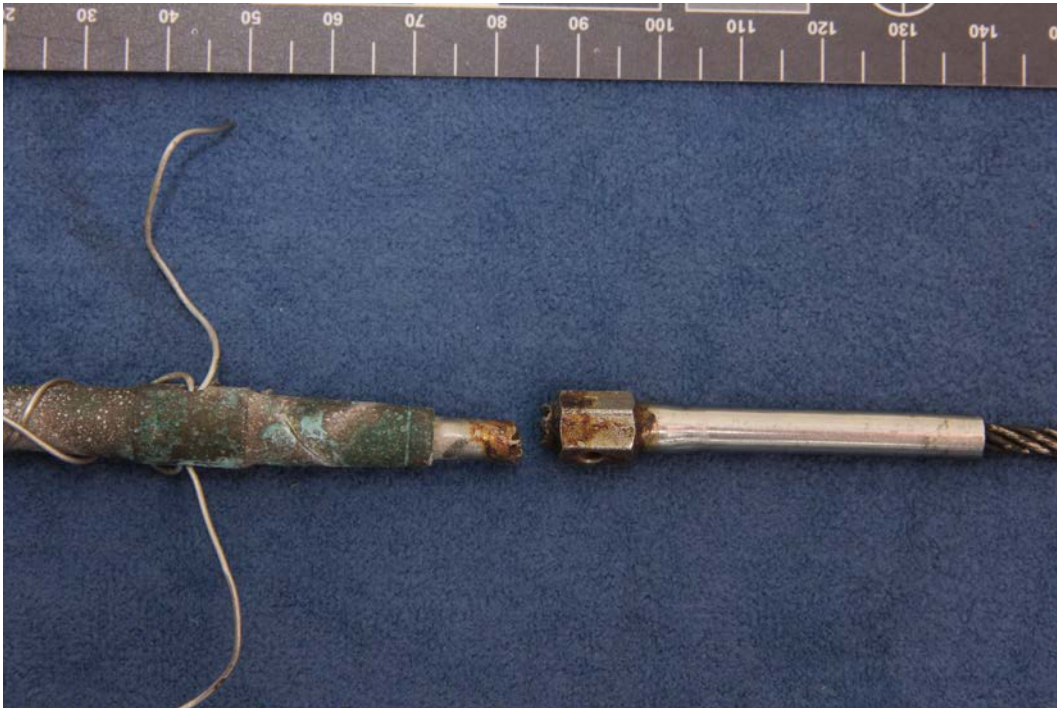
CASA received a service difficulty report on 6 August 2012 regarding a failed aileron control cable terminal on an amateur built aircraft (Minicab GY-201) that was identified during an inspection in accordance with AWB 27-001 Revision 3. The terminal was part number AN669, exhibited the 'F' manufacturing symbol and had probably been in service since the aircraft was manufactured in 1980. The terminal had fractured but had remained connected by the lock wire. The surfaces in the region of the failure were heavily discoloured and the fracture surface had a rough appearance (Figure 14). Significant pitting corrosion was observed on the external surfaces and the internal surfaces of the lock wire hole and swaged end. One half of the terminal (the side containing the wrench flats) was sectioned for metallographic examination perpendicular to the fracture. The polished cross section revealed an extensive network of highly branched cracks. The cracks were predominantly transgranular in nature, and extended both longitudinally through the sample from the primary fracture surface, and horizontally from the external surfaces (Figure 15). These features confirmed that the mode of failure was SCC. Cracking from the lock wire hole surface and from the internal swaged surface was also observed.

Figure 14: Failed terminal from Minicab GY-201 aircraft identified during inspection

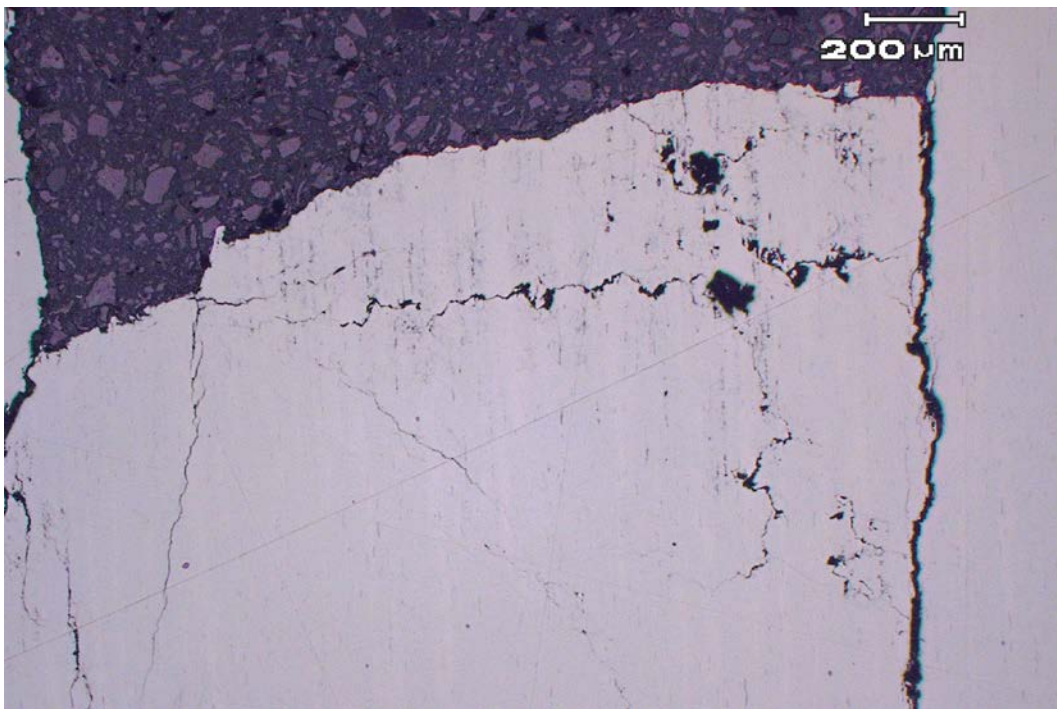
Figure 15: Microstructural cross section of terminal shown in Figure 14 showing network of cracks
