**ATSB TRANSPORT SAFETY REPORT**  
Aviation Occurrence Investigation AO-2009-004  
Final

**Operational event**  
**89 km south-east of Townsville**  
**Aerodrome, Queensland**  
**2 February 2009**  
**VH-ESH**  
**Agusta Westland AW139**

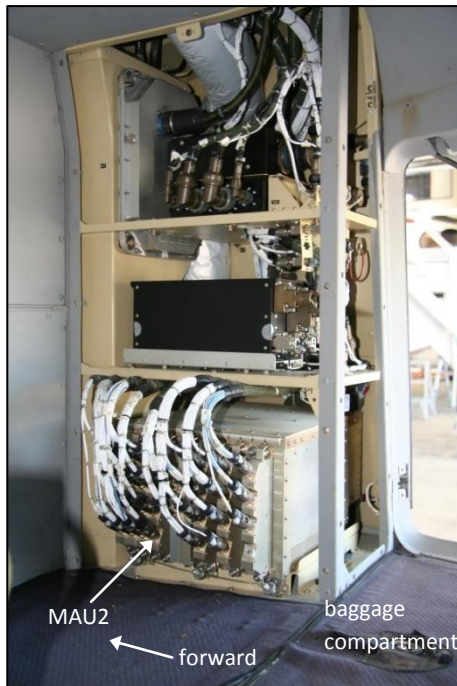
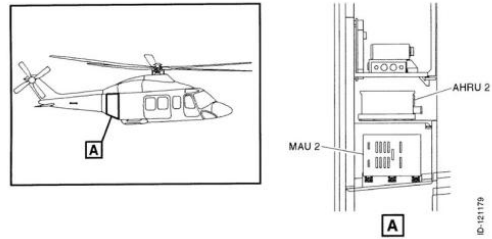
**Figure 5: MAU2 location**

Inspection of the two installed Modular Avionics Units (MAUs), located immediately in front of the baggage compartment, also found evidence of moisture within the right side unit (MAU2). Further detailed examination identified corrosion and contamination on a number of the electronic components located within that unit (Figure 12).

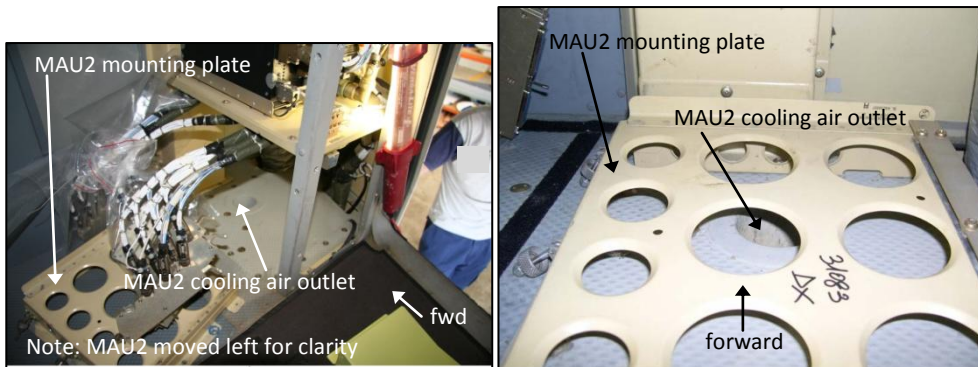
**Figure 8: MAU2 cooling outlet**

Upon investigation into these events, it was discovered that a cooling vent on the aircraft was injecting foreign contaminants and moisture into the aircraft's avionics equipment located in modular avionics unit 2 (MAU2). The air intake for cooling the MAUs is located at the bottom of [the] unit. Over time this injection of moisture and contamination onto the Custom I/O 2 module and other modules located in MAU2 resulted in corrosion and contaminant build up on electronic circuits within the MAU. The corrosion and contaminants build up lead to system malfunctions associated with these aircraft incidents...Initial feedback from the field indicates this is not a problem with modules installed in the MAU1 locations as the cooling duct for this MAU does not enter the cabinet from the bottom.<sup>[10]</sup>

- The design and relative positioning of the external air vent and avionics modules permitted the ingress of moisture and particulates that led to corrosion and contamination of electronic avionics components, and the generation of multiple erroneous crew alerting system messages due to electrical shorting. [*Significant safety issue*]

Following a number of reports of AW139 helicopters experiencing erroneous crew alerting system messages, the helicopter and avionics system manufacturers established that the design and relative positioning of the external air vent was the source of the problem. Once identified, the helicopter manufacturer issued mandatory service bulletin (SB) 139-166 that was applicable to 'short nose configuration' helicopters.<sup>16</sup> The bulletin provided instructions to identify the presence of corrosion on the Modular Avionics Unit (MAU) modules and also detailed modification of the MAU2 ventilation duct to ensure that the modules were not subject to the direct flow of air from the duct outlet.

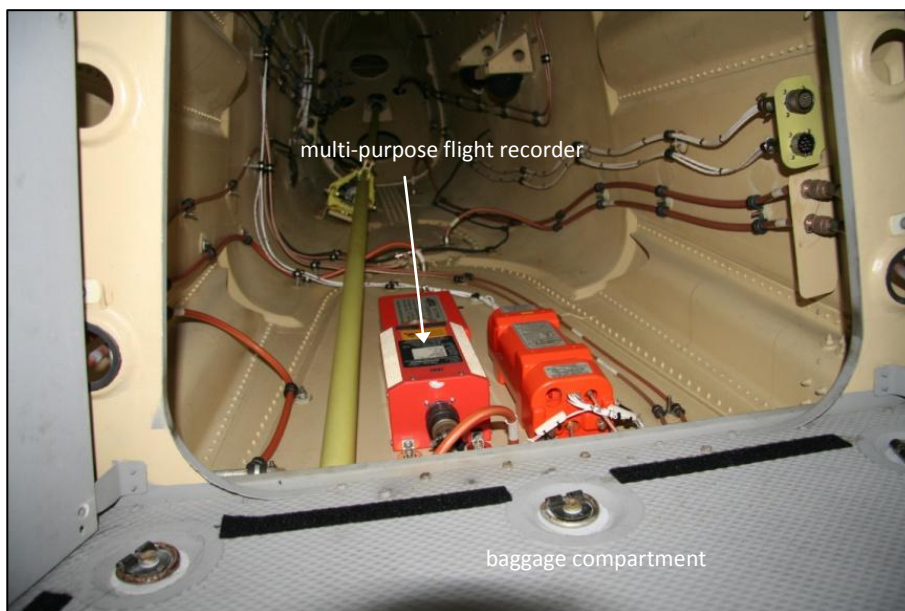
**Figure 11: AW139 tail boom**

Examination of the helicopter by the operator's maintenance personnel on its arrival at Townsville found evidence of significant water ingress within the baggage compartment. Water present below the baggage floor and within the tail boom area in the vicinity of the MPFR (Figure 11) was assessed as being responsible for the

activation of the MPFR circuit breaker observed by the crew. Owing to the resultant interruption of the electrical power supply to the MPFR, no recorded information relevant to the flight, including the activation of any aural and visual warnings, was available. A second source of electronic data, primarily used to assist with fault diagnosis, was however available for analysis.

The first indication of a potential problem with the helicopter occurred shortly after departure from Mackay Aerodrome with the activation of crew alerting system (CAS) messages relating to failure of the multi-purpose flight recorder (MPFR). The source of the failure was later identified as water ingress, following exposure of the helicopter to heavy overnight rainfall that affected the MPFR power line and resulted in activation of the MPFR circuit breaker.

Following the occurrence, the operator developed a modification, in accordance with an engineering order, to prevent moisture ingress affecting the multi-purpose flight recorder power supply. Details of the modification were supplied to the helicopter manufacturer.

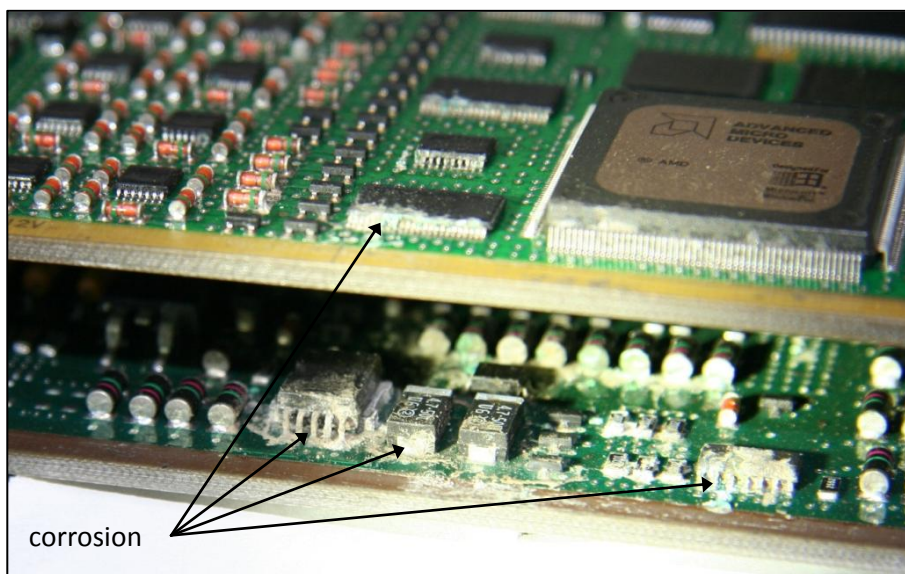
**Figure 12: Example of corroded electronic module**

The findings of the material analysis indicate the presence of corrosion and contamination that is consistent with dust and dirt being blown into the MAU2 cabinet along with high proportions of sodium and chlorine which is consistent with operation in a coastal environment.

The remainder of the CAS messages experienced by the crew throughout the flight were identified by the avionics system manufacturer as spurious and originated from moisture and particulate ingress, via an external cooling vent, affecting the electronic avionics modules. Repeated exposure of the modules to moisture and particulates prior to the flight, resulted in corrosion and contamination of the electronic circuits. Subsequent moisture from operation in rain during the flight permitted the generation of multiple erroneous messages due to electrical shorting, that was exacerbated by the corroded areas of the avionics modules.
