Powerplant/propulsion event Launceston aerodrome – 20 August 2009

Abstract

The left engine was a CFM International (CFMI) CFM56-7B24, high bypass ratio turbofan (Figure 1), serial number 888952.

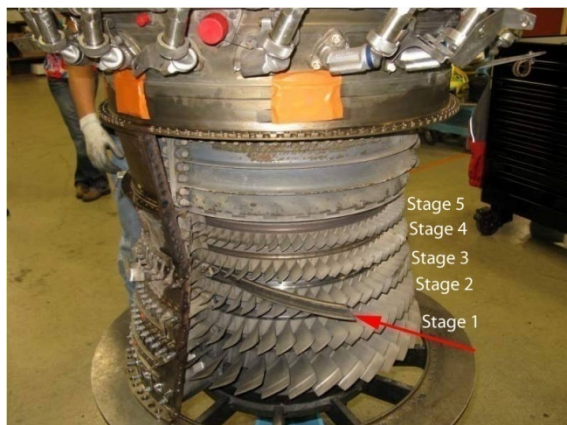
Separation of the HPC forward stator case halves (Figures 2 and 3) revealed damage to the HPC blades, VSV, inner shrouds and honeycomb seals.

Figure 2: HPC rotor following removal of stator. Note the rotated Stage 3 seal segment (arrowed).

Although loose, the stage 1 and 2 inner shroud segments were intact and the honeycomb seals had not rotated. However, the stage-3 honeycomb seal segment located in the 9 - 12 o'clock position looking forward was missing, and the adjacent 12 - 3 o'clock segment had been displaced about 4 inches (102 mm). Two small pieces consistent with the missing seal segment were found in the debris recovered from the engine (Figure 7).

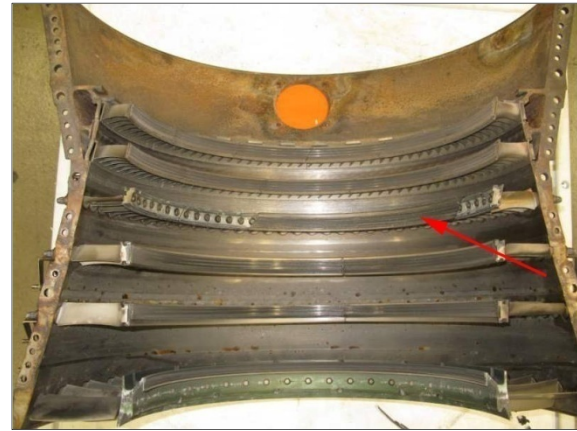
Figure 3: One half of the HPC stator following removal from the core

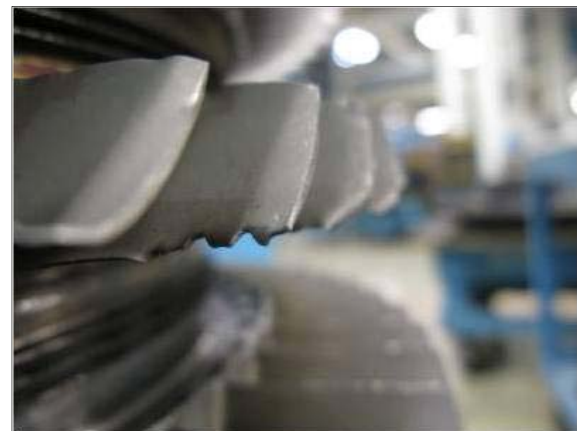
The HPC rotor damage commenced at the stage-3 blades and continued downstream. There was no evidence of blade fracture and all damage appeared to be consistent with hard object impact (Figure 4).

Figure 4: Example of HPC rotor blade damage.

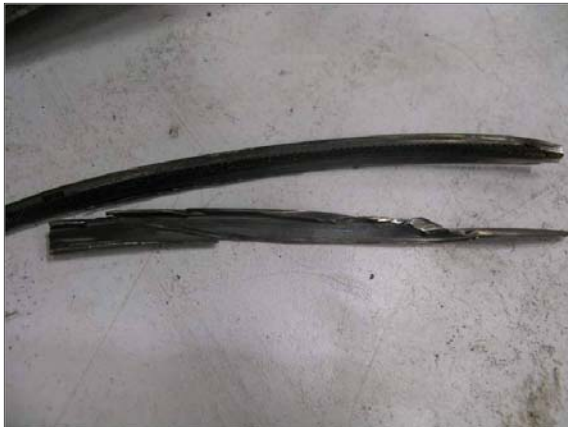
Figure 7: Seal segments found in debris.

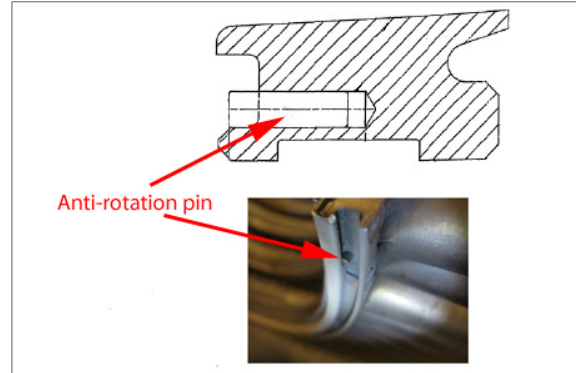
The anti-rotation pins at the 3 and 9 o'clock positions (Figure 8) exhibited significant wear in the areas in contact with the seal segments (Figure 9).

Figure 8: Cross section through shroud showing location of anti-rotation pin

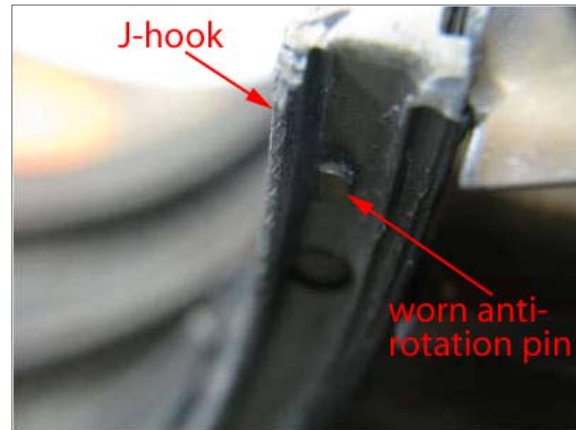
Figure 9: HPC inner shroud with worn stator seal J-hook and anti-rotation pin.

- Wear of the variable stator vane (VSV) bushings and inner shroud had allowed movement between the seal retainer and inner shroud segments.
- This subsequently produced heavy wear of the seal retainer anti-rotation pins.

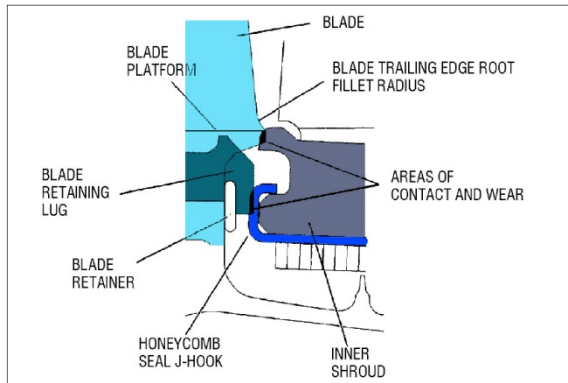
standards for a borescope inspection (BSI) on high time since new (TSN) CFM56-7B engines in order to detect and monitor wear or rotation of inner shroud J-hooks'. The bulletin stated that wear of the VSV inner bushings allows the HPC inner shrouds to move forward, which in turn allows the vanes and inner shrouds to rotate forward into the rotor hardware (Figures 10 and 11).

Figure 11: Contact between inner shroud and honeycomb seal and the preceding blade (from SB 72-0515).

The bulletin recommended a borescope inspection after 24,000 hours TSN, or 24,000 flight hours since the HPC inner and outer VSV bushing and outer washers had been replaced with new parts.

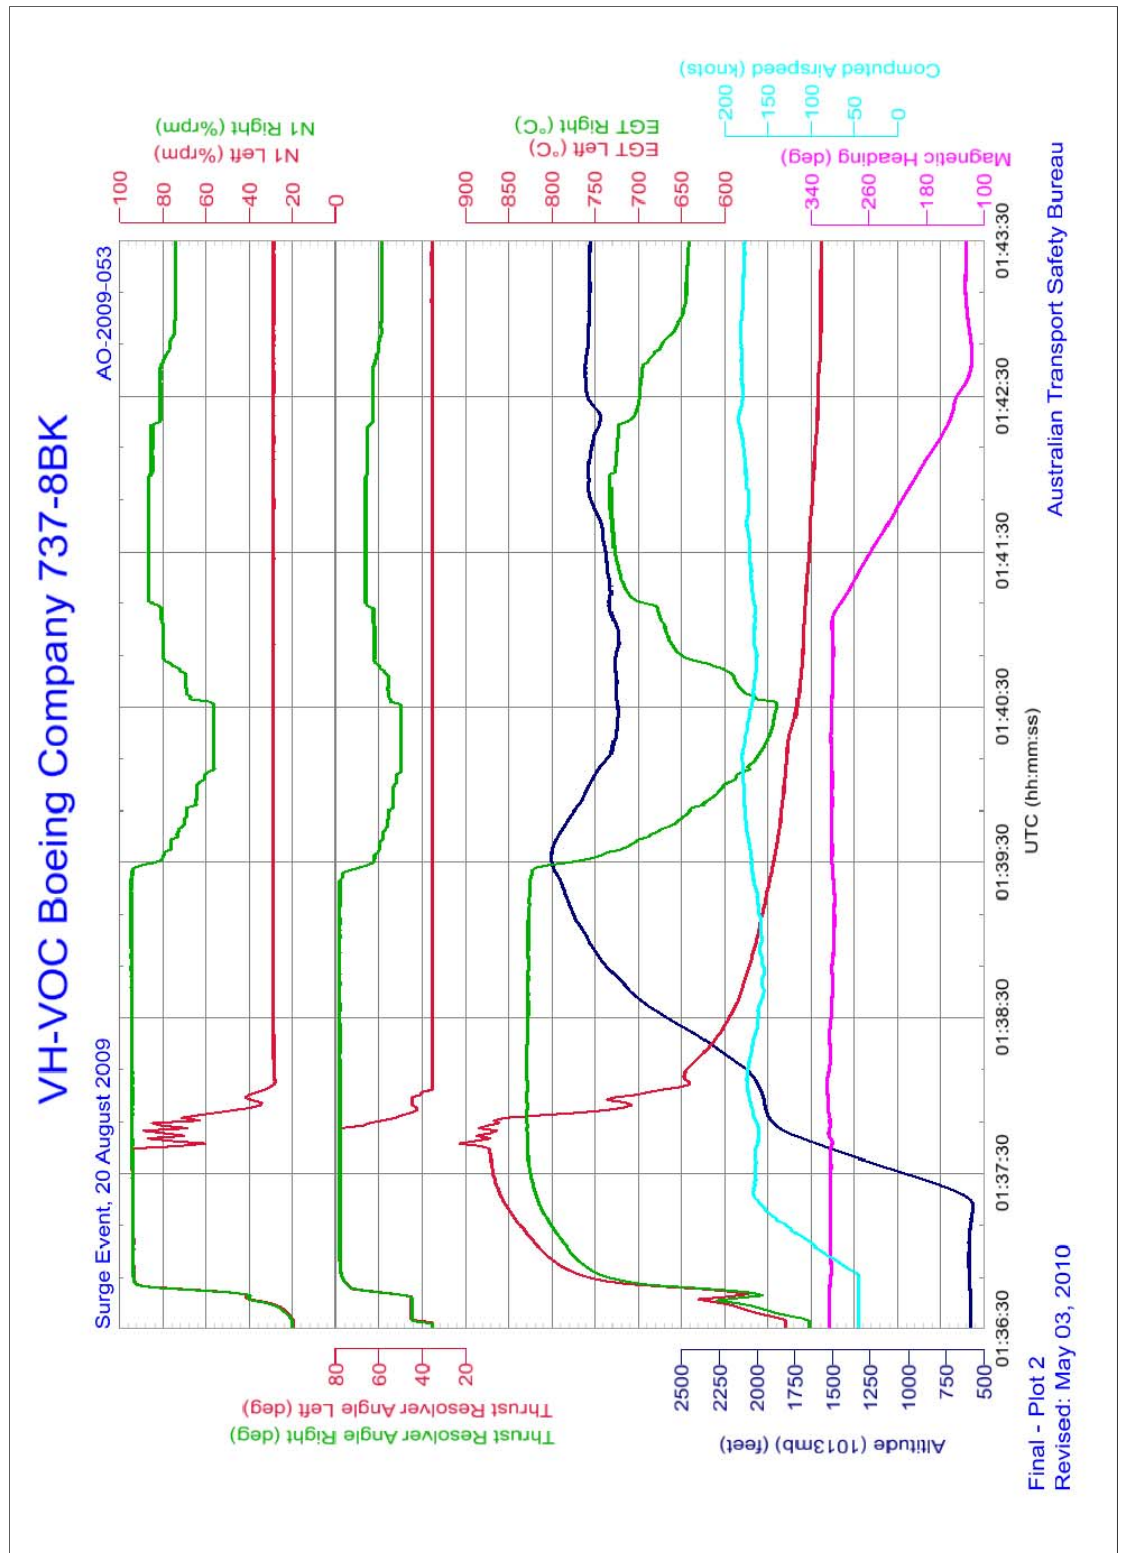
ATTACHMENT A: FLIGHT DATA RECORDER PLOT

A further review of the FDR data also indicated that the EGT and fuel flow parameters for the left engine had shown a minor increase with respect to the right engine over the preceding two flights. The FDR included data from the previous 16 flights and until the second-last previous flight to the incident flight, the left and right engine parameters had remained almost identical.

The short-term increase in the occurrence engine exhaust gas temperature (EGT) levels noted from the flight data recorder (FDR) data was consistent with the effects of the damage developing within the HPC.

Plot of the flight data recorder information showing a seven minute period during the time of the compressor surge and immediately after. The plot shows values of the engine rotor speeds (low pressure), altitude, exhaust gas temperature (EGT), thrust resolver angle, magnetic heading, and computed airspeed.
