# Collision with terrain, VH-VSK

## 2 km NNE of Durham Downs Homestead, Queensland

### 18 October 2010

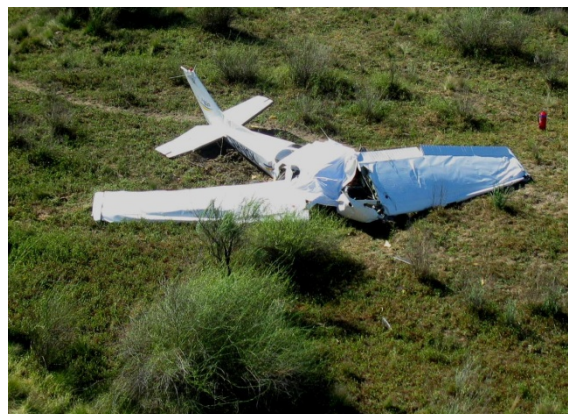
**Figure 1: Aerial view of the wreckage**

The aircraft was seriously damaged by the ground impact forces (Figure 1). There was no evidence of fire.

Deformation damage to the wing leading edges indicated that the aircraft's attitude at impact was about 55° nose-down. The right wing sustained more damage than the left, indicating that the right wing impacted the ground before the left wing. The initial impact position was about 4 m from the final location of the wreckage.
