Descent below the minimum permitted altitude, Airbus A320 VH-VNC

15 km SSE of Avalon Airport, Vic | 30 June 2011

ATSB Transport Safety Report
Aviation Occurrence Investigation
AO-2011-076
Final – 18 December 2013

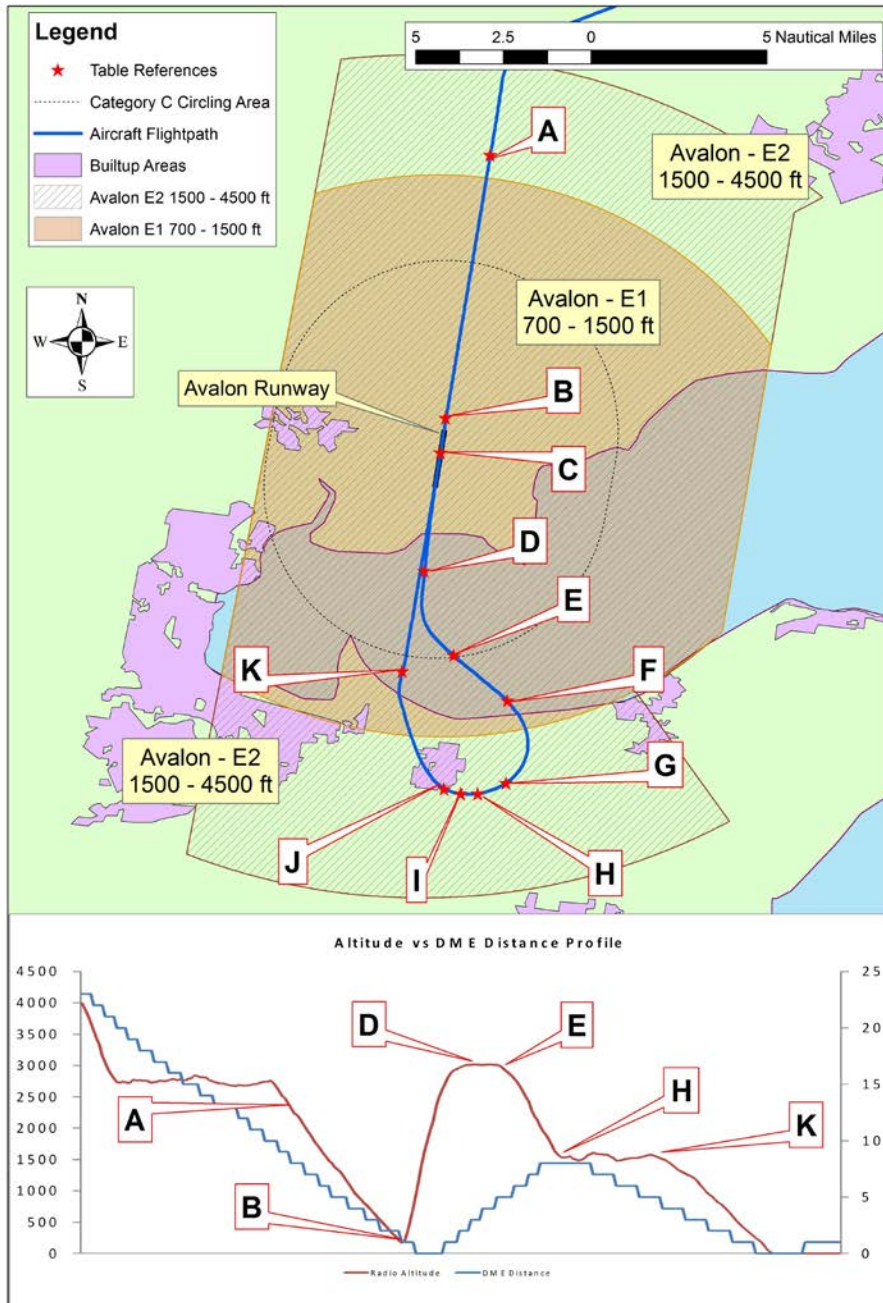
Figure 1: Aircraft track and descent profile with airspace dimensions

At 2256 Eastern Standard Time,⁷ Melbourne Approach (ML-APP)⁸ cleared the aircraft to leave controlled airspace on the ILS approach to runway 18 (Point A in Figure 1). At 200 ft, the crew

checked the tailwind, which was 15 kt and as such, a go-around was executed and the crew conducted the missed approach procedure for the runway 18 ILS (Point B in Figure 1).

As the aircraft levelled at 3,000 ft the following radio communications were conducted between the PF and ML-APP (Point D in Figure 1):

At 2304:40, as the aircraft descended through 2,800 ft, the ML-APP controller received a Clearance Level Adherence Monitoring (CLAM)¹⁶ warning, identifying that VH-VNC had left its current assigned altitude. In response to the CLAM, the following radio communications took place between the PF and ML-APP as the aircraft was passing 2,600 ft (Point F in Figure 1):

The aircraft descended through the minimum permitted altitude of 2,000 ft at 2305:25 as the PM was programming the FMGS. At that time the aircraft was 8 NM (15 km) to the south-south-east of runway 36, passing through a southerly heading as it turned back in to the runway. Towards the end of the attempts by the PM to enter the runway 36 guidance into the FMGS, the PF requested the PM to return his attention to support duties due to the aircraft's proximity to the ground. Those duties included configuring the aircraft for landing and providing the PF with guidance to the runway.

As the aircraft was turning back towards the runway, the PF asked the PM if he had it in sight. The PM responded at 2305:38 that the runway was in sight, as the aircraft was descending through 1,760 ft (Point G in Figure 1). Ten seconds later, the aircraft's automation captured the target altitude of 1,600 ft (Point H in Figure 1). At 2305:55 the ML-APP controller identified that the aircraft was below the MVA in that area and initiated the following radio communications (Point I in Figure 1):

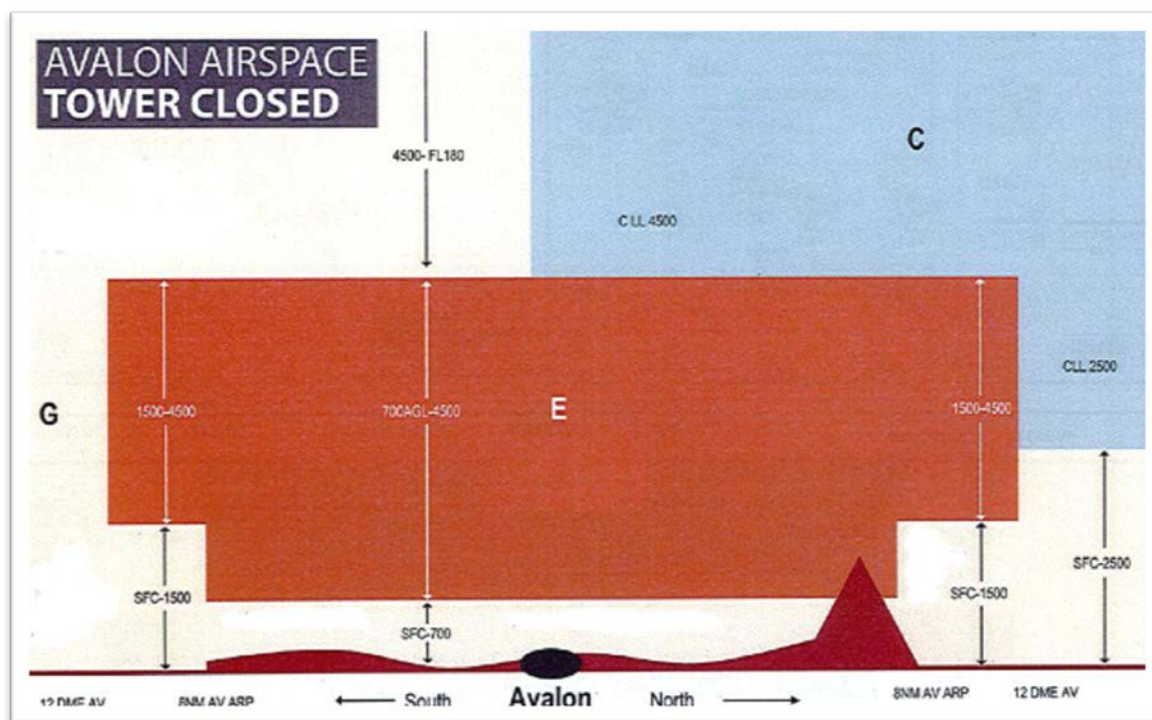
Figure 2: Avalon airspace, tower closed configuration

Avalon Tower operated daily from 0700 until 2000 and was closed outside of these hours. The closure of the control tower meant that the airspace immediately above Avalon to a height of 700 ft and within 8 NM (15 km) was re-classified as Class G (uncontrolled) (see Figure 1 and Figure 2). From 700 ft to 1,500 ft the airspace was Class E (Avalon-E1), and above that was additional Class E airspace (Avalon-E2) that extended from 1,500 ft to 4,500 ft.

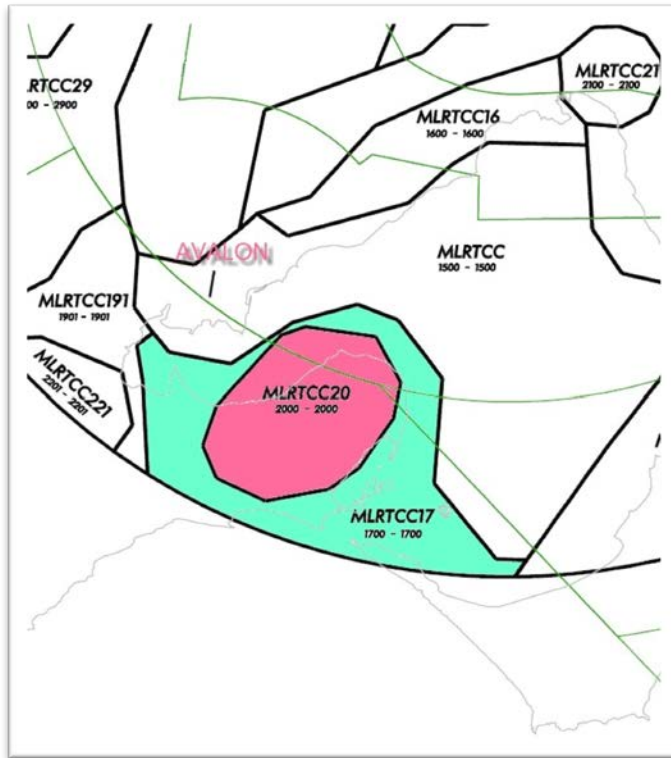
Figure 3: Melbourne RTCC chart

MLRTCC17 in Figure 3. The initial descent below the minimum permitted altitude of 2,000 ft occurred while the aircraft was in MLRTCC20. The controller queried the aircraft's altitude as the aircraft was about to exit MLRTCC20 and enter MLRTCC17. Closer to but still south of Avalon, an MVA of 1,500 ft was possible.
