Pilot incapacitation while operating a Robinson R44 Helicopter, VH-HCA

180 km SSW of Newman, Western Australia | 3 September 2011

ATSB Transport Safety Report
Aviation Occurrence Investigation
AO-2011-109
Final

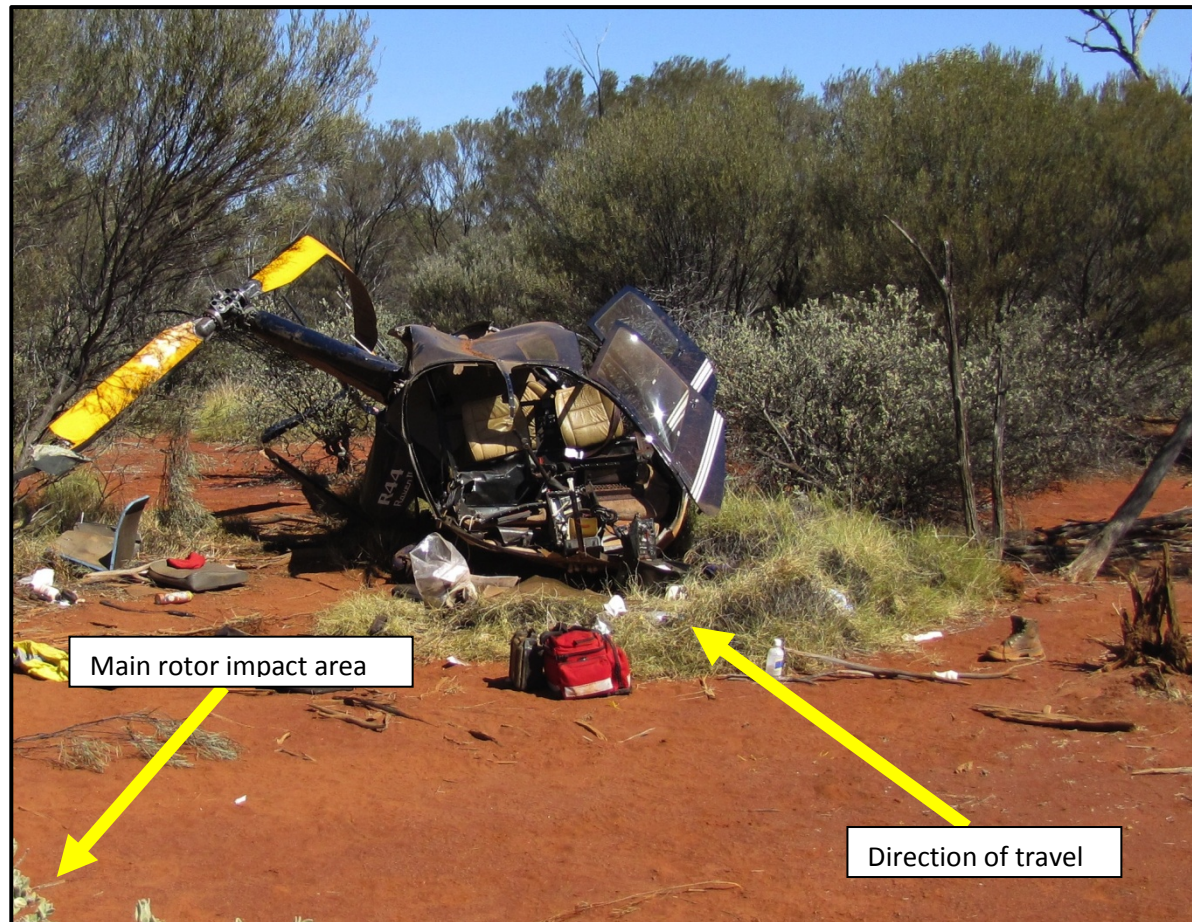
Figure 3: Helicopter accident site

Significant crush damage to the underside of the helicopter's forward fuselage was consistent with the helicopter impacting the ground in a nose-down attitude. The damage to the helicopter, wreckage orientation and surrounding environment indicated that the final trajectory was from the north-west. The confined distribution of the wreckage meant that there was probably a relatively low forward airspeed prior to impact (Figure 3).

Examination of the wreckage showed that the three steel fuel storage containers did not contain fuel and were secured in their mounts. A significant amount of aviation type fuel was observed leaking from the displaced auxiliary fuel tank. Despite leaking fuel and that the aircraft's fuel tanks were not fitted with bladder-type fuel tanks, there was no fire.

On-site examination of the helicopter did not identify any mechanical failure that would have precluded it from operating normally.
