Loss of control involving Eurocopter AS350BA, VH-RDU

93 km N of Rockhampton Airport, Queensland | 8 September 2011

ATSB Transport Safety Report
Aviation Occurrence Investigation
AO-2011-110
Final – 5 September 2013

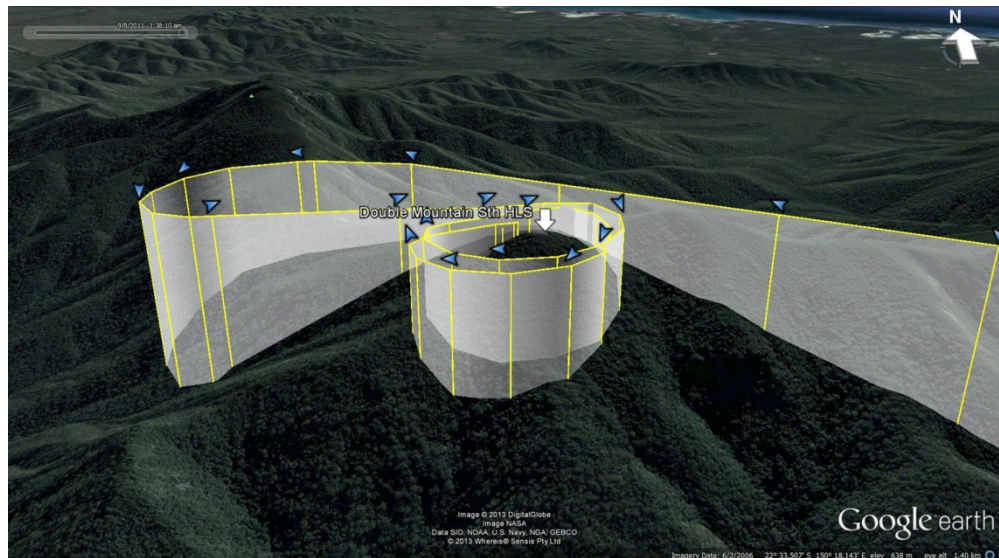
Figure 2: Helicopter's GPS tracks around the Double Mountain South HLS

At 1117, the helicopter departed for Double Mountain South HLS, about 60 km to the north-west, arriving overhead the HLS at 1135. It passed just to the north of the HLS, tracking north-west before turning left to track back to the landing site (Figure 2).

The GPS data indicated that the helicopter passed north abeam the HLS on an easterly track, with a groundspeed of 34 kt and at an altitude of about 2,500 ft, about 100 ft above the HLS. It then climbed away and commenced a right circling approach back towards the HLS. On a north-easterly track towards the HLS, the helicopter slowed to a groundspeed of 33 kt and descended to about 2,510 ft, before it climbed away for a second circling approach back towards the HLS.

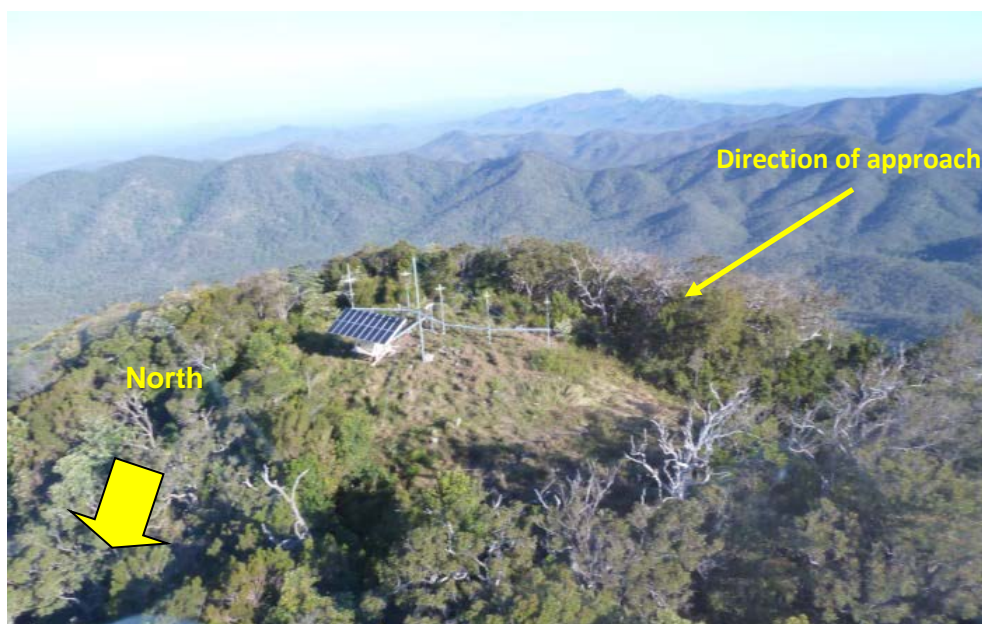
Figure 5: View of the Double Mountain South HLS, looking south-east

The Double Mountain South HLS is situated atop the south-eastern peak of Double Mountain in Department of Defence (DoD) controlled land. It is located at an elevation of 2,421 ft and was surrounded by trees on three sides and a mast and antenna array on the other (Figure 5). A number of trees impinged the approaches to the HLS and the sloped landing surface was uneven and covered by long grass with numerous tree stumps and rocks that protruded above ground level.

The audit report stated that operations into the existing HLS sites were considered to be very hazardous and that they be considered as high risk, confined area operations. It found that the Shoalwater Bay training area HLSs, including the one at Double Mountain South, did not conform to the recommended specifications in CAAP 92-2(1) and identified a number of hazards specific to that site, including:

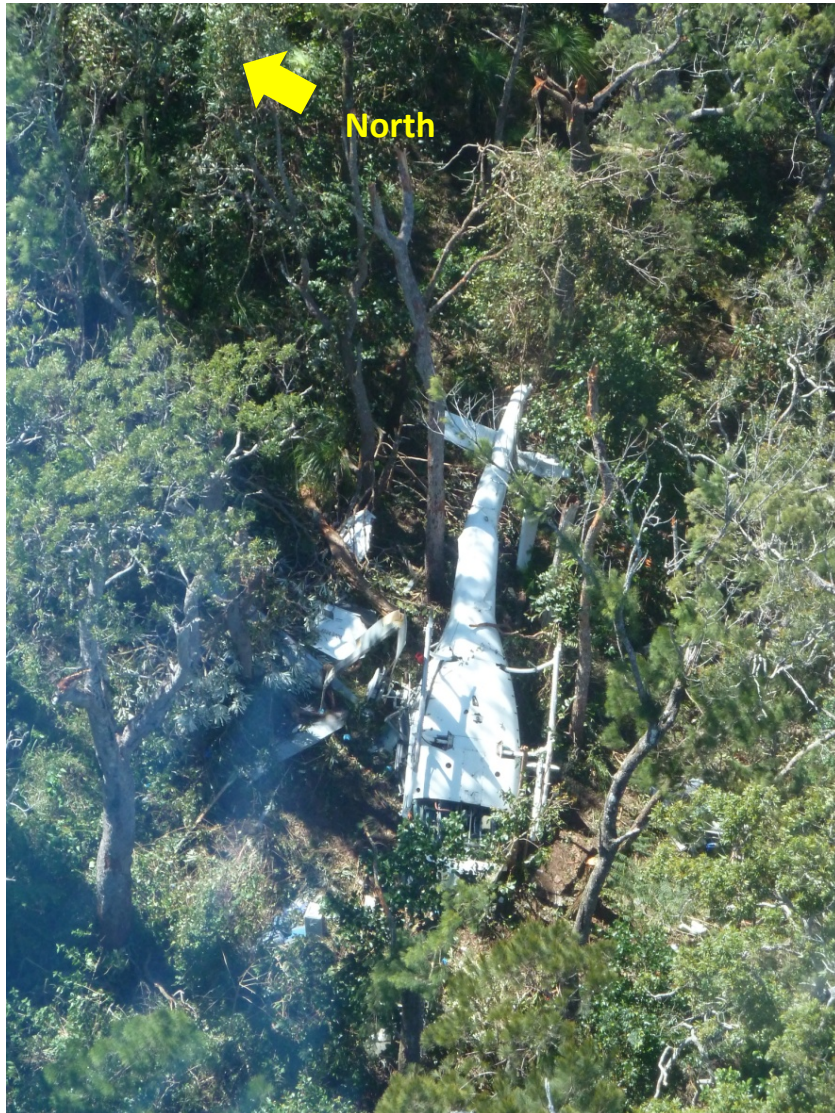
Figure 6: Aerial view of the wreckage

All of the helicopter's major rotor and dynamic components were accounted for at the accident site, except for one of the tail rotor blades that was liberated during the impact sequence. Continuity of the flight control system was established.

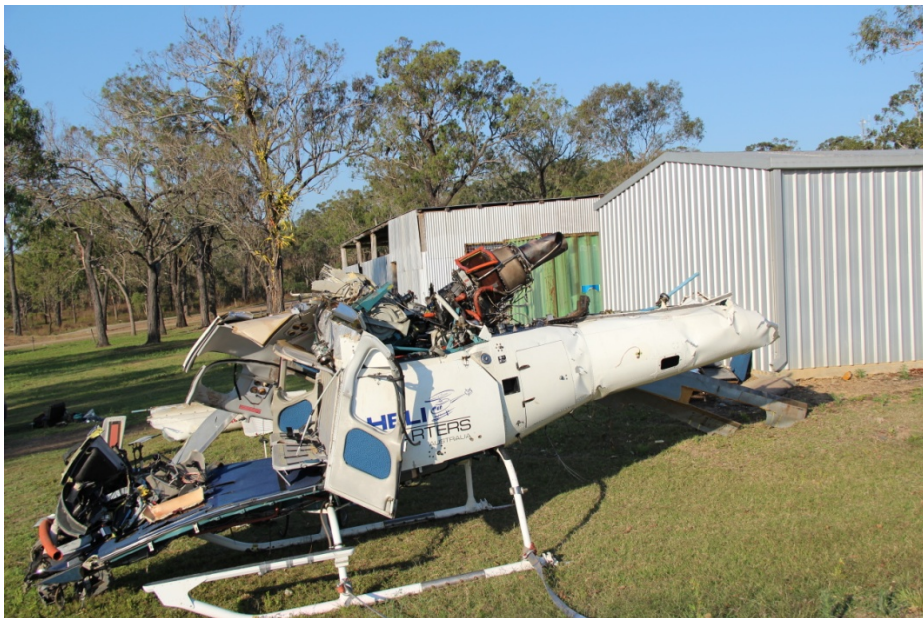
Figure 8: Recovered wreckage

A second examination of the wreckage was made after the helicopter was airlifted from the accident site to a nearby location that permitted a more detailed inspection of the helicopter and its systems. To facilitate that examination, the helicopter was rolled upright and placed on its skid-landing gear. This allowed access to areas that were inaccessible at the accident site (Figure 8).

Damage to the rotors and rotor drive systems displayed evidence of the helicopter being powered at the time it contacted the trees but the amount of power could not be determined. The plastic fuel tank that was situated in the area behind the cabin

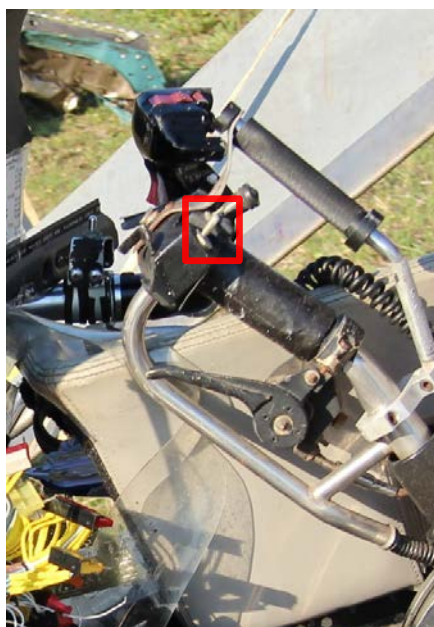
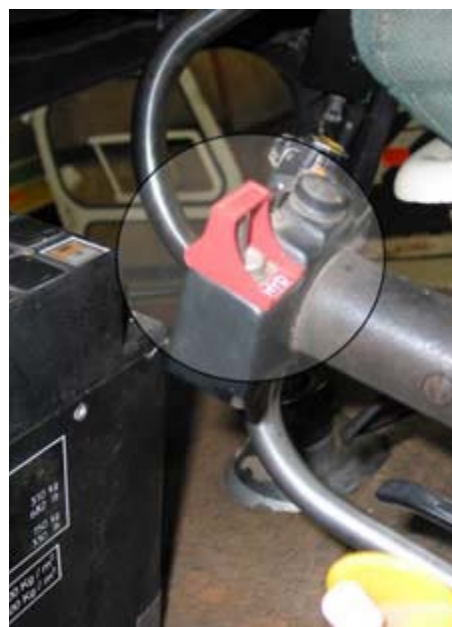
Figure 9: Hydraulic cut-off switch – VH-RDU (left) and a typical installation (right)

The HYD CUT OFF switch was a toggle switch attached to the end of the collective lever (Figure 9). It had a plastic guard to avoid inadvertent selection. The HYD CUT OFF switch was found in the ON (forward) position. However, the plastic guard was broken off, which probably occurred during the impact sequence and could have resulted in the switch being moved to that position. Therefore, the position of the HYD CUT OFF switch prior to impact could not be confirmed.

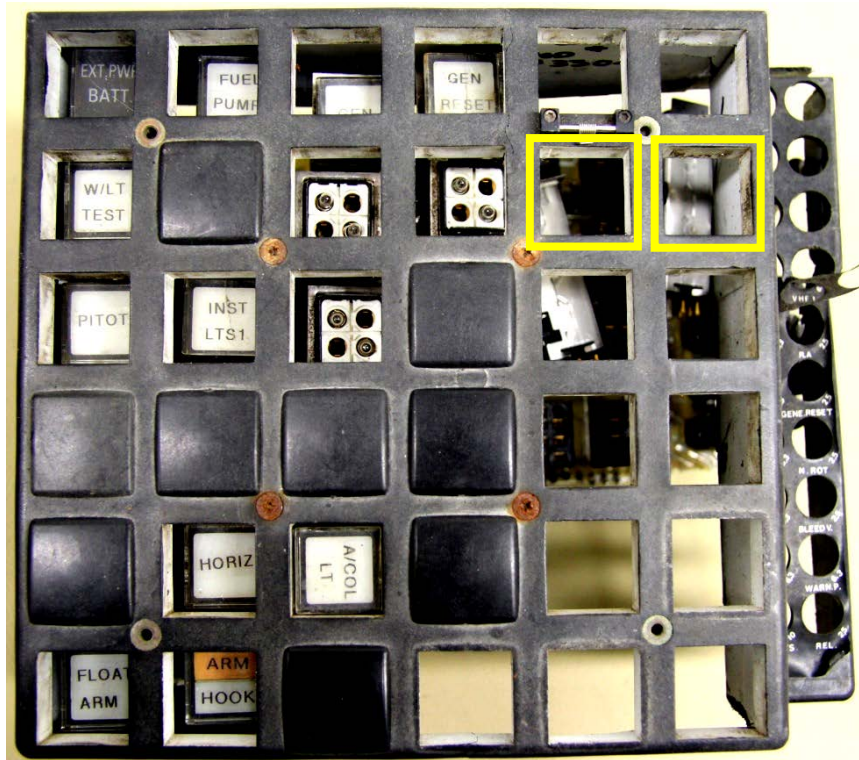
Figure 10: Hydraulic test (HYD TEST) and Horn mute (HORN) switches – dislodged and missing

Due to the disruption and damage to the cabin and the associated electrical wiring it was not possible to test the function of the low hydraulic pressure component of the dual function warning horn. In addition, the HYD TEST switch and the warning horn mute switch on the centre pedestal selector panel were dislodged and their selection prior to impact could not be determined (Figure 10).

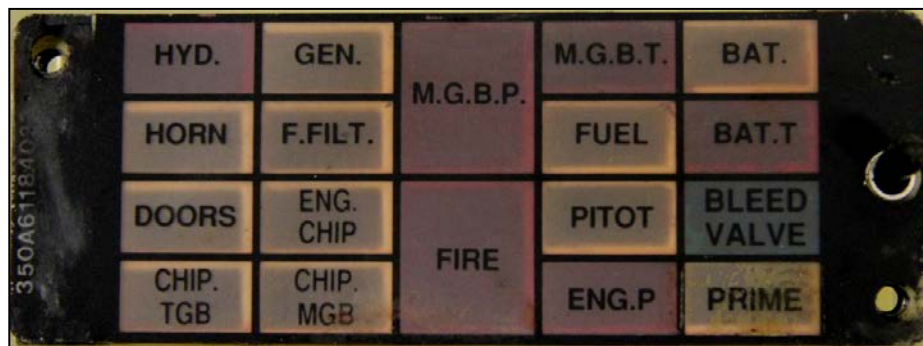
Figure 11: Warning-caution-advisory panel

The warning panel (Figure 11) was recovered and the lamps examined to determine if any warning lights had been illuminated at impact. Although none exhibited stretched elements that might indicate their illumination at impact, the angle and magnitude of the impact may not have been sufficient to produce that characteristic. Consequently, it could not be determined if either the HYD (low hydraulic pressure) warning or the HORN (mute) lamps were on at the time of impact.
