Loss of control involving Eurocopter AS350BA, VH-RDU

93 km N of Rockhampton Airport, Queensland | 8 September 2011

ATSB Transport Safety Report
Aviation Occurrence Investigation
AO-2011-110
Supplementary – 18 February 2014

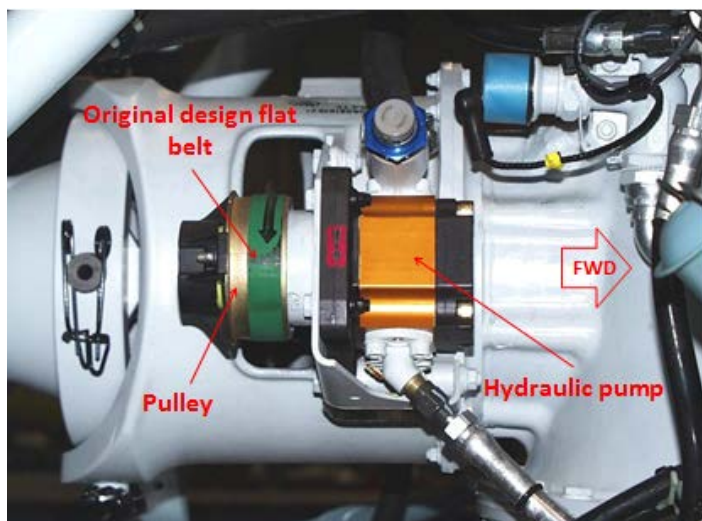
Figure 1: Original design hydraulic drive system, showing the green flat drive belt

The helicopter's original design flat, coated-fabric, hydraulic pump drive belt had a service life limit of 600 hours. The hydraulic pump drive belt, along with an adjacent compressor drive belt, was not found at the accident site or during the subsequent wreckage examination. Although the belts were most likely liberated during the impact sequence due to displacement of the drive pulleys, the alternative possibility of an in-flight failure of the hydraulic pump drive belt could not be eliminated.

An original design, flat drive belt installation is at Figure 1.

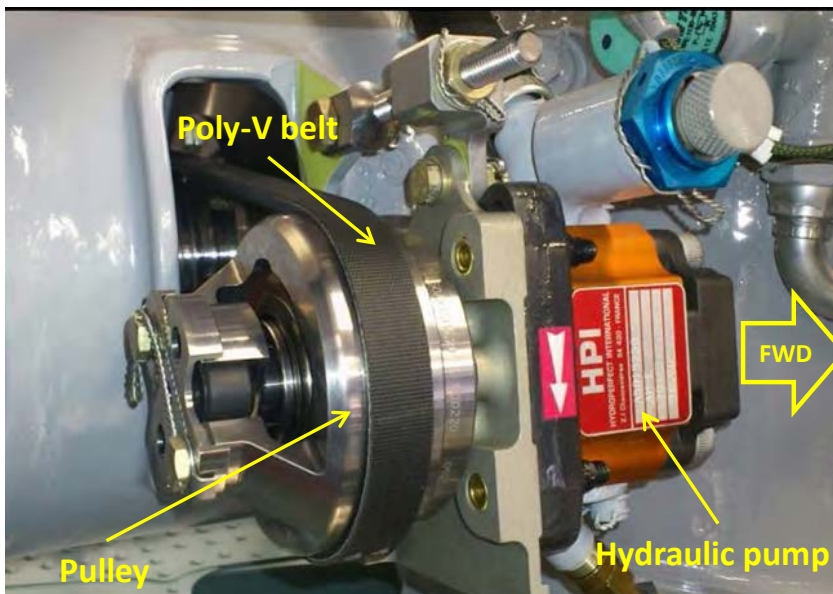
Figure 2: Redesigned hydraulic drive system, with Poly-V belt

In 2010, Eurocopter redesigned the hydraulic pump drive system in the AS350-series helicopter to incorporate the Poly-V belt with a new hydraulic pump, a keyed drive to replace the splined drive, and a stainless steel (driven) pulley with a dual-row ball bearing (Figure 2). The redesigned drive system was incorporated into Modification MOD 07.9566 and, in December 2011, Eurocopter issued SB 29.00.15 to support the upgrade of in-service AS 350-series helicopters with this modification.

Subsequently, following several incidents involving seizure of the dual-row ball bearing in the stainless steel drive pulley, Eurocopter introduced a periodic inspection of this type of bearing. A replacement bearing and new fitting procedure was promulgated in Alert Service Bulletin EASB 00.05.72 Revision 0, issued in February 2013 and Revision 1, issued in June 2013.
