Abnormal engine indications involving a Boeing 747-438, VH-OJS

Near Suvarnabhumi Airport, Bangkok, Thailand, 16 October 2010

ATSB Transport Safety Report
Aviation Occurrence Investigation
AO-2011-134
Final – 31 October 2013

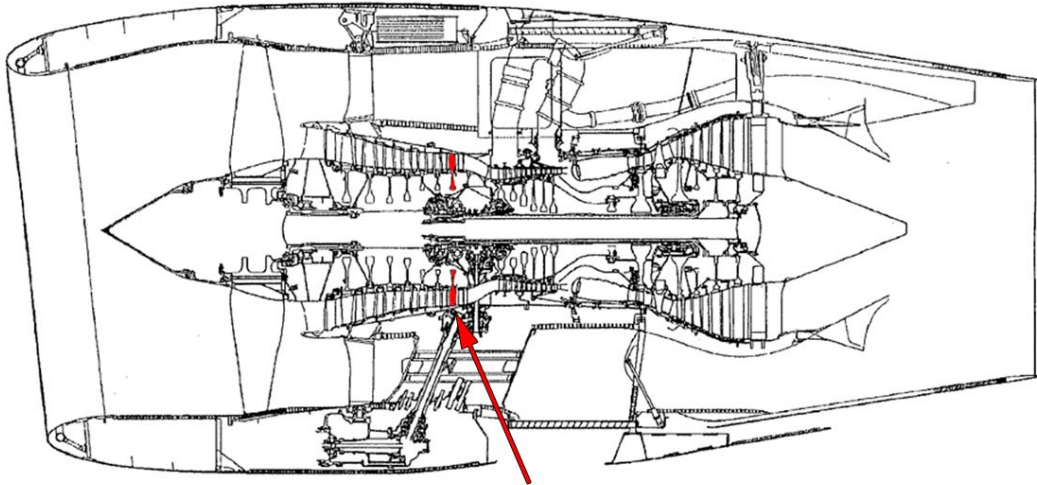
Figure 1: RB211-524 engine with stage 7 IPC rotor highlighted

The initial inspection showed that a single, stage 7 intermediate pressure compressor (IPC) blade had separated from its slot in the compressor disc (Figure 1). Disassembly of the engine confirmed the blade release and revealed significant damage to the remaining IPC blades as well as to the surrounding components.

There was evidence of a small, localised titanium fire that appeared to be the result of the released blade being jammed between the stage 7 IPC rotors and stators.

The investigation concluded that the released stage 7, IPC blade had most probably been locked in place at an offset angle to the engine axis during assembly. The offset installation resulted in localised wear and significantly increased bedding stresses between the blade and disc. The increased stresses resulted in the initiation and propagation of a fatigue crack through the blade root until the blade was released under normal operational loads.

As a result of this occurrence, Rolls-Royce has advised the ATSB that they have introduced additional quality inspection checks to mitigate the risk of future events relating to misassembly during IPC blade installation.
