Aircraft proximity event involving a Cessna 172S, VH-VMM and a Schweizer 269C-1, VH-FTR

9 km NE of Parafield Airport, South Australia, 1 September 2012

ATSB Transport Safety Report
Aviation Occurrence Investigation
AO-2012-115
Final – 21 March 2013

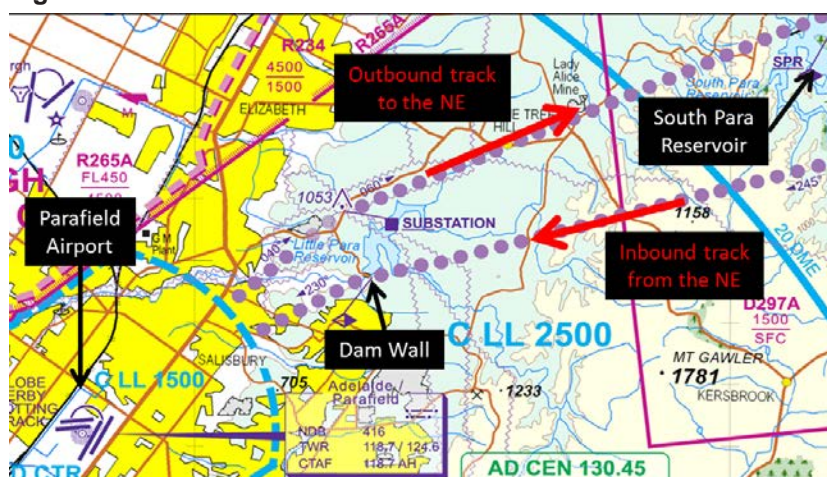
Figure 1: Inbound from the Dam Wall

On 1 September 2012, the flight instructor and student pilot of a Schweizer 269C-1 helicopter, registered VH-FTR (FTR), were conducting a training flight from Parafield, South Australia and return, via the ‘Dam Wall’, a visual flight rules (VFR) approach point (Figure 1).

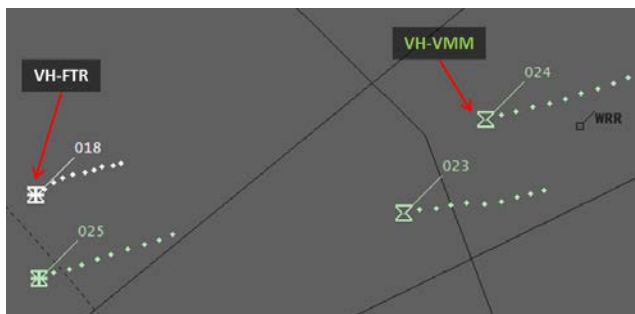
Figure 2: Aircraft positions at 1629:00

At about 1629 Central Standard Time¹, the instructor of FTR advised Adelaide Centre air traffic control (ATC) that he was south-west of the South Para Reservoir on descent to 1,500 ft, inbound for the Dam Wall. Adelaide Centre advised the instructor that there was an aircraft above and to the left at 2,500 ft inbound and two other aircraft 3 NM behind (Figure 2). The instructor became concerned with the aircraft behind as he could not sight them. The instructor also stated that, soon after, he received a traffic warning on the helicopter’s traffic warning system (TWS) for an aircraft 1 NM behind, at the same altitude.

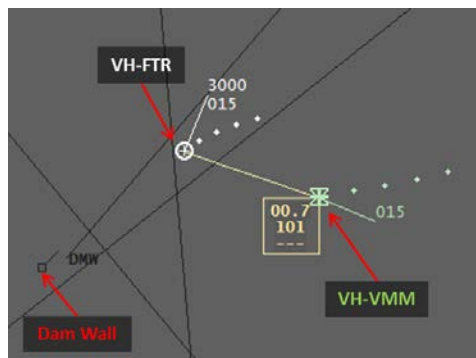
Figure 3: Aircraft positions at 1633:18

Time	VH-FTR	VH-VMM	Separation
1633:18	FTR was maintaining 1,500 ft.	<p>The pilot broadcast his inbound call to Parafield Tower, maintaining 1,500 ft, and received instructions to join downwind for runway 03 Right (R). He was advised of traffic in his 1 o'clock position at the same level. The pilot responded 'copy traffic'. Parafield Tower also advised that the aircraft's transponder had not yet been changed to the appropriate code (Figure 3).</p> <p>The pilot reported initially tracking for the base leg of the runway 21 Left circuit, but soon after, changed heading to track downwind for runway 03R.</p>	Lateral separation was 0.7 NM; vertical separation was 0 ft.
1633:31	As the instructor could not sight the traffic behind, he advised the student to descend to 1,400 ft.	VMM was maintaining 1,500 ft.	Lateral separation reduced to 0.5 NM (Figure 4); vertical separation was 100 ft.
1633:51	FTR was maintaining 1,400 ft.	VMM was observed descending through 1,400 ft.	Lateral separation reduced to 0.2 NM; vertical separation was 0 ft.

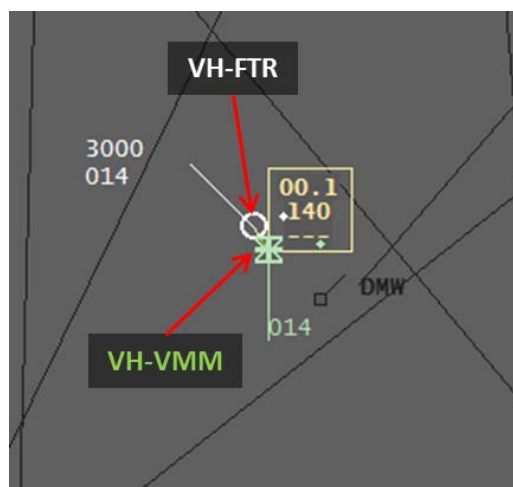
Figure 5: Aircraft positions at 1634:04

1633:56	The instructor advised Parafield Tower that FTR was the traffic passed on to VMM [1633:18].	VMM was observed maintaining 1,300 ft.	Lateral separation reduced to 0.1 NM; vertical separation was 100 ft.
1634:04	<p>Parafield Tower provided FTR with circuit joining instructions. FTR was maintaining 1,400 ft.</p> <p>The instructor and student observed VMM pass overhead.</p>	VMM was observed climbing through 1,400 ft.	Vertical separation was less than 50 ft (Figure 5).
1634:18	The instructor advised Parafield Tower of the incident.
