Hard landing involving Cessna P206B, VH-EGG

Monduran (ALA), Queensland, 29 August 2012

ATSB Transport Safety Report
Aviation Occurrence Investigation
AO-2012-135
Final

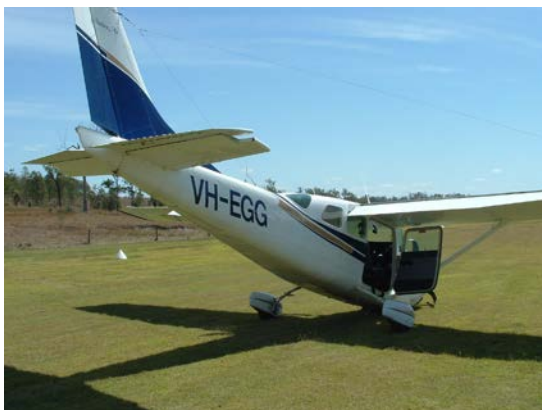
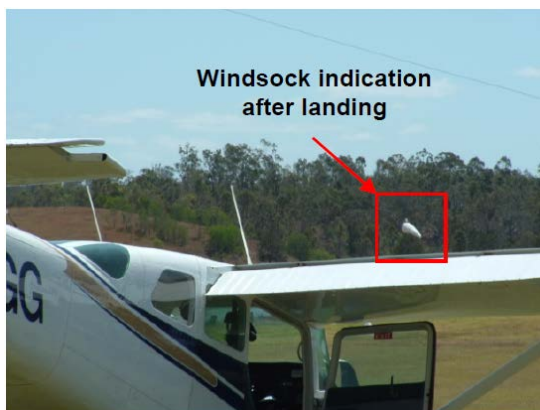
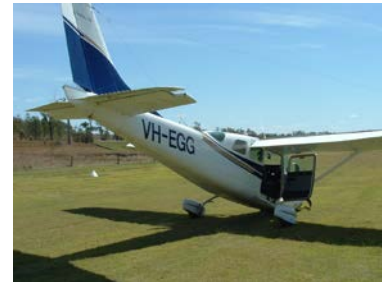
Figure 1: VH-EGG and windsock indication

During the landing, at about 10 ft above the runway, the flare¹ was commenced. Immediately after, a significant wind gust was experienced, resulting in a hard landing on the main landing gear. The aircraft bounced and the pilot applied a small amount of power in an attempt to regain control. A second wind gust of greater intensity then occurred. The aircraft stalled² and touched down hard, collapsing the nose landing gear. The pilot maintained directional control and the aircraft came to a stop.

The aircraft sustained damage to the propeller, nose landing gear and lower engine cowls (Figure 1).
