Loss of control and forced landing involving Bell 206B3 helicopter, VH-ZMN

18 km north-east of Perth Airport, Western Australia | 19 January 2013

ATSB Transport Safety Report
Aviation Occurrence Investigation
AO-2013-016
Final – 1 August 2013

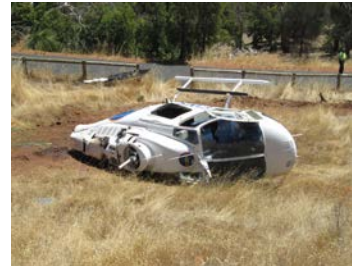
VH-ZMN fuselage

The pilot regained some control close to the ground, but assessed that the performance of the helicopter was insufficient to avoid a forced landing. In an area with a number of obstacles the pilot selected a clearing and managed the available energy to perform a low-impact landing. The slope was such that the helicopter immediately rolled over with the engine still operating, but importantly for occupant survivability did not catch fire. The pilot and camera operator sustained minor injuries while the helicopter was seriously damaged.

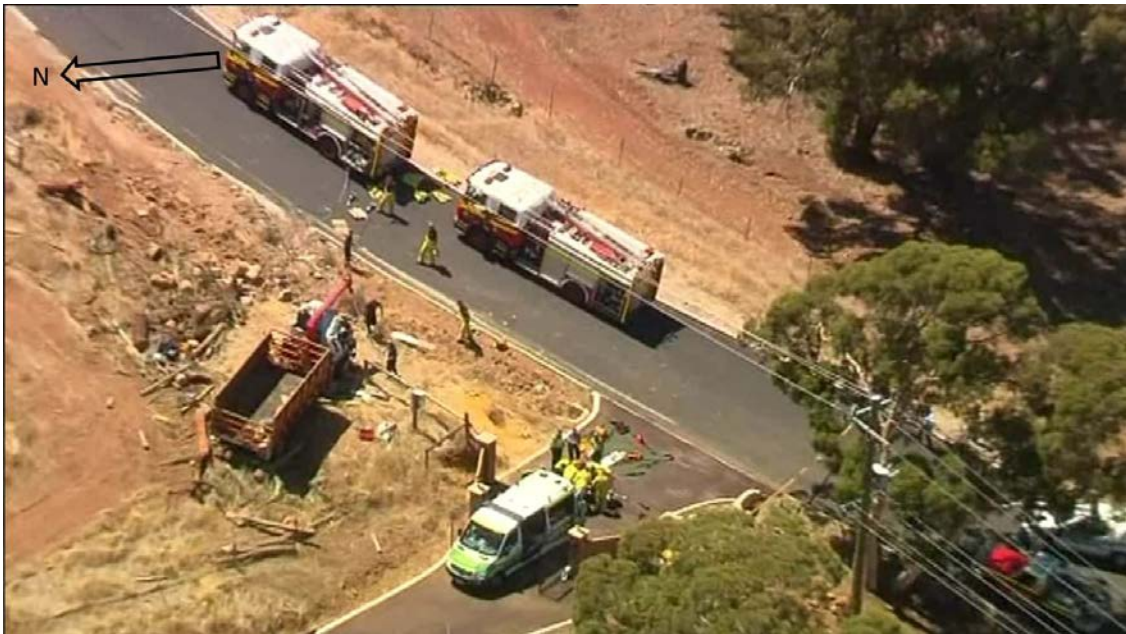
To facilitate filming the pilot established a generally into-wind hover at an altitude of about 1,000 ft above mean sea level (Figure 1), which in that area of the hilly terrain was about 700 ft above ground level (AGL). Air traffic control initially cleared the pilot to operate the helicopter in the vicinity not above an altitude of 1,500 ft, but later reduced this clearance limit to not above 1,000 ft.

Figure 1: View of the accident site recorded from the helicopter in the hover

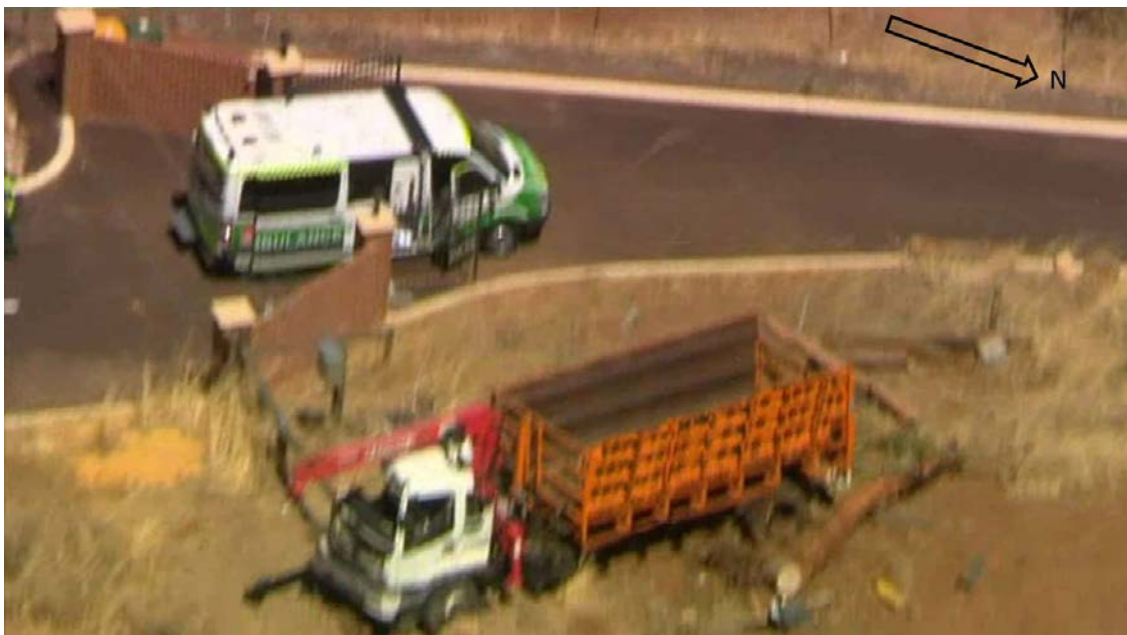
The pilot initiated a right turn and, based on the recorded GPS data, the helicopter had reached somewhere between 20 and 30 kt airspeed at 500 ft AGL when the nose of the helicopter moved abruptly to the left (Figure 2). The pilot responded firmly with right pedal to correct at which point the helicopter suddenly and rapidly yawed to the right.

Figure 2: View of the accident site recorded from the helicopter immediately before the rapid right rotation (Note: camera zoom distorts the apparent height)

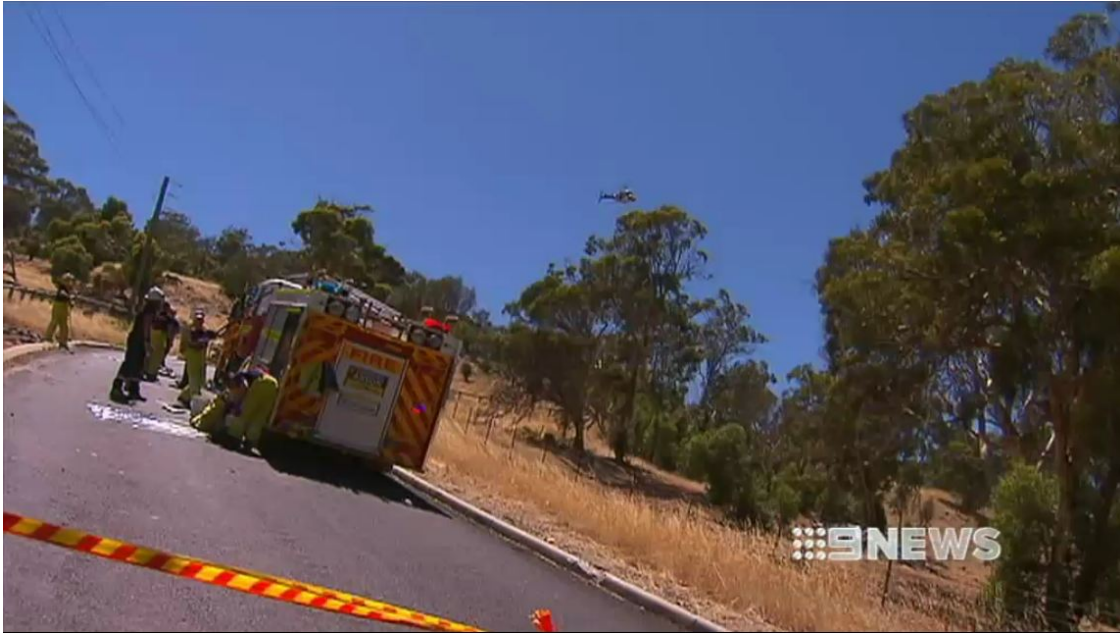
The pilot regained some control close to the ground (Figure 3), but assessed that the performance of the helicopter was insufficient to avoid a forced landing. In an area with a number of obstacles the pilot selected a clearing and managed the available energy to perform a low-impact landing in the vicinity of the truck rollover. The slope was such that the helicopter immediately rolled over (Figures 4 and 5) with the engine still operating, but importantly for occupant survivability did not catch fire. The pilot and camera operator sustained minor injuries while the helicopter was seriously damaged.

Figure 3: View from the vicinity of the truck accident, showing the helicopter after the pilot had regained some control and immediately before the forced landing

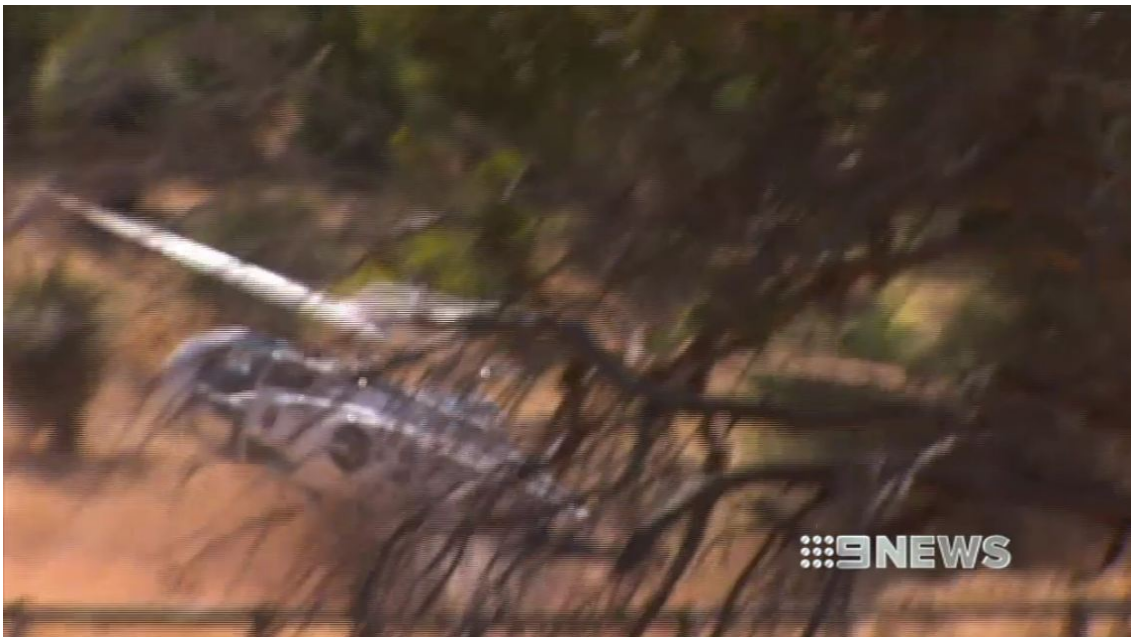
Figure 4: Helicopter rolling left after touchdown showing main rotor separation

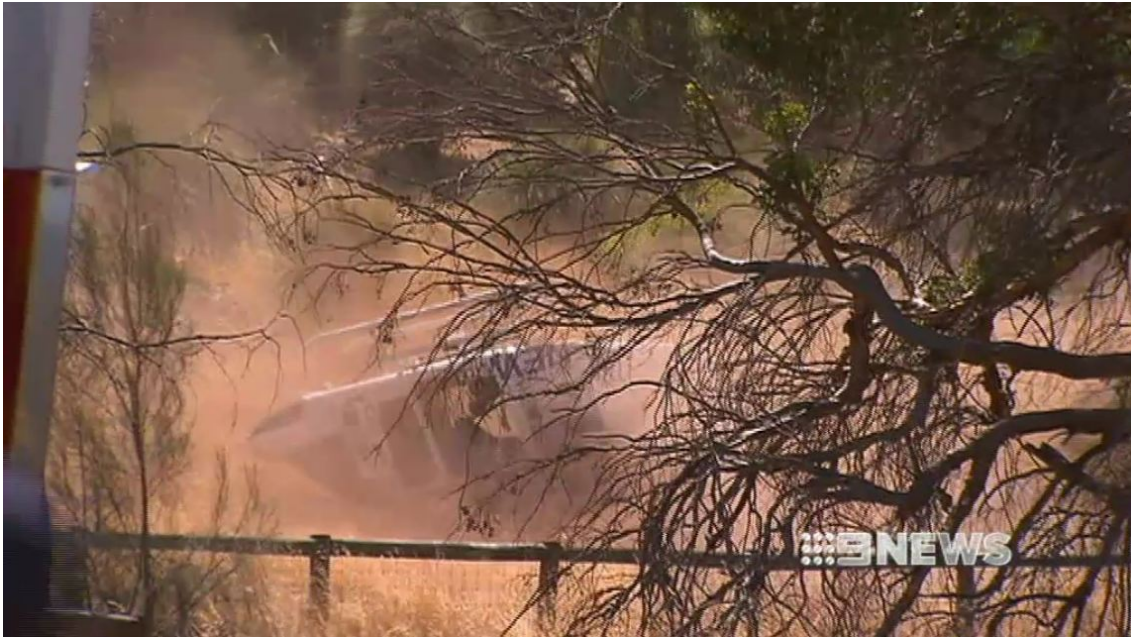
Figure 5: Helicopter inverted before coming to rest on its right side

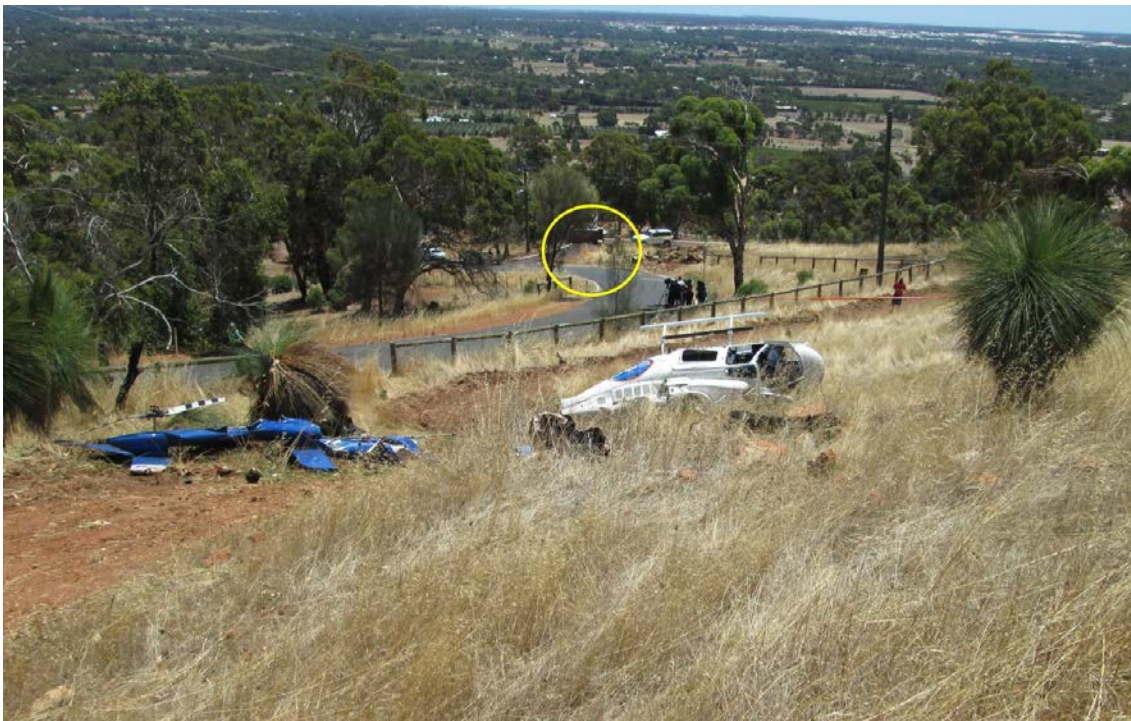
The crew exited the helicopter with minor injuries and were attended by the emergency services already at the scene. Although the helicopter was seriously damaged (Figure 6), the engine continued to run for a short time, before being shut down by the pilot.

Figure 6: Bell 206 accident site looking west with the truck accident site circled

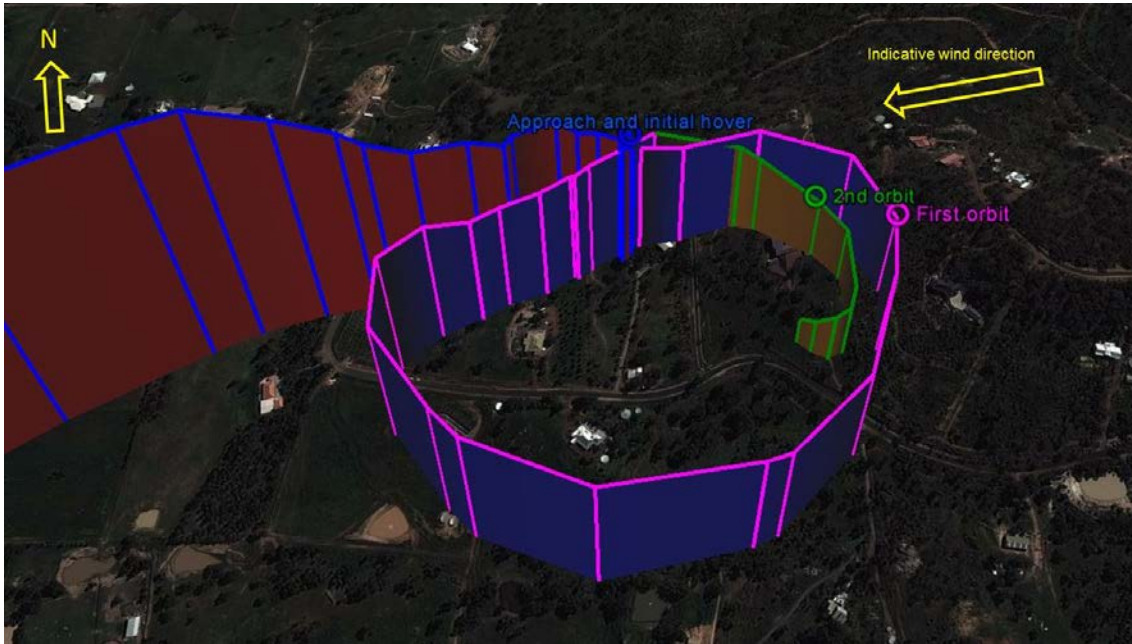
Figure 7: GPS data representing the helicopter's track and height in vicinity of the accident site

By applying a steady easterly wind of 15 kt to all of the recorded global positioning system groundspeeds and tracks, the ATSB estimated airspeeds of 26 and then 28 kt at the likely point of entry to the second orbit. In contrast, the estimated airspeeds at the comparable part of the first orbit were 38 and then 43 kt. Changing the wind direction value in the calculations to be from the east-north-east did not have a significant effect on these figures. Acknowledging that the actual winds would have been variable, the airspeeds on entry into the second orbit were comparatively 10 kt lower than those in the first.

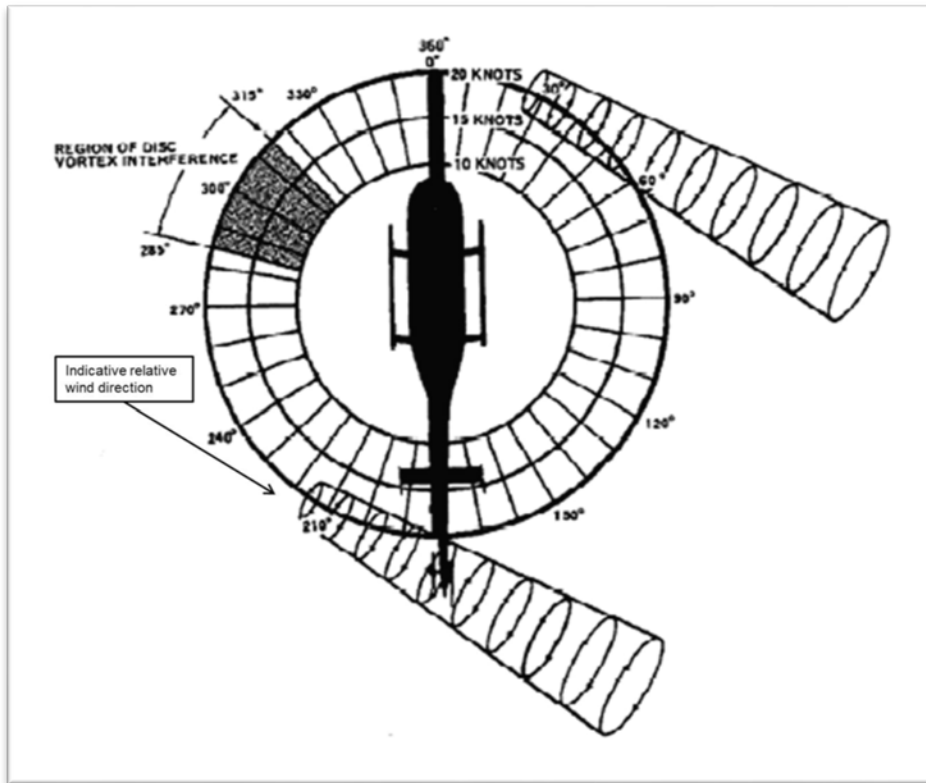
It is likely that as the pilot manoeuvred the helicopter into the right turn, exposing it to a left quartering crosswind of at least 10 to 15 kt, some of the main rotor vortices disturbing the airflow were blown into the tail rotor to increase thrust momentarily and generate the left yaw experienced by the pilot (Figure 8). As the pilot corrected with right pedal, the main rotor vortices probably passed through the tail rotor with the effect of immediately reducing tail rotor thrust and accelerating the right yaw. This reversal of yaw surprised the pilot and developed into a number of rotations.

Figure 8: Main rotor disc vortex interference
