Aircraft proximity event between two Cessna 172s, VH-EOE and VH-LWX

Moorabbin Airport, Victoria, 19 March 2013

ATSB Transport Safety Report
Aviation Occurrence Investigation
AO-2013-053
Final – 17 September 2013

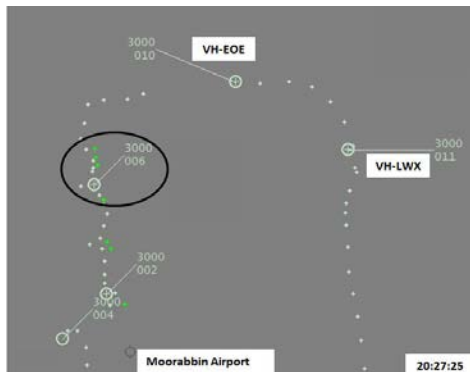
Figure 1

As LWX approached the position where the pilot normally turned from downwind onto base, the pilot looked to the left and identified what he thought were the flashing lights of the aircraft he had been instructed to follow (Figure 1). The flashing lights were below the horizon against a background of lights from the surrounding Melbourne suburbs. The turn brought LWX onto a base leg inside that of EOE (Figures 2 and 3).

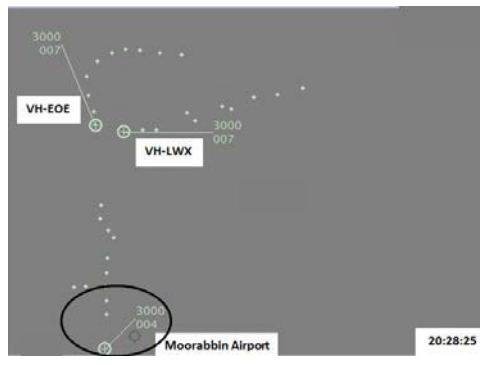
Figure 4

Approaching the position where he was to turn onto final approach (Figure 4), the pilot of LWX looked to the right, to check for aircraft on final further away from the airport, then looked left and again misidentified the aircraft he had been instructed to follow.

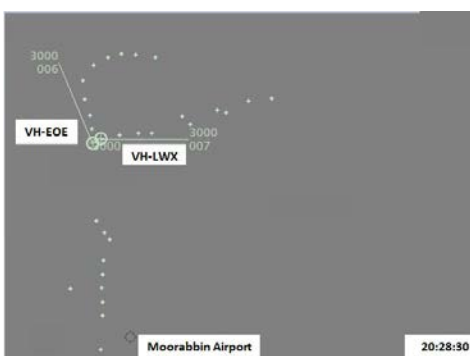
Figure 5

At about 2028, as the pilot of LWX levelled out on final (Figure 5), ATC queried whether he still had the aircraft he had been instructed to follow in sight. Before he could answer, the instructor pilot of EOE transmitted he was descending as ‘...they’re passing right over the top of us’. After acknowledging EOE, ATC instructed the pilot of LWX to go-around⁶ (Figure 6).
