Collision with terrain involving Robinson R44 helicopter, VH-HWQ

Bulli Tops, New South Wales, | 21 March 2013

ATSB Transport Safety Report
Aviation Occurrence Investigation
AO-2013-055
Preliminary - 5 April 2013

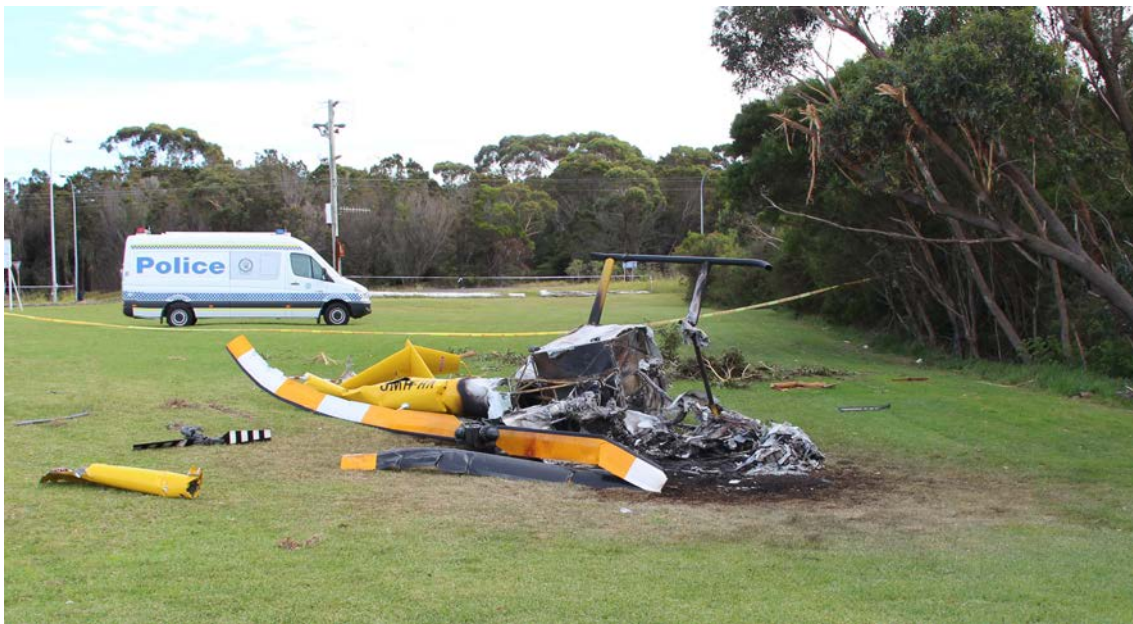
At about 1207 Eastern Daylight-saving Time¹, the pilot was manoeuvring at a grassed area at Bulli Tops. Witnesses reported that the R44 had approached the grassed area from the south-east and touched down facing in a north-westerly direction. Shortly after landing, the witnesses observed the helicopter lifting off and then turning to the right through 180°. As the helicopter faced a north-easterly direction, the main rotor struck branches of a nearby tree on the northern edge of the grassed area (Figure 1).

The helicopter was then observed to descend onto the grass and roll over onto its right side. Soon after, a fire started on the grass under the rotor mast and the cabin. A number of witnesses attempted to extinguish the fire and remove the occupants, but were unsuccessful due to the intensity of the fire. The pilot and three passengers were fatally injured and the helicopter was destroyed.

Figure 1: Wreckage with the broken tree branches in the background

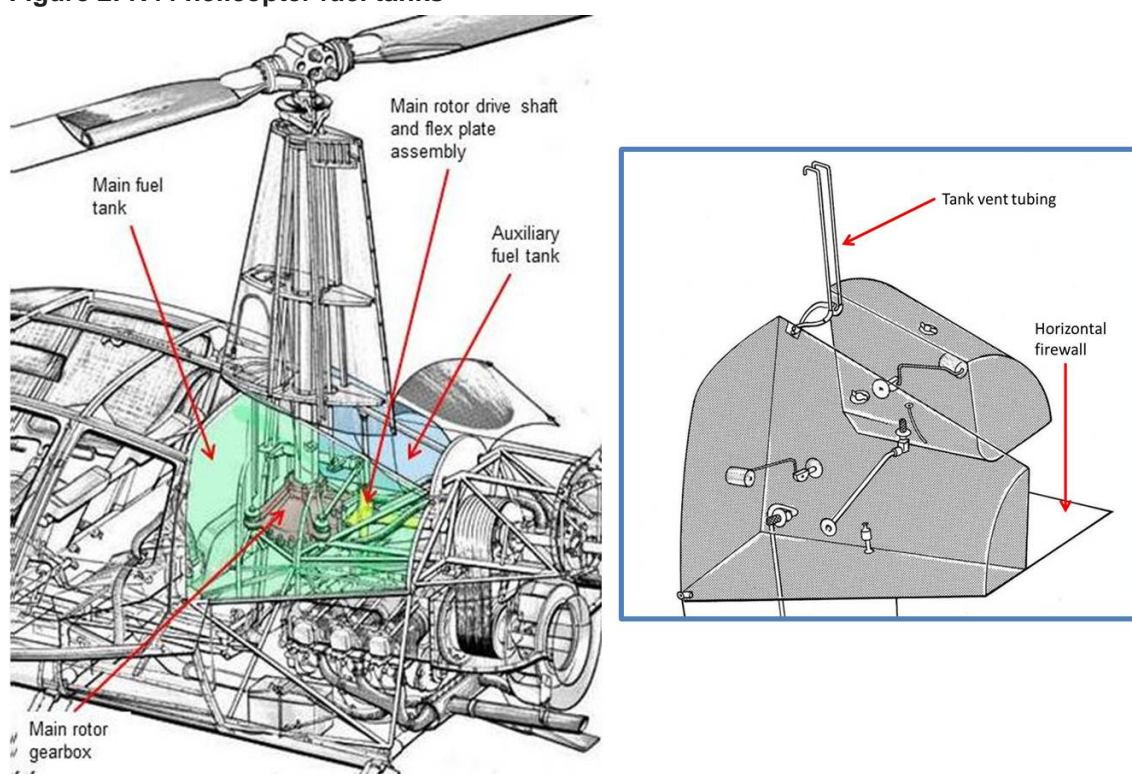
The R44 was originally manufactured with two all-aluminium fuel tanks that were installed above the engine firewall, either side of the main transmission (Figure 2).

The maintenance provider for VH-HWQ advised that helicopter manufacturer's Service Bulletin SB-78B, to replace the all-aluminium fuel tanks with bladder tanks, had been planned to be conducted prior to the due date of 30 April 2013. The rotor brake switch had been replaced on 17 April 2012 in accordance with Service Bulletin SB-82 (see below), which reduced the risk of the switch as a possible ignition source in the event of a fuel leak. Further details of these bulletins are provided below.

Figure 2: R44 helicopter fuel tanks

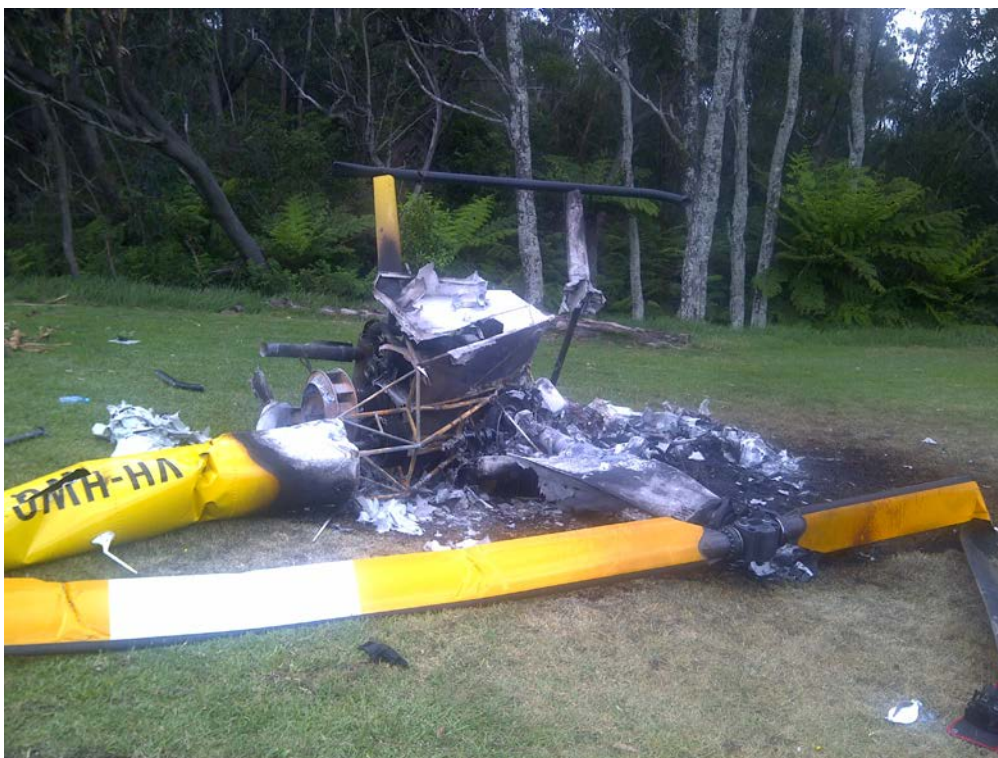
All of the helicopter's major components were identified at the accident site, and the wreckage was located across a relatively small area (Figure 3).

The wreckage was resting on its right side and orientated facing to the east on a heading of 103° M. There was evidence of two main rotor strikes on the tail boom and the boom was severed during the accident sequence. A large section of tail rotor drive shaft was located approximately 15 m to the south-west of the main wreckage. Both main rotor blades were still attached to the main rotor head with both blades displaying rearward and upward bending.

Examination showed that the main rotor impact caused the main rotor mast and gearbox assembly to move, breaching one or both fuel tanks. That provided the fuel source for the post-impact, fuel-fed fire. Due to the extent of the post-impact fire, identification of the ignition source was not possible. The intense fire destroyed the cabin area.

Overall, the physical evidence was consistent with the witness evidence and indicated a very low-energy impact. Preliminary assessment of the wreckage identified no pre-existing defects associated with the helicopter.

Figure 3: Main wreckage
