Aircraft proximity event between a Piper PA-28, VH-TXH and a Cessna 172S, VH-EWX

Moorabbin Airport, Victoria, 22 March 2013

ATSB Transport Safety Report
Aviation Occurrence Investigation
AO-2013-059
Final – 17 September 2013

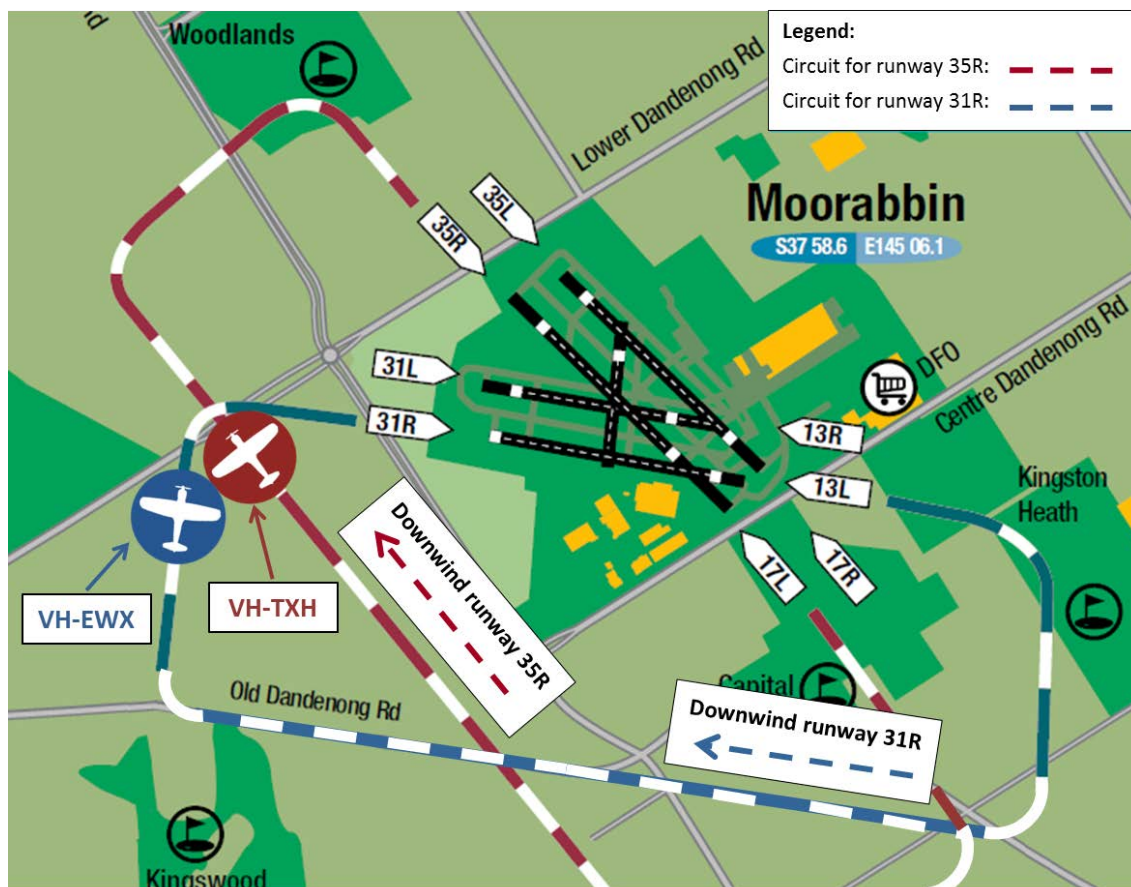
As EWX approached base, at about 1626, the pilot became aware of TXH in his 2 o'clock³ position, tracking contrary to the runway 31R circuit pattern (Figure 1). TXH was observed to pass under the nose of EWX, about 100 to 150 m in front and about 50 ft below. To avoid the other aircraft and to keep it in sight, the pilot of EWX turned to track behind and subsequently follow TXH. As the pilot executed this manoeuvre, Moorabbin Tower broadcast a safety alert.

The pilot believed he may have inadvertently aligned his circuit with the runway 35 direction and that, when he turned base he had already crossed the centreline for runway 31R and 31L. He stated he could not conduct a 'go around' as he was well past the position from where such a manoeuvre could be commenced. The pilot reported seeing no traffic at the base position or subsequently.

Figure 1: Approximate positions of VH-TXH and VH-EWX in relation to circuit directions
