# Weather related precautionary landing involving a Piper PA-28, VH-MSG

20 km NE of Hamilton, Victoria, 13 April 2013

**ATSB Transport Safety Report**  
Aviation Occurrence Investigation  
AO-2013-071  
Final – 28 June 2013

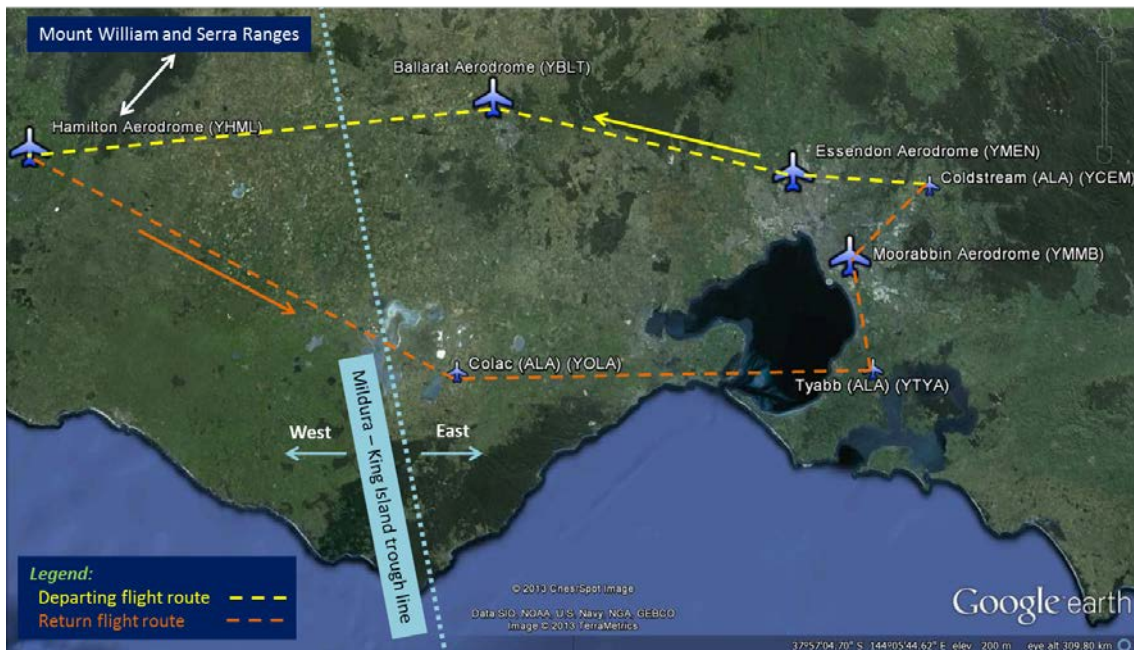
Figure 1: Planned flight route

On 13 April 2013, a student pilot of a Piper PA-28 aircraft, registered VH-MSG, was preparing for a navigation training flight from Coldstream, Victoria and return, operating under the visual flight rules (VFR). The planned flight route was from Coldstream to Essendon, Ballarat, Hamilton and return via Colac, Tyabb and Moorabbin (Figure 1).

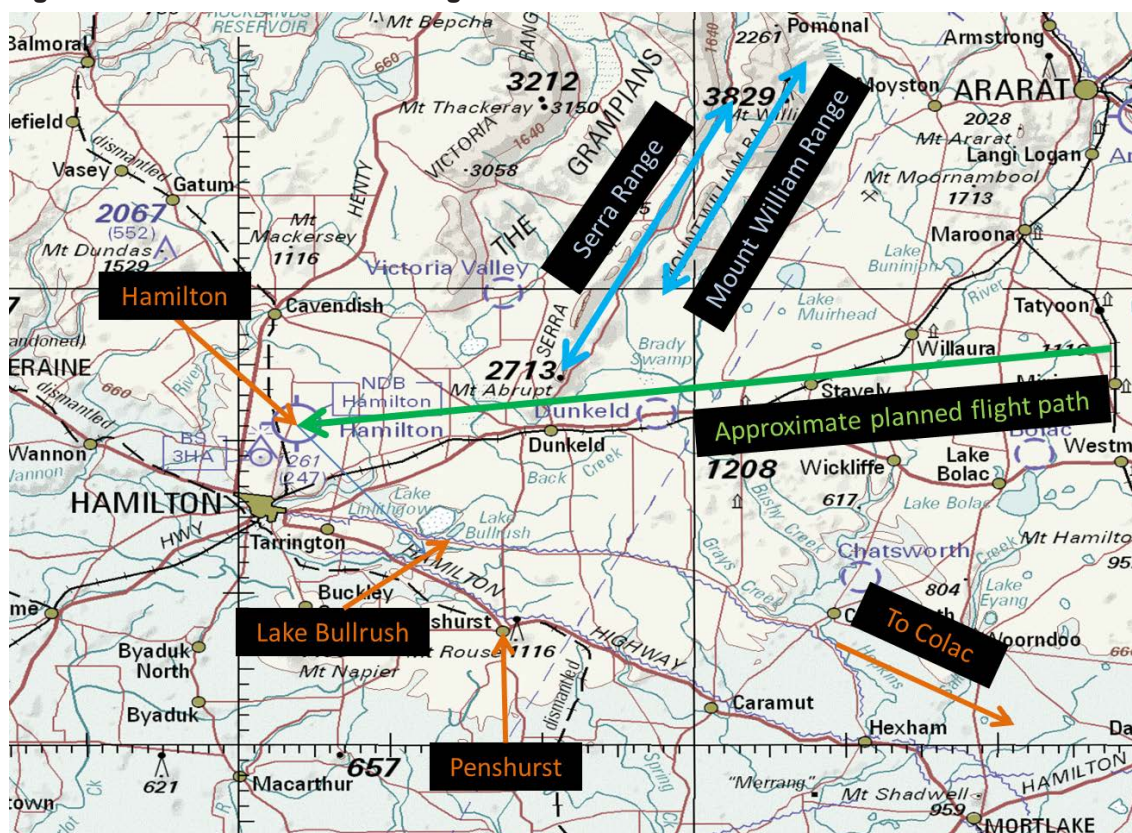
**Figure 2: Hamilton and surrounding area**

towards Penshurst, with the intent of tracking to Hamilton from the south-east (Figure 2). At about the same time, the pilot commenced a descent.

Overhead Lake Bullrush, the pilot was confronted with a ‘wall of cloud’. The pilot determined that he would not be able to land at Hamilton and commenced tracking for Colac. Shortly after, he received a call on the CTAF from persons on the ground (ground personnel)<sup>2</sup> at Hamilton aerodrome. The pilot informed them that he was diverting to Colac.

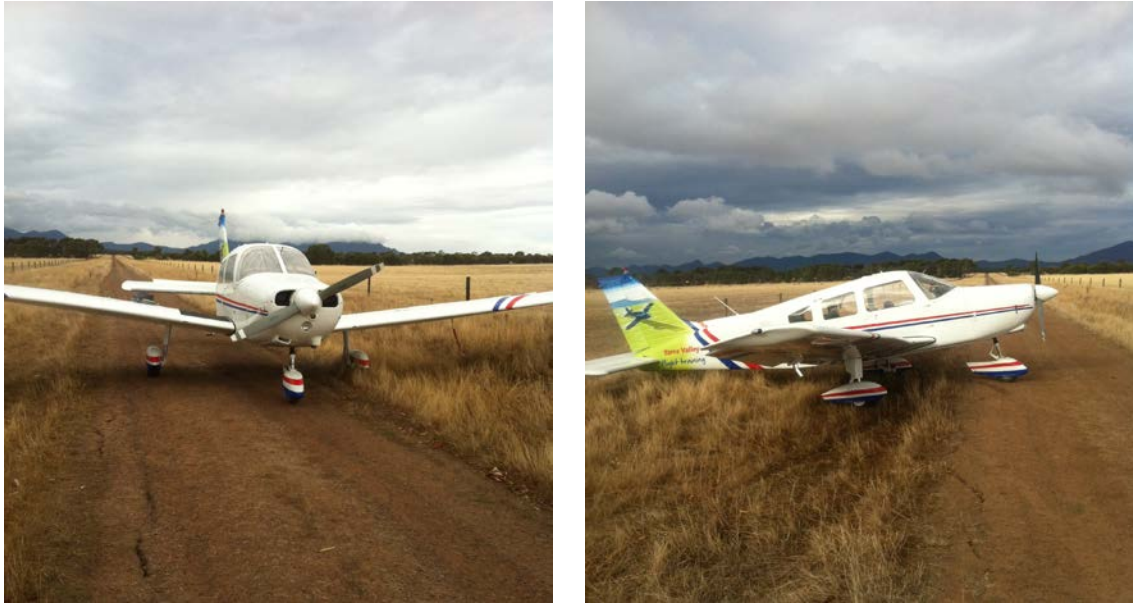
**Figure 3: VH-MSG after landing (left) and moved off the road shortly after (right)**

The ground personnel continued talking to the pilot on the radio, which became a distraction. He turned the radio off so he could focus on the landing. Soon after, at about 1430, the aircraft landed on the road (Figure 3).

The pilot reported that the actual headwinds experienced on the flight were stronger than that forecast, which resulted in a reduced ground speed and increased flight time. He estimated that his actual arrival time at Hamilton was 1 hour or more after his planned arrival time. It was likely that the forecast trough was passing through the area at that time.

As a result of this occurrence, the aircraft operator has advised the ATSB that they are considering incorporating into their operations manual, minimum weather criteria for student pilots conducting solo navigation flights. These criteria would exceed the visual meteorological conditions (VMC) minima and the VFR alternate aerodrome requirements stipulated in the Aeronautical Information Publication (AIP)<sup>6</sup>, and also include a minimum time buffer on forecast changes to non-VMC.

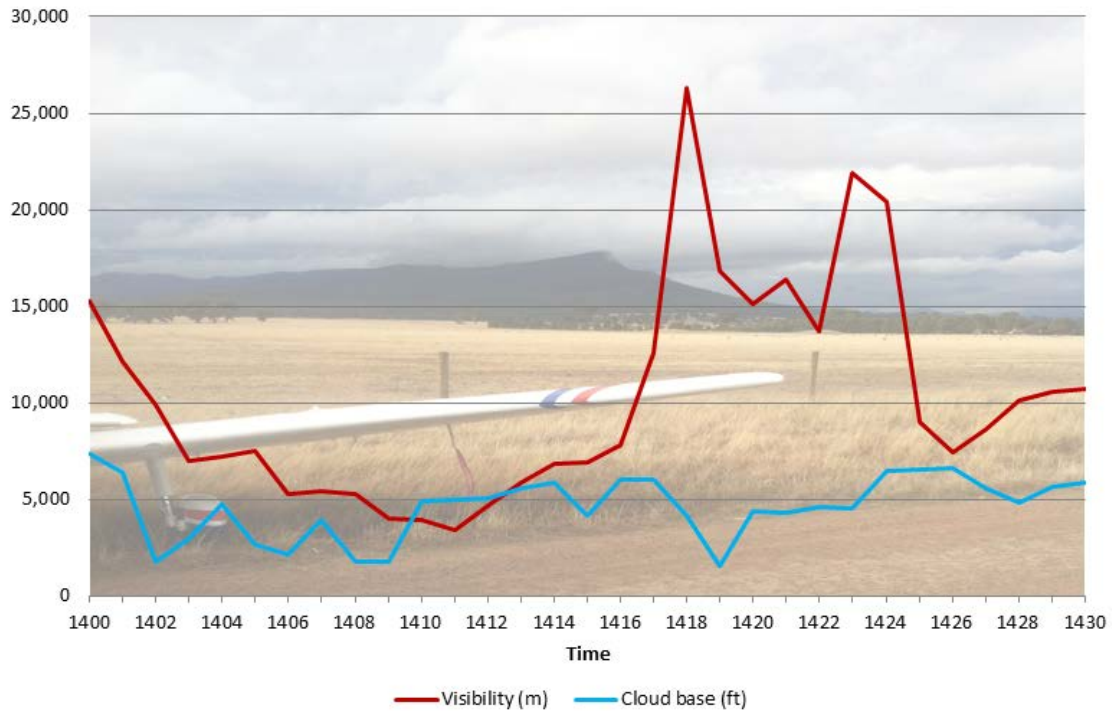
**Figure 4: Bureau of Meteorology one-minute data**

- At 1406: indicated that the wind was 280° (True) at 18 kt gusting to 31 kt; visibility was greater than 10 km, scattered cloud at 2,200 ft, broken cloud at 3,300 ft, and overcast cloud at 7,700 ft.
- At 1412: indicated that the wind was 280° (True) at 20 kt gusting to 31 kt; visibility was 5,000 m, scattered cloud at 1,800 ft, broken cloud at 3,500 ft, and overcast cloud at 5,100 ft.
- At 1429: indicated that the wind was 300° (True) at 19 kt, visibility was greater than 10 km, scattered cloud at 1,700 ft, broken cloud at 4,400 ft, and overcast cloud at 6,000 ft.

The BoM also provided the ATSB with one-minute interval data recorded by the AWS. A graphical depiction of the visibility (m) and cloud base (ft) between 1400 and 1430 is shown in Figure 4.
