Power loss involving Robinson R44, VH-ZON

11 km NNE of Arkaroola (ALA), South Australia, 15 July 2013

ATSB Transport Safety Report
Aviation Occurrence Investigation
AO-2013-118
Final – 31 October 2013

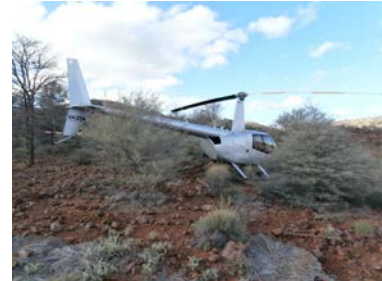
VH-ZON at accident site

The pilot focussed on conducting the autorotation and landing, and ignored the repeated calls from base to check on the situation. The helicopter touched down on the rocky ridge and sustained substantial damage. After landing, the pilot noted the engine was not running, he shut the helicopter down and then checked on his passengers. The passengers did not sustain any injury.

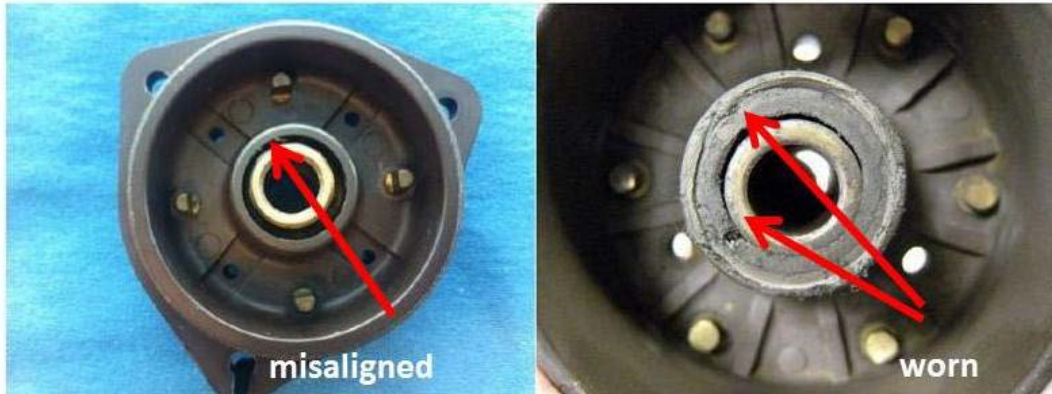
Figure 2: Two examples of unserviceable distributor blocks

- The left magneto had been replaced twice since December 2012. The distributor block had been overhauled 32.1 hours prior to the accident.
- A detailed inspection of the magnetos found the right magneto was operating normally, but the left magneto had failed. The left magneto distributor block bearing had excessive movement beyond normal tolerances. This movement had allowed the timing gear to disengage and re-engage during operation, resulting in the significant alteration of the magneto timing. The incorrect timing may have opposed the operation of the right magneto, which could have resulted in an engine stall.

The Civil Aviation Safety Authority (CASA) is aware of the existing problem with Teledyne Continental Motors and Champion Aerospace (Slick) magnetos. A search of the CASA Service Difficulty Report (SDR) database over the 24 months to June 2013 revealed nearly 45 per cent of ignition failures were attributed to magneto failures. On 24 July 2013, CASA issued Airworthiness Bulletin (AWB) No: 74-005, page 4 & 5, paragraph 3.3 – *Distributor Block Bearing Failures*. This AWB highlights many magneto related issues and indicates that despite close inspection of new distributor blocks, there is no way to determine if they will prove to be reliable. The AWB notes that this is currently the matter of an active on-going investigation in conjunction with manufacturers. Further reading is available at: www.casa.gov.au/wcmswr/_assets/main/airworth/awb/74/005.pdf
