In-flight breakup involving PZL Mielec M18A Dromader, VH-TZJ

37 km west of Ulladulla, New South Wales, 24 October 2013

ATSB Transport Safety Report
Aviation Occurrence Investigation
AO-2013-187
Interim – 23 December 2013

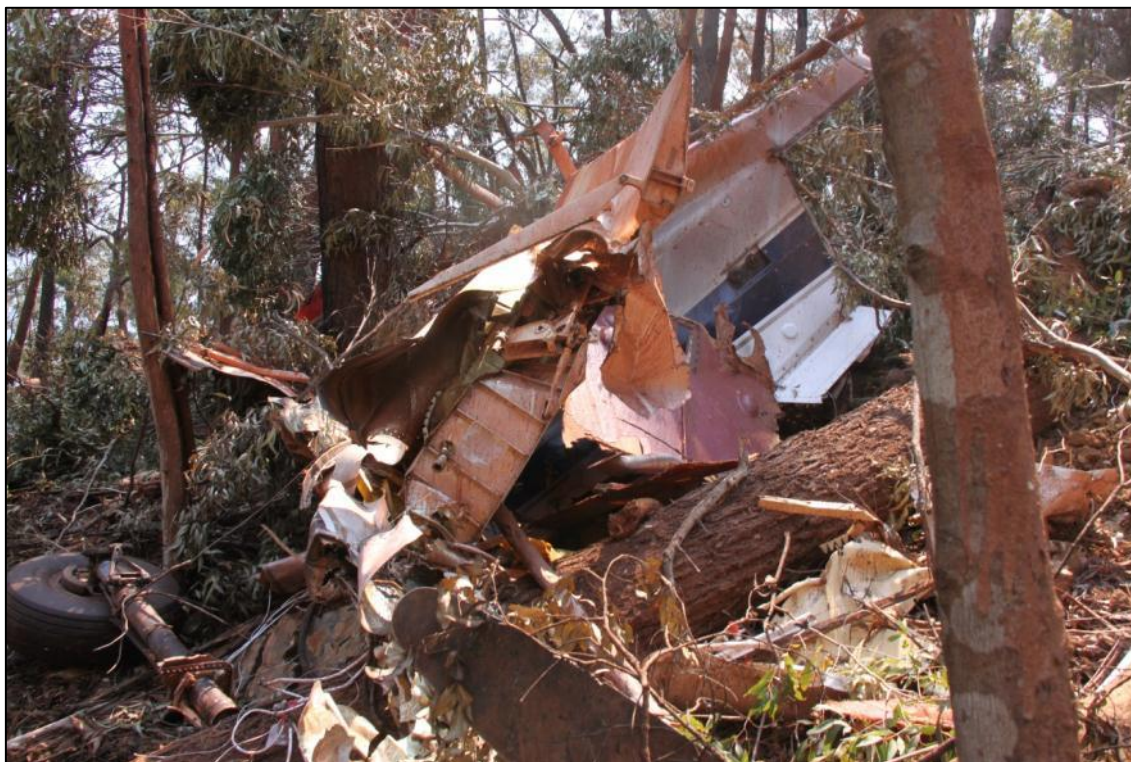
Figure 3: Main wreckage

The helicopter crew later reported that TZJ made a broad, descending left turn onto an approximate north-north-westerly heading, flying along the ridgeline at about 100 ft above the trees and directly towards the target (Figure 2). At about the same time as or immediately after the aircraft's wings were rolled level, the left wing separated. The aircraft immediately rolled left and descended, impacting terrain. The accident occurred at about 1004. The aircraft was destroyed by impact forces and some parts of the wreckage were additionally damaged by small post-impact fires (Figure 3). The pilot was fatally injured.

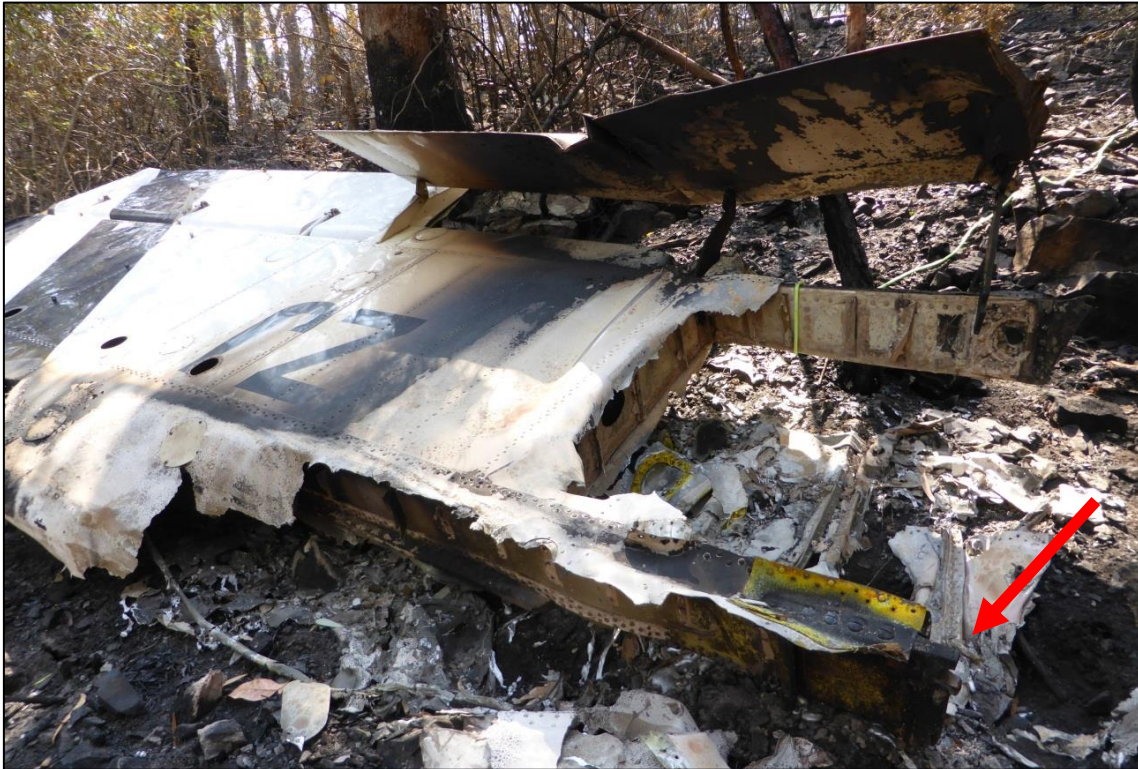
Figure 6: Outboard left wing (underside of wing visible, lower attach fitting arrowed)

The on-site examination found that the left wing had separated at the attachment joint between the outboard wing and centre wing sections, about 6 m from the wingtip (Figure 6). Preliminary examination of the attach fittings indicated that the left outboard wing lower attachment lug had fractured through an area of pre-existing fatigue cracking in the lug lower ligament (Figure 7 and Figure 8). The fatigue cracking reduced the structural integrity of the fitting to the point where operational loads produced an overstress fracture of the remaining lug material. The detached section of lug was retained by the centre wing lugs and showed a matching fracture surface (Figure 8).

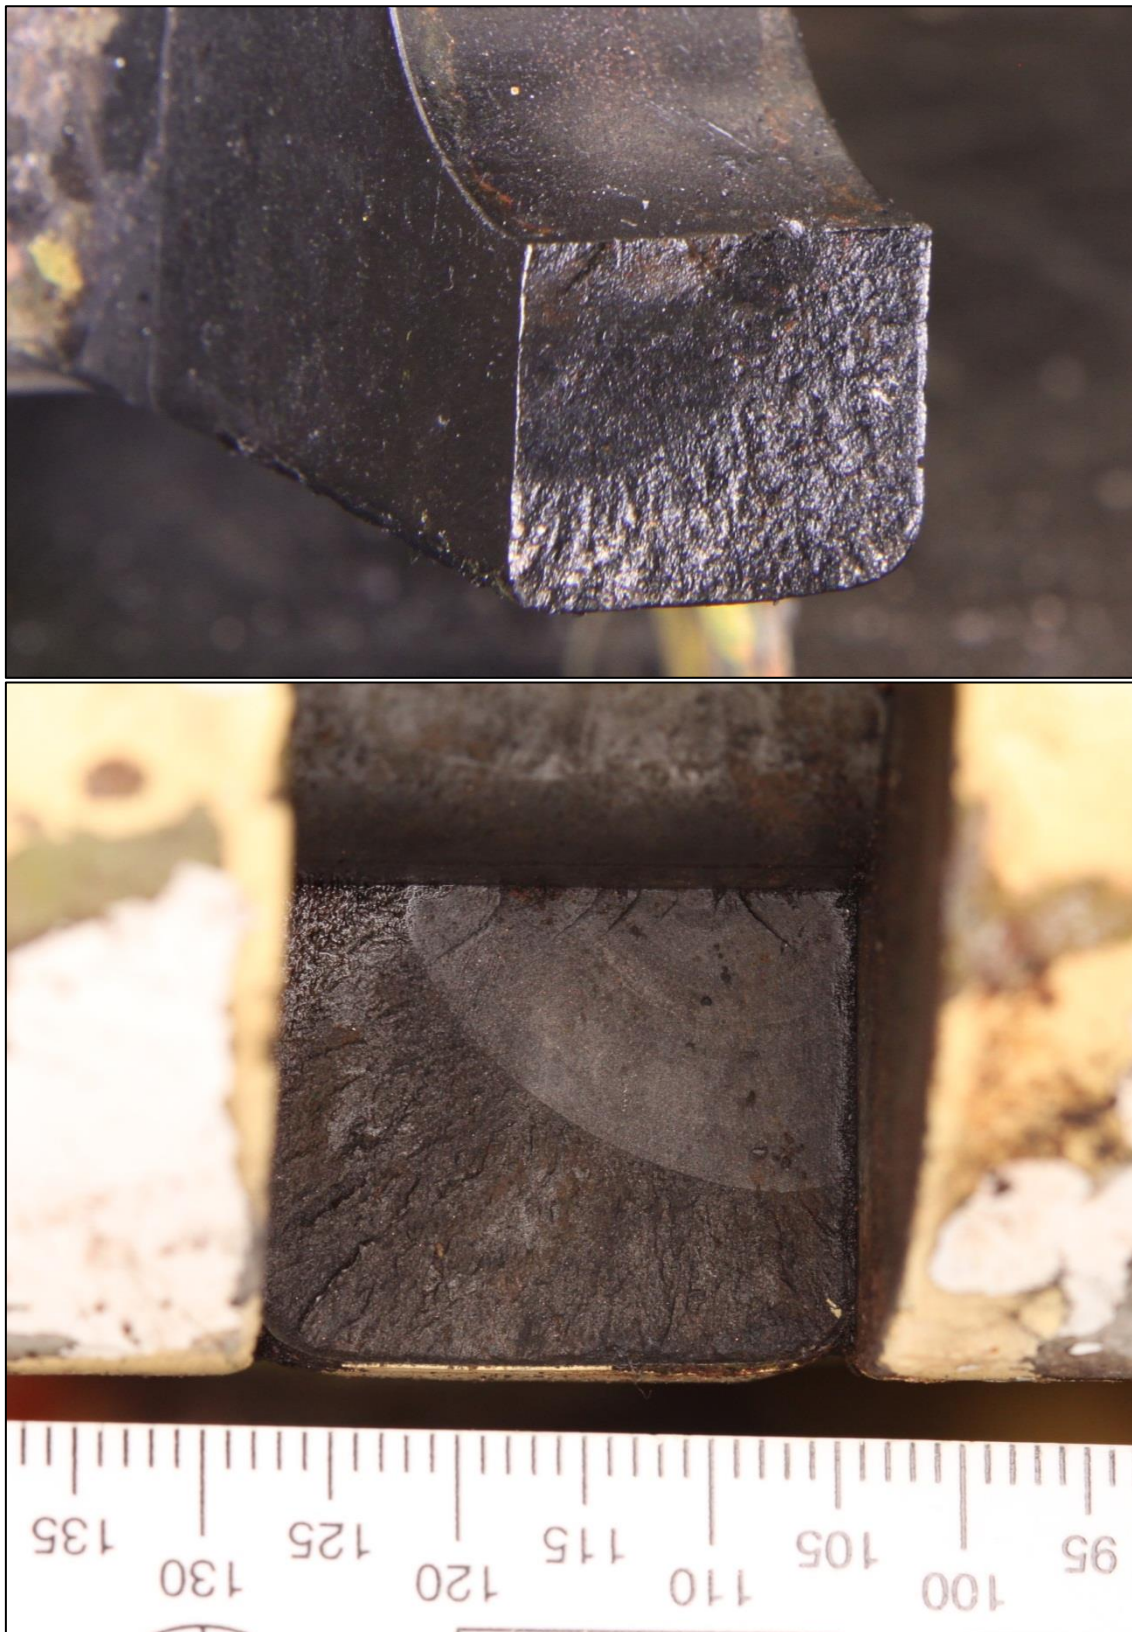
Preliminary examination indicated that the left outboard wing lower attachment lug had fractured through an area of pre-existing fatigue cracking in the lug lower ligament.

Figure 8: Mating fracture surfaces of left lower main spar attachment lug. Main (outboard) part above, detached (inboard) part below.
