In-flight breakup involving PZL Mielec M18A Dromader VH-TZJ

37 km west of Ulladulla, NSW | 24 October 2013

ATSB Transport Safety Report
Aviation Occurrence Investigation
AO-2013-187
Preliminary – 2 December 2013

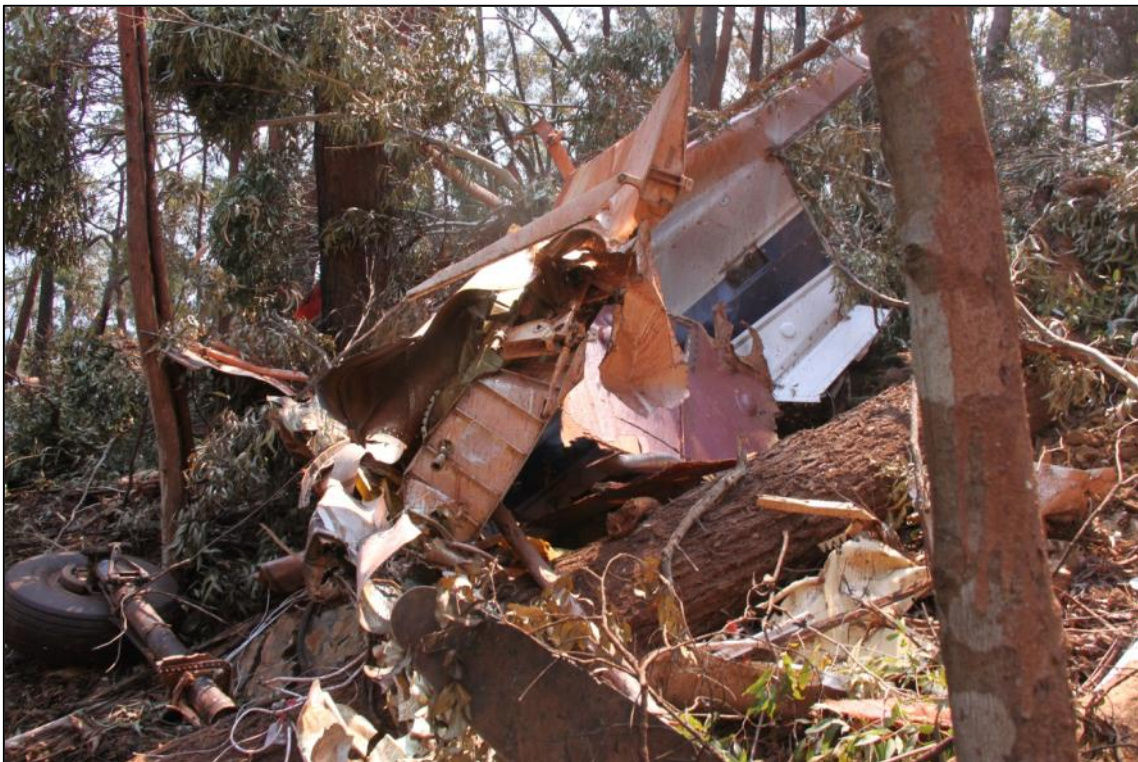
Figure 3: Main wreckage

The helicopter crew later reported that TZJ made a broad, descending left turn onto an approximate north-north-westerly heading, flying along the ridgeline at about 100 ft above the trees and directly towards the target (Figure 2). At about the same time as or immediately after the aircraft's wings were rolled level, the left wing separated. The aircraft immediately rolled left and descended, impacting terrain. The accident occurred at about 1004. The aircraft was destroyed by impact forces and some parts of the wreckage were additionally damaged by small post-impact fires (Figure 3). The pilot was fatally injured.

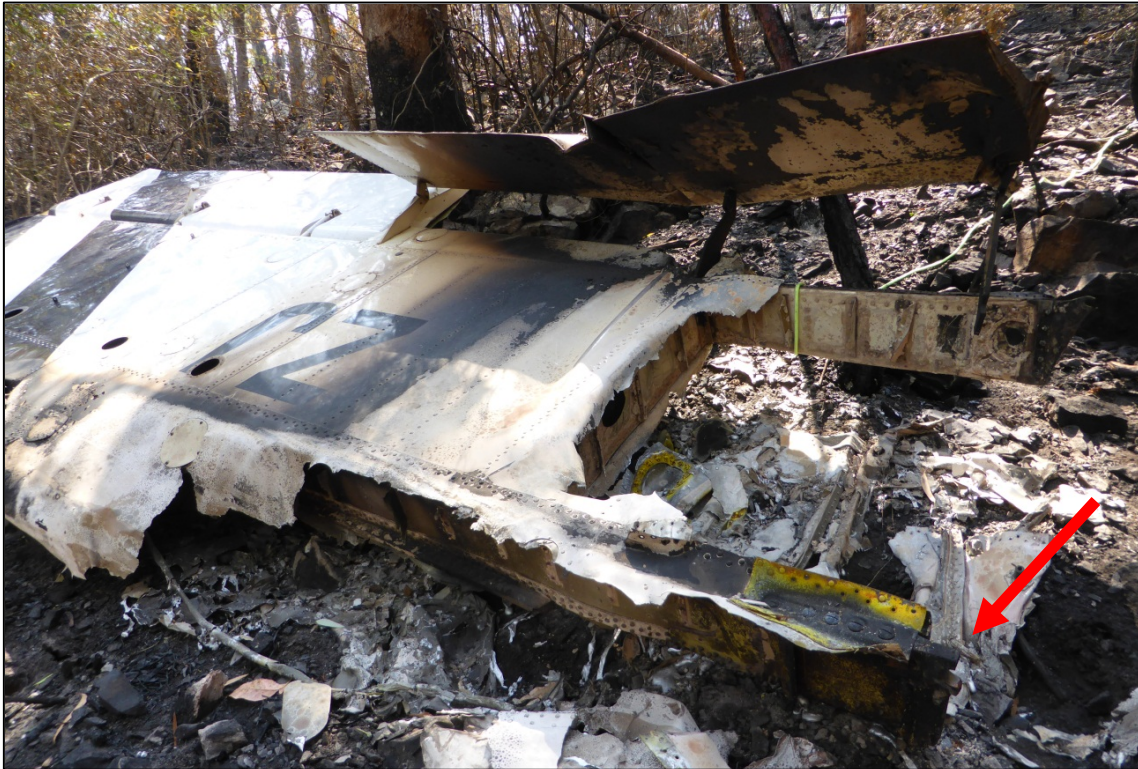
The on-site examination found that the left wing had separated at the attachment joint between the outboard wing and centre wing sections, about 6 m from the wingtip (Figure 6). Preliminary examination of the attach fittings indicated that the left outboard wing lower attachment lug had fractured through an area of pre-existing fatigue cracking in the lug lower ligament (Figure 7 and Figure 8). The fatigue cracking reduced the structural integrity of the fitting to the point where operational loads produced an overstress fracture of the remaining lug material. The detached section of lug was retained by the centre wing lugs and showed a matching fracture surface (Figure 8).

Figure 6: Outboard left wing (underside of wing visible, lower attach fitting arrowed)

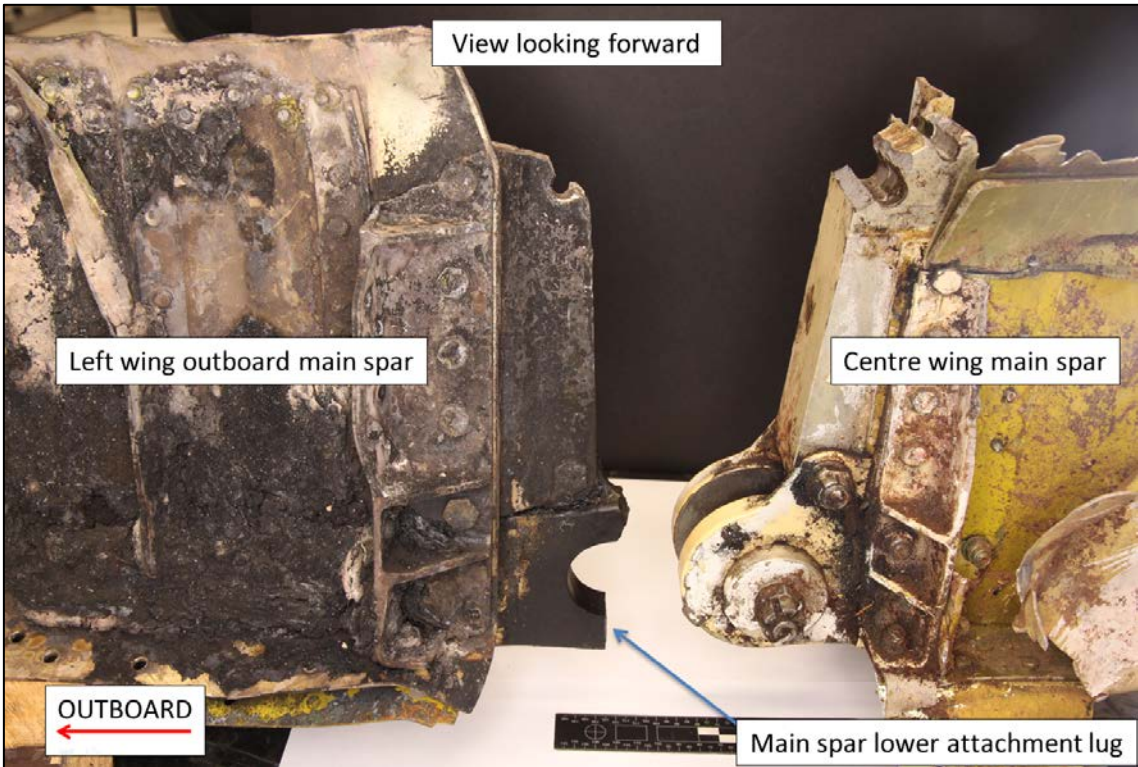
Figure 7: Lower main spar attach fitting

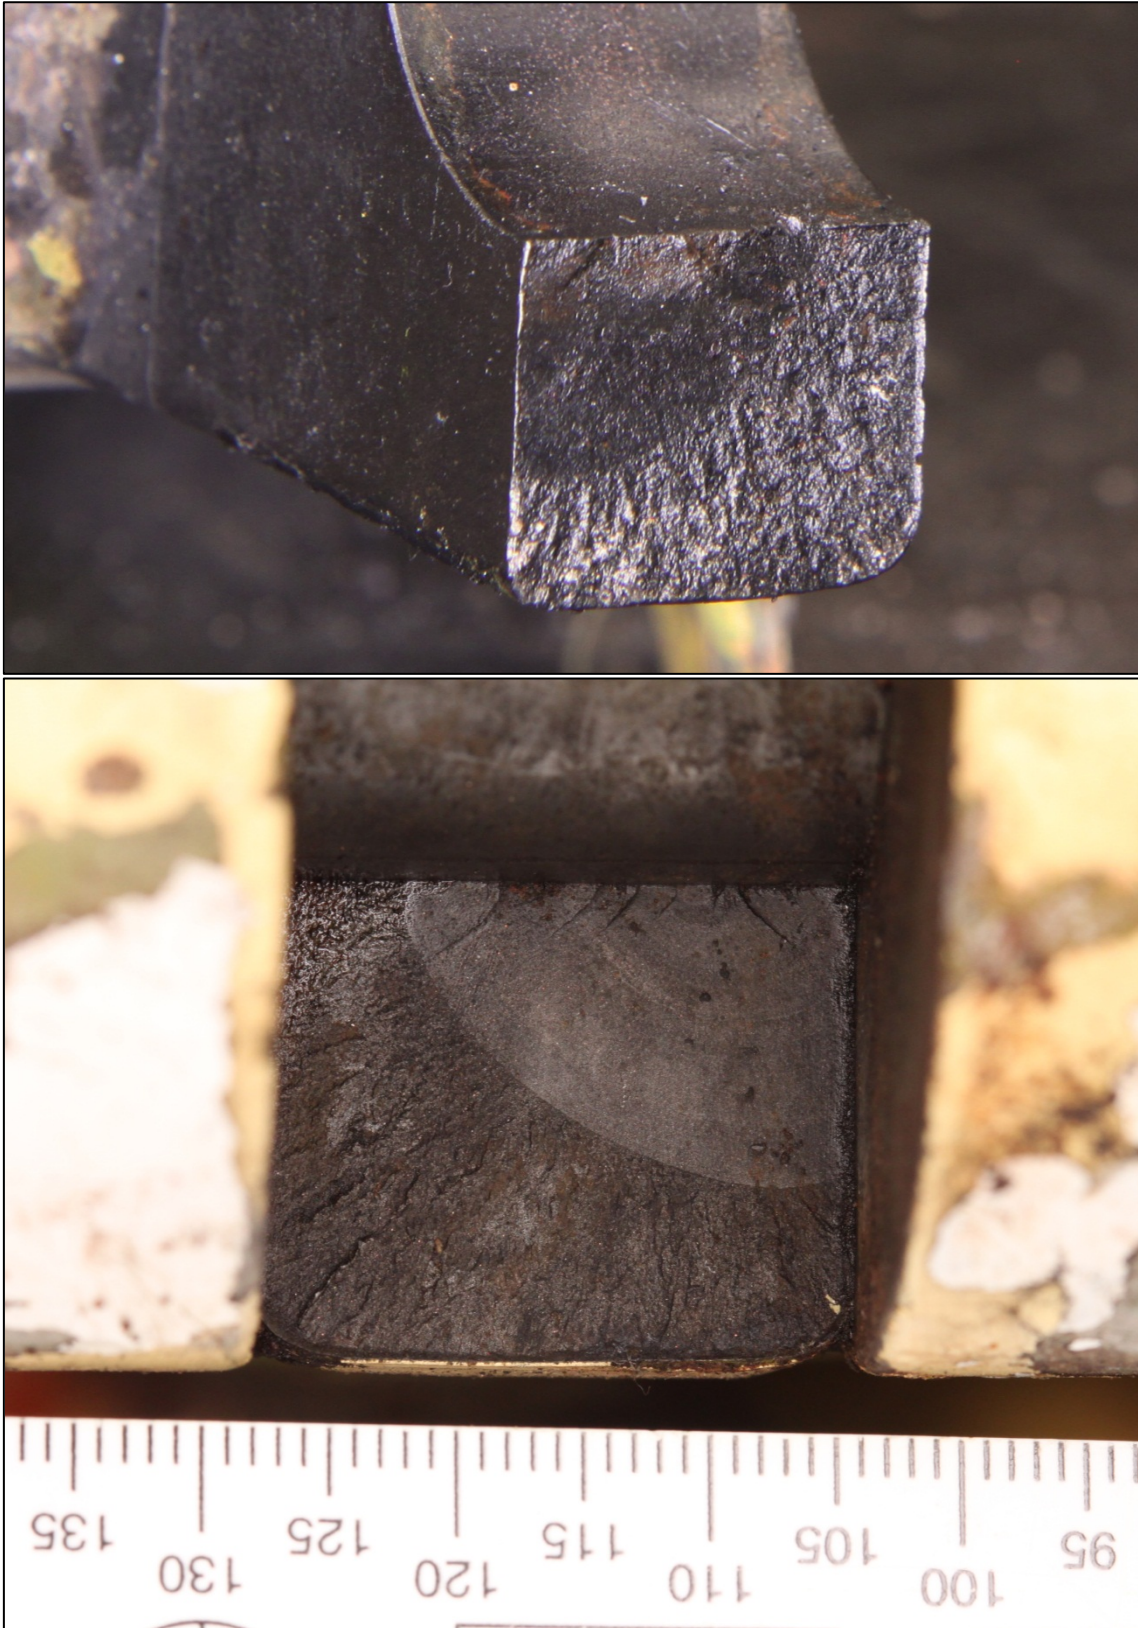
Figure 8: Mating fracture surfaces of left lower main spar attachment lug. Main (outboard) part above, detached (inboard) part below.

On 15 November 2013, CASA issued an amendment to AD/PZL/5, revoking the approval for the eddy-current procedure for conducting the wing joint inspections. It also added a 100-hourly visual inspection, and additional wing-off inspections every 2,500 hours. CASA also issued a direction to the registered operators of M18 aircraft in Australia that the aircraft could be flown once the amended AD was complied with.
