Collision with terrain involving a Grumman G-164A, VH-CCF

18 km N of Deniliquin aerodrome, New South Wales, 31 December 2013

ATSB Transport Safety Report
Aviation Occurrence Investigation
AO-2014-001
Final – 19 March 2014

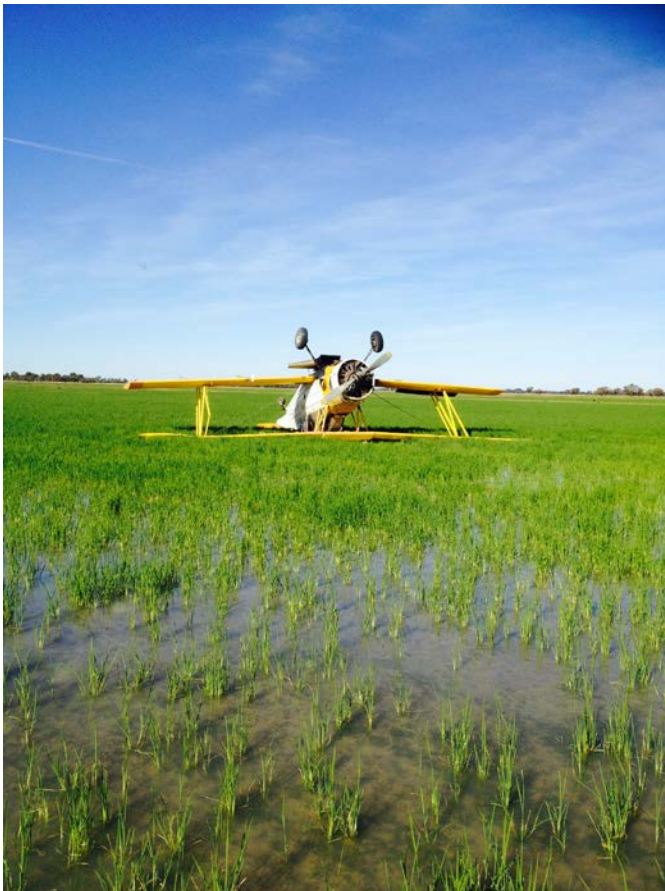
Figure 1: Damage to VH-CCF

When at about 20-30 ft AGL, with a nose high attitude, the pilot felt the aircraft's wings shaking, indicating an imminent stall.² The pilot increased engine power in an attempt to avert the stall, but the aircraft continued to descend. Shortly after, the wheels touched down in a rice paddy in about 20 cm of water and the aircraft flipped over (Figure 1). The aircraft was substantially damaged. The pilot was uninjured.

- Normally when the load was jettisoned, the aircraft ballooned and the pilot then lowered the nose to regain airspeed. On this day the aircraft continued to sink.
- The aircraft was loaded with about 450 kg of fertilizer; well below the maximum operating weight for the conditions.
- The wind was a light and gusty southerly. The pilot would normally turn the aircraft into wind after the initial climb, but as there were trees to the south of the airstrip, the pilot elected to turn downwind towards a clear area. It was possible that the aircraft may have encountered a downdraft.
