Collision with terrain involving Van's RV-6A, VH-JON

8 km south of Moorabbin Airport, Victoria | 14 October 2014

ATSB Transport Safety Report
Aviation Occurrence Investigation
AO-2014-164
Final – 25 November 2016

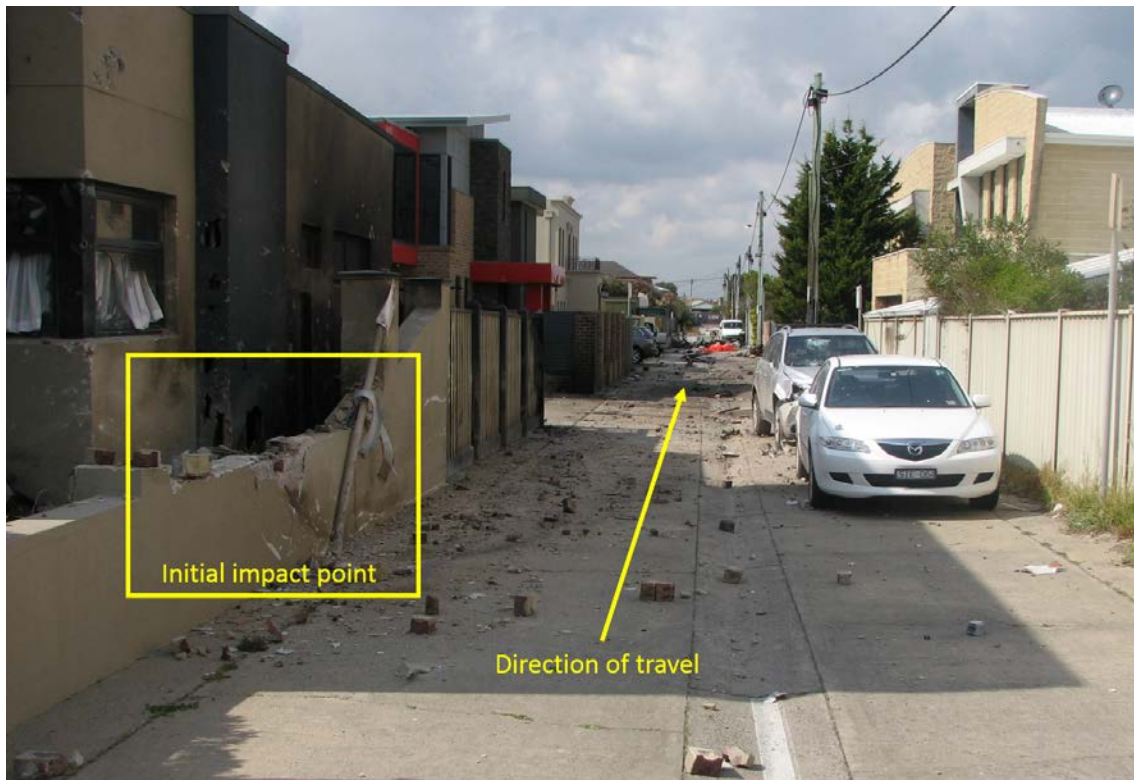
The pilot was fatally injured and the aircraft was destroyed. A number of small post-impact fires were extinguished and a number of houses and cars sustained damage.

Figure 1: Accident site from the initial impact point on the left, looking south down the laneway

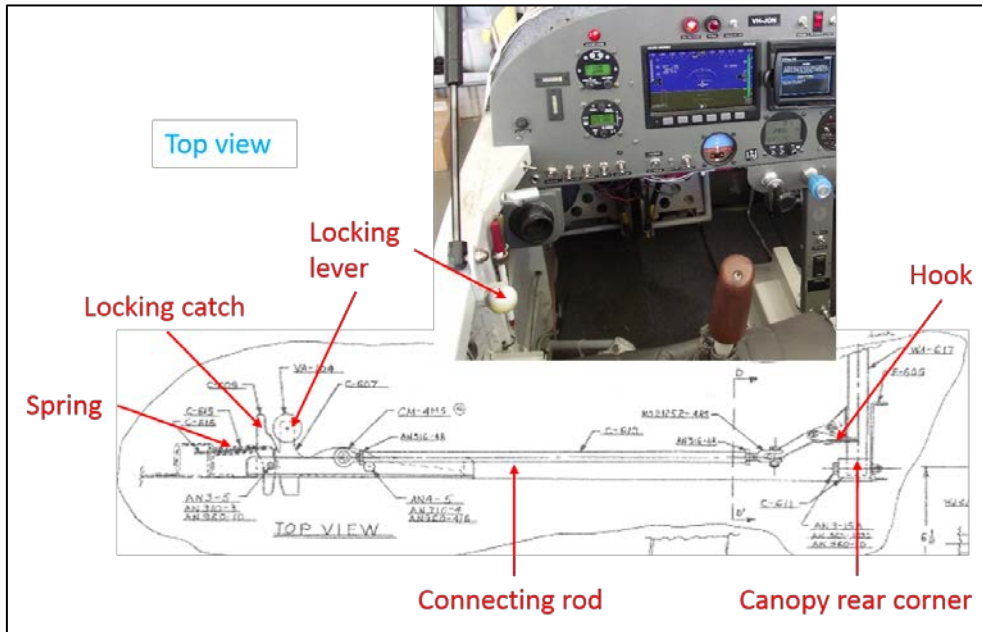
Although the Van's RV-6 could be installed with aft- and forward-hinged canopies, JON was fitted with a forward-hinged 'tip-up' canopy (Figure 2), which had two locking mechanisms. The primary locking mechanism was operated by a locking lever located on the left side of the fuselage, adjacent to the pilot's seat. When placed into the locked position, a connecting rod from the lever latched two hooks into corresponding receptacles in the two rear corners of the canopy. The lever was then locked by a spring-loaded locking catch (Figure 3 and Figure 4).

Figure 3: Van's Aircraft Inc. diagram showing the primary canopy locking mechanism from the top view in the locked position (labelled in red). The locking lever in JON is shown in the photograph at inset

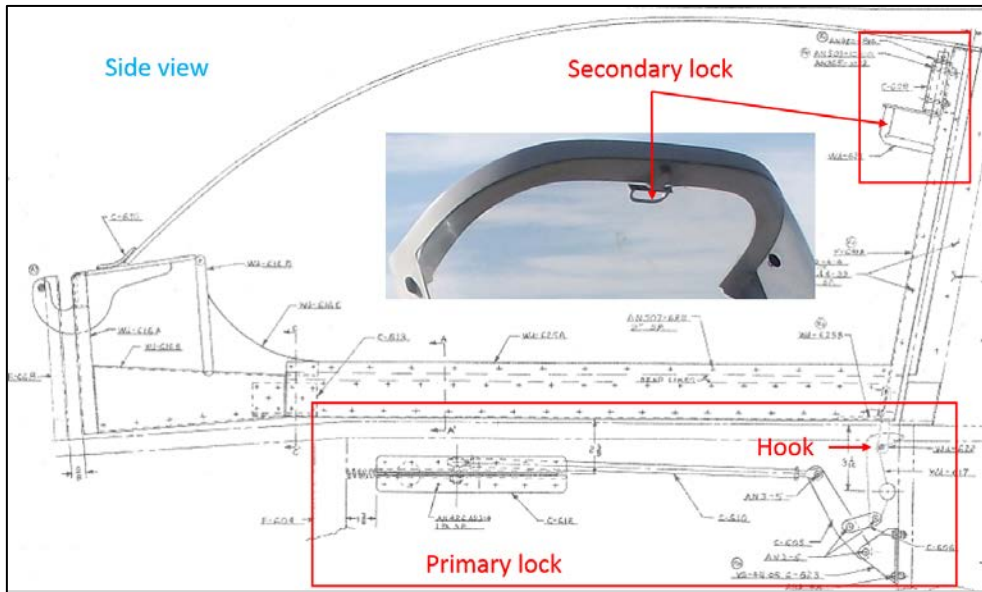
The secondary mechanism was a handle attached to the centre of the canopy frame, which was also used to assist with closing (Figure 4). Once closed, the handle was turned 90° so that a tang on the end of the handle extended under the adjacent fuselage frame. This provided redundancy in the event the main locking mechanism malfunctioned.

Figure 4: Van’s Aircraft Inc. diagram from the side view showing the primary and secondary locking mechanisms. The secondary lock attached to JON is shown in the photograph at inset

The secondary lock was found in the unlocked position and showed no signs of damage. However, as this lock is readily moved by turning the associated handle, it could not be discounted that it moved on impact. Also, it was possible that the lock was initially closed prior to take-off and worked its way open during the flight.

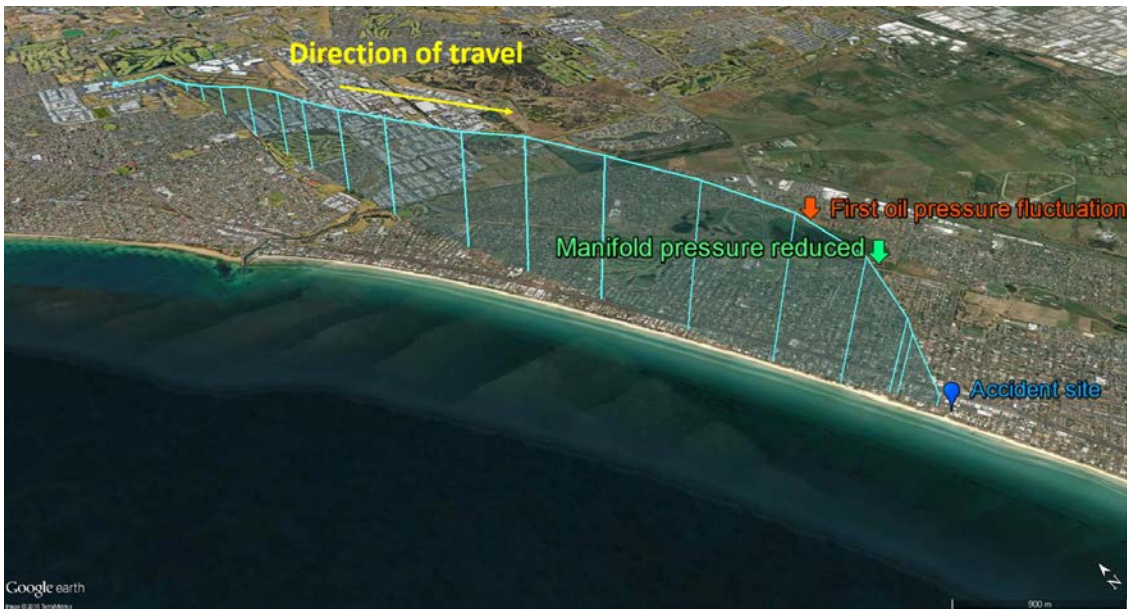
- Up until 1325:52, the engine data appeared stable and the oil pressure remained normal at around 75 pound per square inch (psi). After this, the pressure fluctuated to as low as 34 psi (Figure 5). By the last second of the recorded data, the pressure increased to 72 psi. The fluctuations likely resulted from a sudden change in aircraft attitude temporarily disrupting the oil supply in the oil sump.

- At 1326:00, the engine manifold pressure was recorded as 26.625 inches Hg. After this, it reduced to as low as 4.6875 inches Hg. This coincided with a reduction in fuel pressure and was representative of the pilot reducing the engine power to idle (Figure 5).

Figure 5: Downloaded GPS track, and the position of the first oil pressure fluctuation and reduction in engine manifold pressure

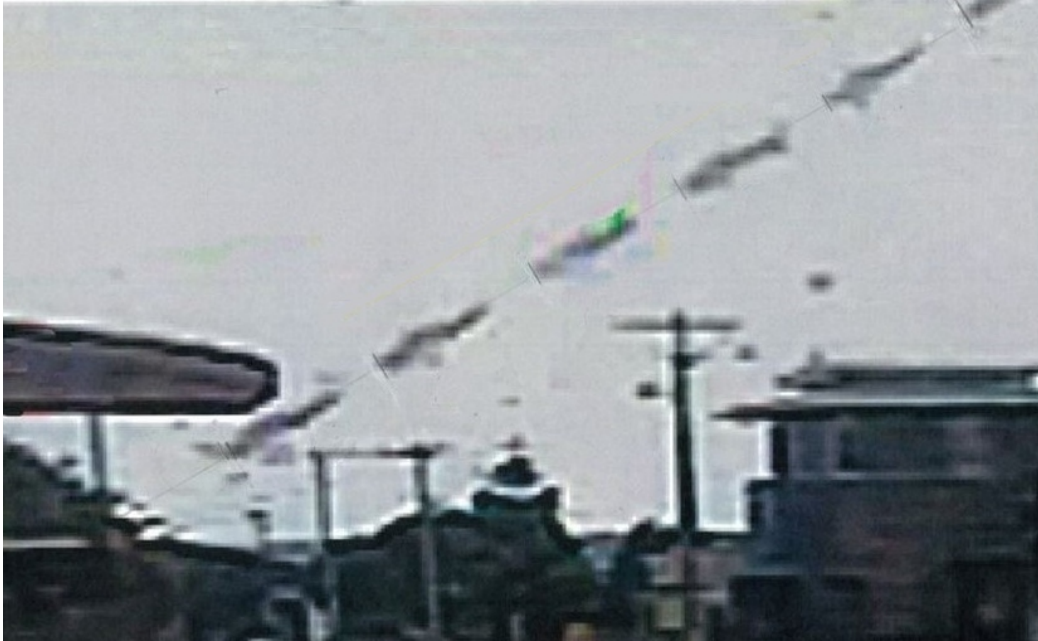
Examination of the wreckage found that the aircraft initially impacted a house fence at a descent angle of about 35° and slightly left wing down. Images recovered from a nearby closed-circuit television camera showed the last seconds of the flight and confirmed a steep nose-down flight path (Figure 6). The ATSB estimated that, based on the video footage, the aircraft's speed at that time was about 200 kt (370 km/h).

Figure 6: Composite image of the aircraft's descent. The image was developed from sequential video frames to show the aircraft's descent and was used to estimate the aircraft's speed within a 1-second timeframe

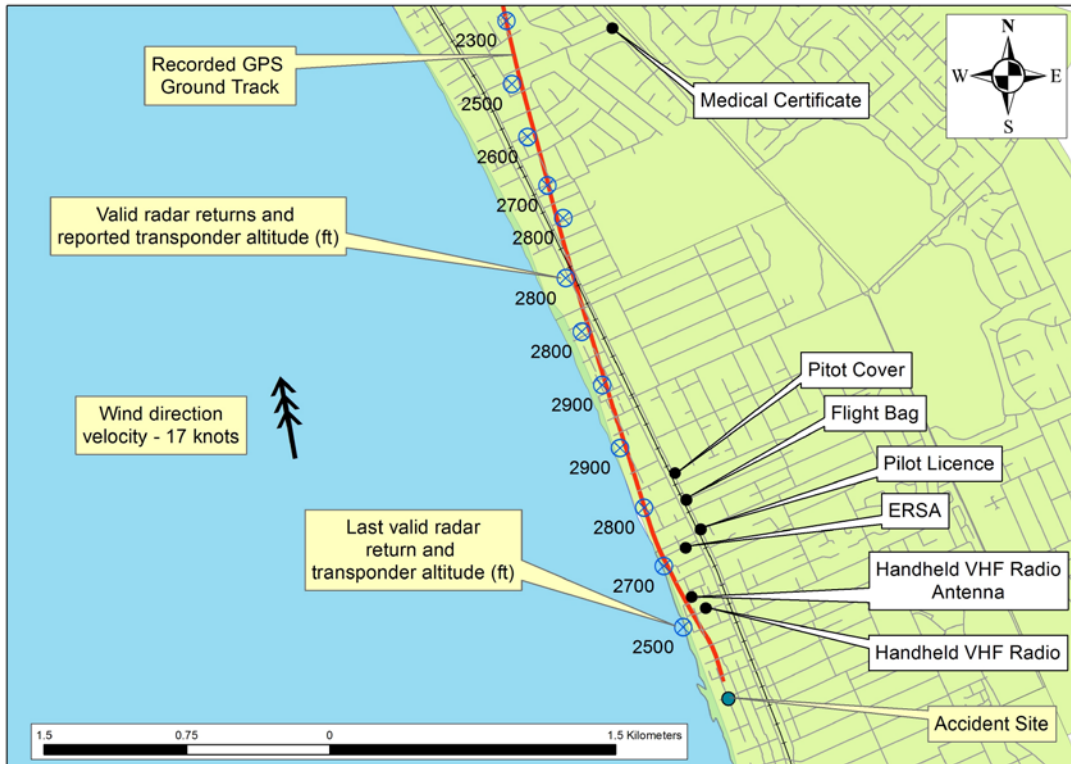
A number of aviation-related items were found by members of the public at distances up to 3 km north of the accident site (Figure 7). These items included the pilot's Civil Aviation Safety Authority flight crew licence and aviation medical certificate, an aircraft pitot tube cover and warning flag, a flight bag, an En Route Supplement Australia and a very high frequency handheld transceiver and antenna. None of these items displayed evidence of fire damage.

Figure 7: Location of recovered aviation-related items relative to the accident site

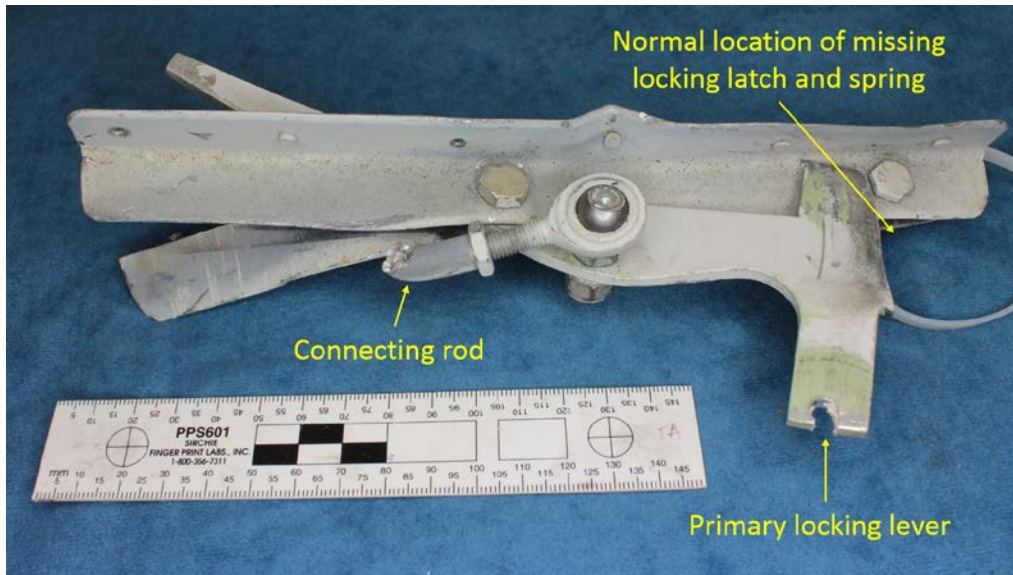
The primary locking lever was found in the unlocked position, however, the surrounding airframe structure was damaged and deformed. The locking catch and spring were not located, but the corresponding bolt was in place. The two hooks and hook receptacles on the rear corners of the canopy were not damaged or deformed.

- The damage and deformation of the lever suggested that it was initially closed, but was forced out of its housing into a partially-open position at some point during the impact sequence.
- While the locking catch and spring were not found, the attaching bolt was intact. It could not be determined whether the catch fractured during the impact sequence or was not previously in position.
- The locking lever connecting rod fractured in overstress, likely due to the impact. It could not be determined whether those impact forces caused the lever to open.

Figure 8: Primary locking lever, normal location of the missing locking catch and spring, and the fractured connecting rod

Damage to the primary locking lever mechanism suggested that it was initially closed but forced open during the impact. However, anecdotal reports from RV-6 pilots indicated that, under some circumstances, it was possible for the canopy in these aircraft to open when the lever was in the closed position. Furthermore, the ATSB could not discount that the pilot of JON may have manipulated the lever in attempt to lock the canopy during the descent.

There was no damage to the two hooks and their respective receptacles at the rear of the canopy whereas, if engaged at the time of impact, some level of damage to these components would be expected. While it was possible that the primary lock was open prior to the impact, the aircraft sustained significant damage, which may have affected the state of the mechanism. Also, the locking catch and spring were not found and could not be examined.

In response to this safety issue, Van's Aircraft Inc. developed a service letter for distribution to builders and operators highlighting the varying consequences of a canopy opening in flight, in particular, involving a tip-up (forward opening) canopy. The letter recommends inspecting the canopy locking mechanism to confirm that it operates as designed and to ensure the mechanism fully engages when closed. Keeping seatbelts fastened during all phases of flight is also emphasised.
