# Birdstrike involving a SAAB 340B, VH-OLM

Moruya Airport, New South Wales | 9 January 2015

**ATSB Transport Safety Report**  
Aviation Occurrence Investigation  
AO-2015-007  
Final – 14 December 2017

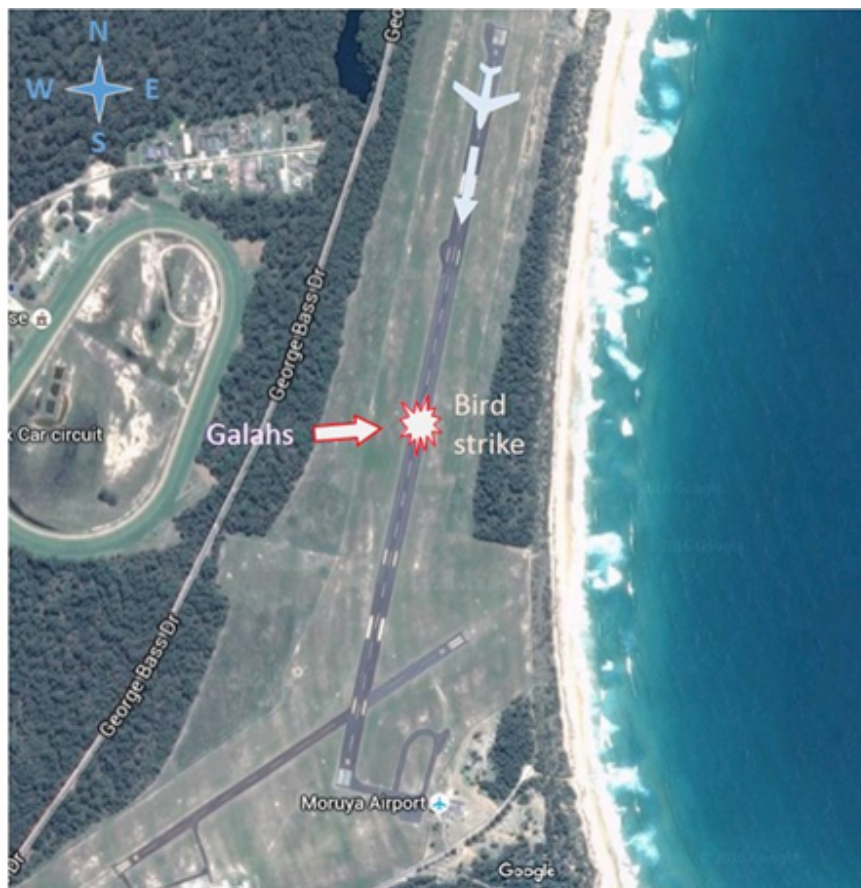
After touchdown, as the aircraft slowed through 80 kt, the captain took control of the aircraft for the taxi to the terminal in accordance with normal company operating procedures. The crew reported that, shortly after the captain took control, a large flock of galahs<sup>2</sup> took off from the grass to the west (right) of the runway and flew at a low height over the runway eastbound (Figure 1). In anticipation of a birdstrike, the captain increased wheel braking and applied reverse thrust on both engines. Prior to reaching the galahs forward thrust was selected. Despite that action, about halfway down the runway the first officer observed birds had impacted the aircraft.

**Figure 1: Moruya Airport showing aircraft and galah flock direction of travel and approximate impact point**

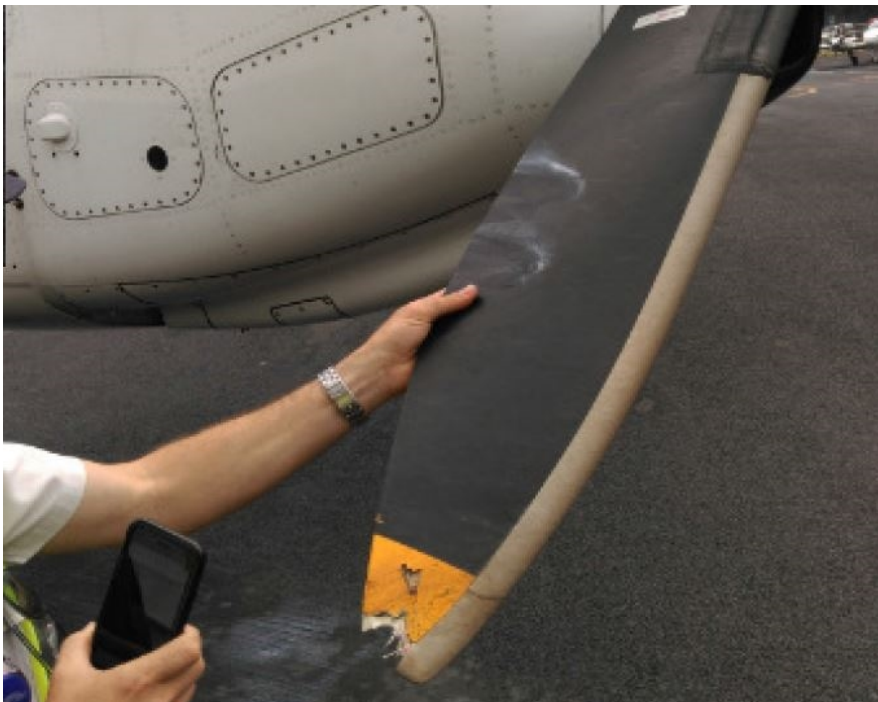
The crew then operated the aircraft from Moruya to Merimbula. After engine shutdown at Merimbula, the first officer opened the forward left door and observed that the tip of one of the left propeller blades had detached (Figure 2). The aircraft was declared unserviceable and grounded.

**Figure 2: Left engine propeller showing damaged blade tip on arrival at Merimbula**

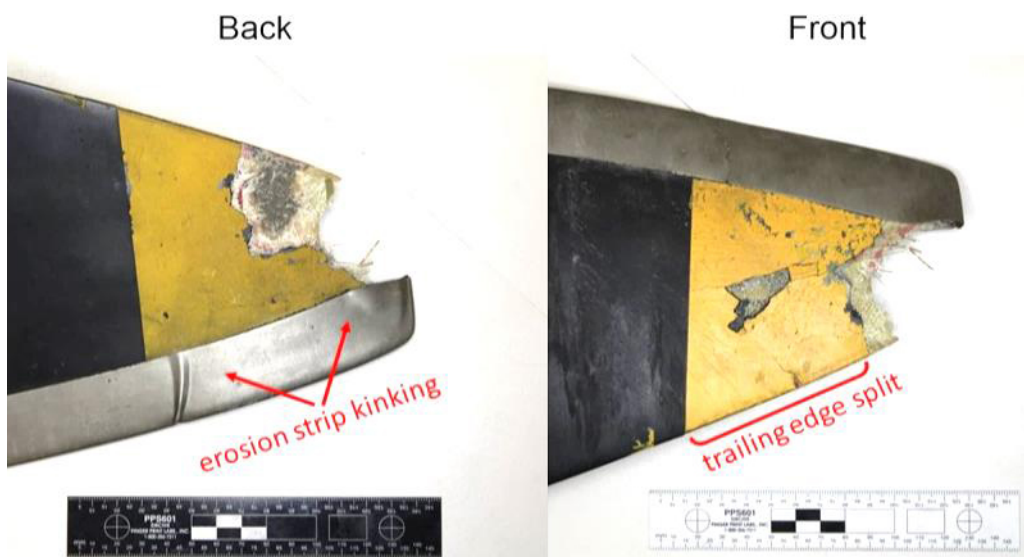
The left propeller blade presented with white powder impact marks toward the trailing edge, about 300–400 mm from the blade tip; about one third up the blade’s length. A section of blade was missing from the tip. Within the tip damage region, splitting at the trailing edge was identified (Figure 4). Damage to the leading edge erosion strip near the tip was also identified, with kinking on the back, and a corresponding crack on the front of the blade.

**Figure 4: Left propeller blade damage showing tip separation, kinking, crack, and splitting of trailing edge**

The propeller manufacturer concluded that the kink in the erosion strip on the back of the blade (Figure 4) was consistent with an impact on the front of the blade near the tip, bending the blade tip rearwards rather than forwards. The manufacturer considered this damage was consistent with a bird or other hard object impact. It also stated that it considered that the buckling of the guard would probably have occurred as a result of the impact rather than due to subsequent aerodynamic loading. Therefore, it believed the kink would most likely have been present at the time the blade was inspected at Moruya.

Examination of the blade found that the failure mode was consistent with a bird impact. Consequently, given the failure occurred on the flight following the birdstrike, it is almost certain that impact with one or more galahs initiated the internal delamination of the blade. This led to a rapid decay of its structural integrity and subsequent separation of the tip, as the blade was subjected to aerodynamic loads during the following flight.

The propeller manufacturer indicated that the buckling of the blade guard would probably have occurred as a result of the impact rather than due to subsequent aerodynamic loading, and the damage to the guard would have been evident when the blade was inspected by the flight crew at Moruya.

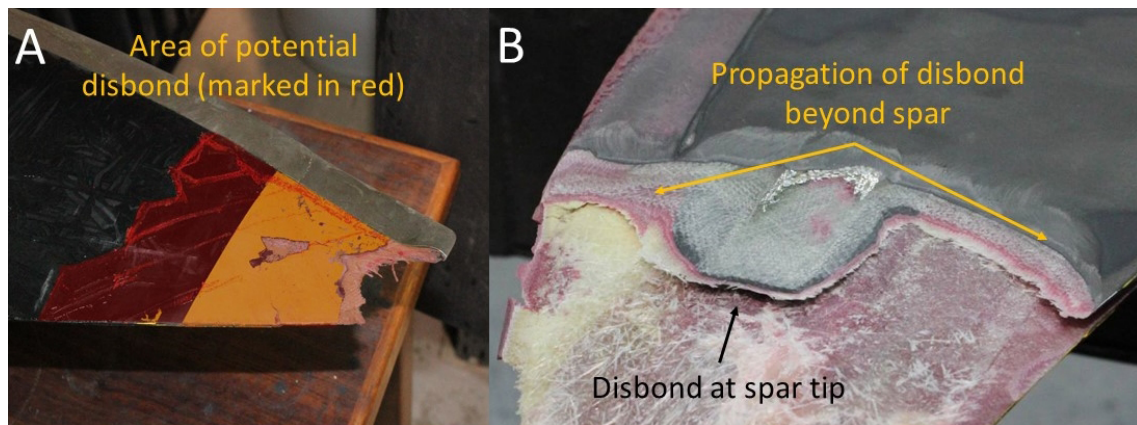
The blade was subsequently sent to a third party laboratory for NDT and destructive testing under the supervision of the ATSB. A dual probe ultrasonic tester was used over the entire surface of the blade. Disbond was detected in a region extending from the spar through to the tip of the blade (Figure 5A). Further destructive testing in the form of surface grinding was carried out to determine at which layers the disbond had occurred. That action showed disbonding at the carbon fibre spar tips. The disbond had also propagated along the glass fibre layer of the blade beyond the spars (Figure 5B).

**Figure 5: Region of disbonding shown**

The propeller manufacturer determined the damage was consistent with the effects of impact on the blade from the birdstrike. The most likely failure mechanism was considered to be delamination between the blade's foam core and spar barrier membrane. The delamination then progressed outboard into the fibreglass layer beyond the spar resulting in the subsequent tip failure.
